Adopted Measures for Evaluation and Remediation of the Damages Occurred in Darbandikhan Dam due to a Major Earthquake

Abstract

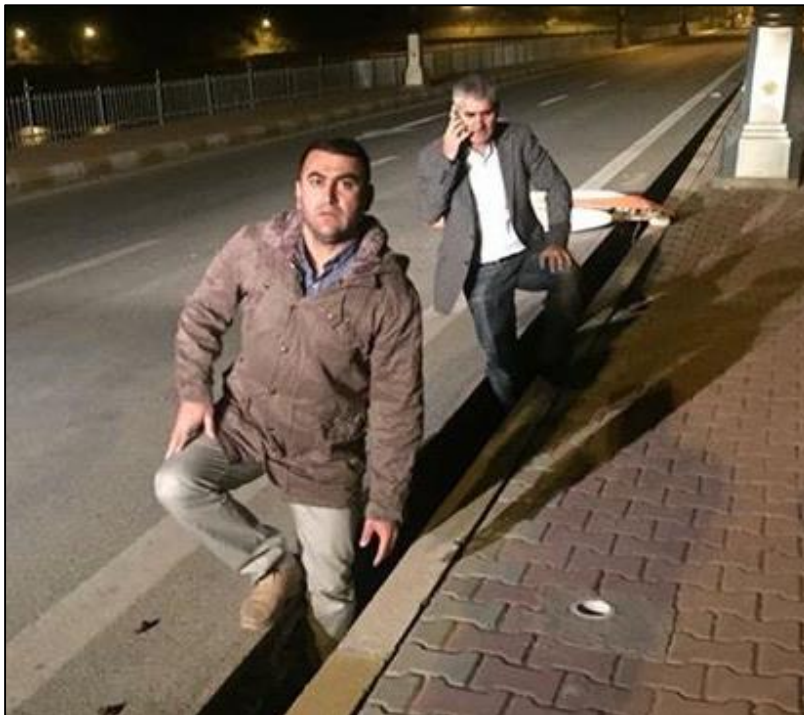
Figure 3 Visual inspection just after the earthquake.

During the visual inspections, many cracks and fallen rocks were observed on the crest of the dam, especially near the abutments. The cracks and fallen rocks were then documented. From the preliminary visual inspections, it was concluded that more inspections (detailed inspections) were necessary in order to identify all the crack patterns in detail. Therefore, the General Directorate of Dams and Reservoirs (GDDR), Iraq, decided to conduct a detailed safety inspection in collaboration with the University of Sulaimani/Engineering Consultation Bureau (SECB). The main purposes of the detailed safety inspections were:

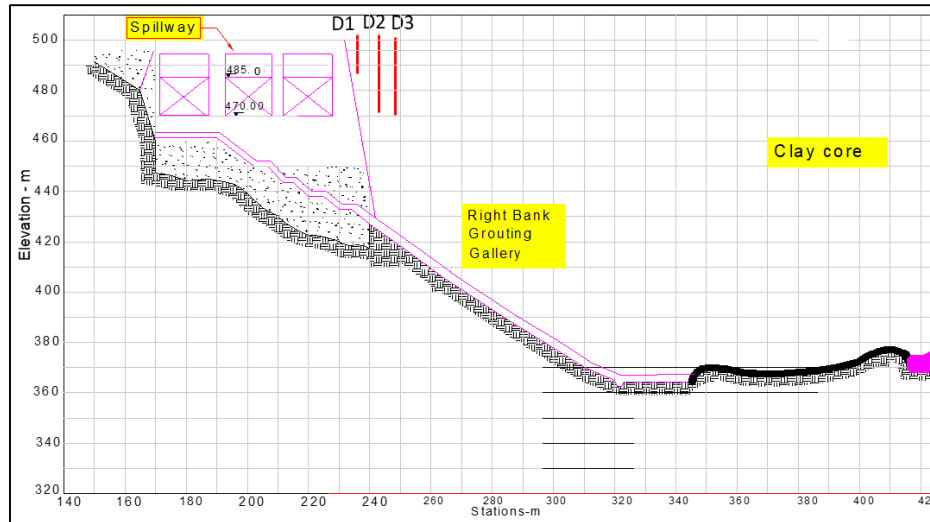
In order to detect cracks and weakened zones within the upper part of the dam body especially in the clay core, a geophysical investigation was carried out in 2018 at the transverse crack locations near the spillway. In this geophysical investigation, conducted by AMAK Company, two different methods were used; Ground Penetrating Radar (GPR) and the Multichannel Analysis of Surface Waves method (MASW) (Hijab 2018). From the interpretations of the geophysical data, the geophysical investigators identified three anomalies (deformations) at three locations with three different depths; at 8.0m, 22m, and 22m for D1, D2, and D3 respectively as shown in Figures (4) & (5). Accordingly, they recommended further field investigation in order to check the situation of the deformation in the clay core at zones D1, D2, and D3.

Figure 4 shows the locations of the deformation zones (D1, D2, and D3) along the dam body section (Hijab, 2018).

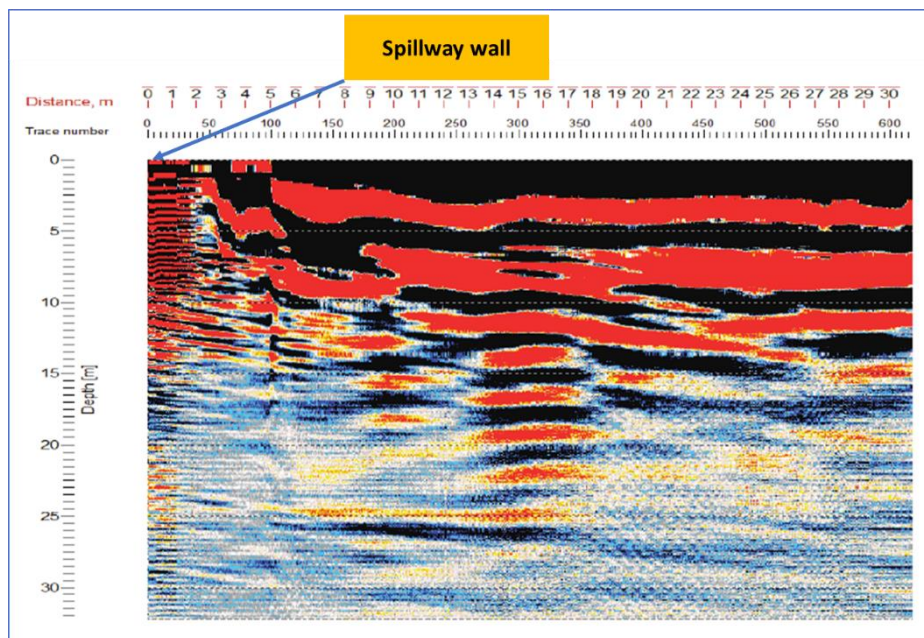
Figure 5 Radargrams of the GPR profile of locations D1, D2, and D3 at distance 3m, 10m, and 17m, respectively, measured from the spillway structure (Hijab, 2018).

From the results of the visual inspections of the borehole logs, strength test results, and constant-head tests, the traces of cracks and softening or weakened zones in the clay core at the three locations were not obtained. The incompatibility between the geotechnical and the geophysical results can be attributed to the existing of different types of materials in the study area (i.e. concrete, clay, sand, gravel, and rock materials).

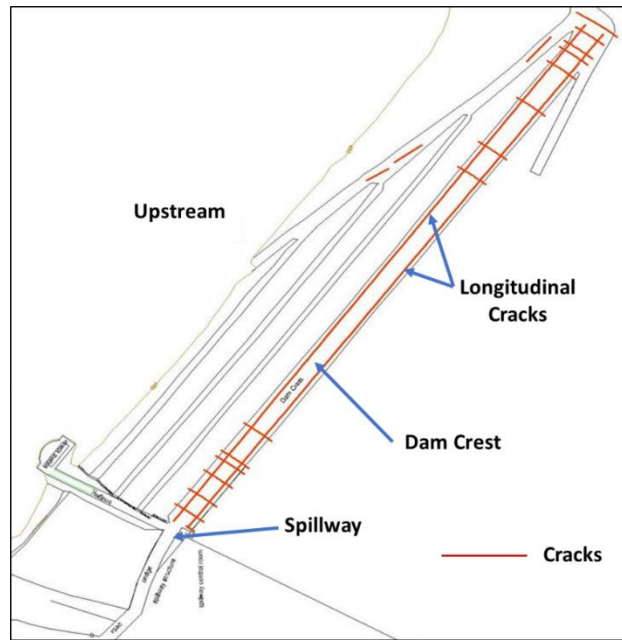
The cracks occurred due to the earthquake were mostly along the crest of the dam that ran mainly in the longitudinal direction, and some transverse cracks at the abutments. However, there were no differences in elevation between the two sides of the transverse cracks on the crest of the dam except that the one next to the spillway wall. Figure 6 shows a detailed mapping of cracks observed after the earthquake. Several test pits were dug at the crack's locations, except the transverse crack next to the spillway, all the cracks on the crest were superficial cracks; they were developed just in the protective layer and terminated at the top of the clay core (their depths were less than two

Figure 6 Cracks pattern (Yousif et al., 2019)

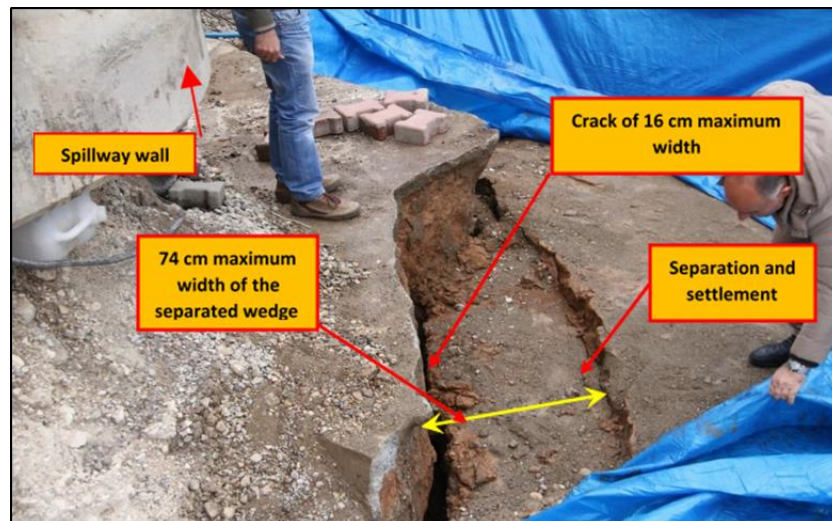
meters). **Error! Reference source not found.** shows the transverse crack next to the spillway. It appeared that the crack formed a wedge at this location. The maximum width of the wedge was 74 cm (Yousif et al., 2019). A tape measure was used for measuring the depth of the crack which was about 1.5 m.

Figure 7: The crack at the contact between the spillway and the embankment (Yousif et al., 2019).

According to a statistical analysis carried out by Pells and Fell (2003), the depth of cracks that occurred in embankment dams due to earthquakes ranges from 15 to 100 times the width of the crack at the crest. For the Darbandikhan dam, the width of the major transverse crack that occurred in the clay core next to the spillways structure was about 16 cm. So, the estimated depth of this major crack should be between 2.4 m and 16 m from the top of the clay core (i.e. it may go down from elevation 490.6 m to elevation 479m).

Based on the results of the detailed inspections, the repair works for the damaged parts of the dam crest was started in June 2019. The asphalt road, sidewalk, and electrical poles (they were old and some of them partially damaged) were first demolished and then reconstructed as shown in Figure 11. Regarding the spillway-embankment interface, it was decided to excavate the cracks to depths where the cracks will disappear and reconstruct it again as shown in Figure 10. Since it was found that the interface crack between the spillway wall and the embankment part of the dam was a superficial crack, it does not endanger the safety of the dam.

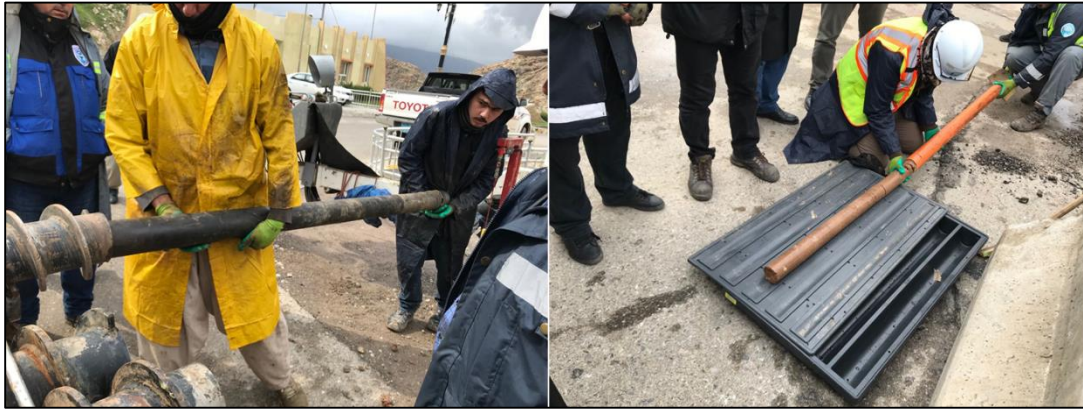
Based on the geophysical recommendations, further field tests were carried out in order to check the condition of the clay core at the area close to the spillway. Three boreholes at three locations (D1, D2, and D3 shown in Figure 4) were drilled using a continues method of drilling. Visual inspection was then carried out on the borehole logs. In addition, to check the strength of the clay core, an in-situ test was carried out on the clay core borehole logs using a pocket penetrometer instrument. Pocket cone-penetrometer is a valuable tool for providing approximate values of the undrained strength quickly (Bowles, 1996). Table (1) shows the results of the pocket penetrometer tests for D2 borehole. It can be seen that the values of (q_u) vary from 1.25 to 4.2 kg/cm². This indicates that the consistency of

clay for borehole number D2 (as an example) varied from stiff clay to hard clay. The results for the other tests, D1 and D3 boreholes, were similar to the results of D2 borehole.

Figure 8 Clay core log using continuous core method.

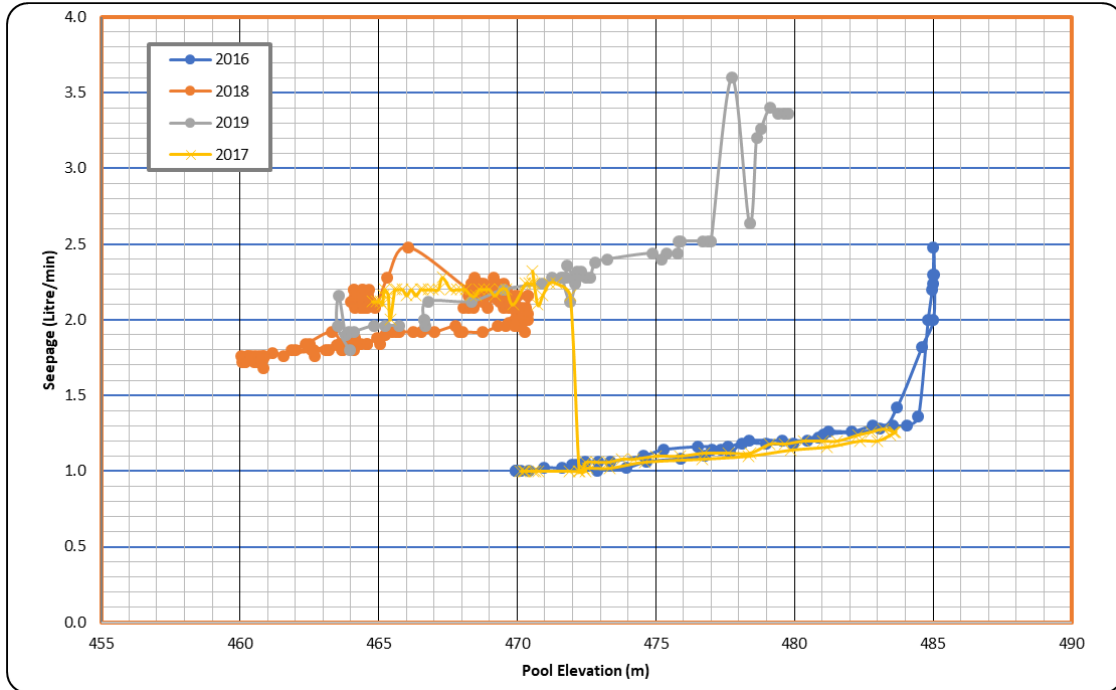
hit the dam on November 12, 2017 (see Figure 9). One day after the major earthquake, the seepage in the left bank grouting gallery increased rapidly from 1 l/min to about 2.1 l/min; about 110% increased. Since then the increase (about 110%) has been persistent. However, after the major earthquake, the pattern of the relationship between the seepage discharges and water elevations in the reservoir returned to the previous shape.

Figure 9: Left abutment grouting gallery seepage vs pool elevation.

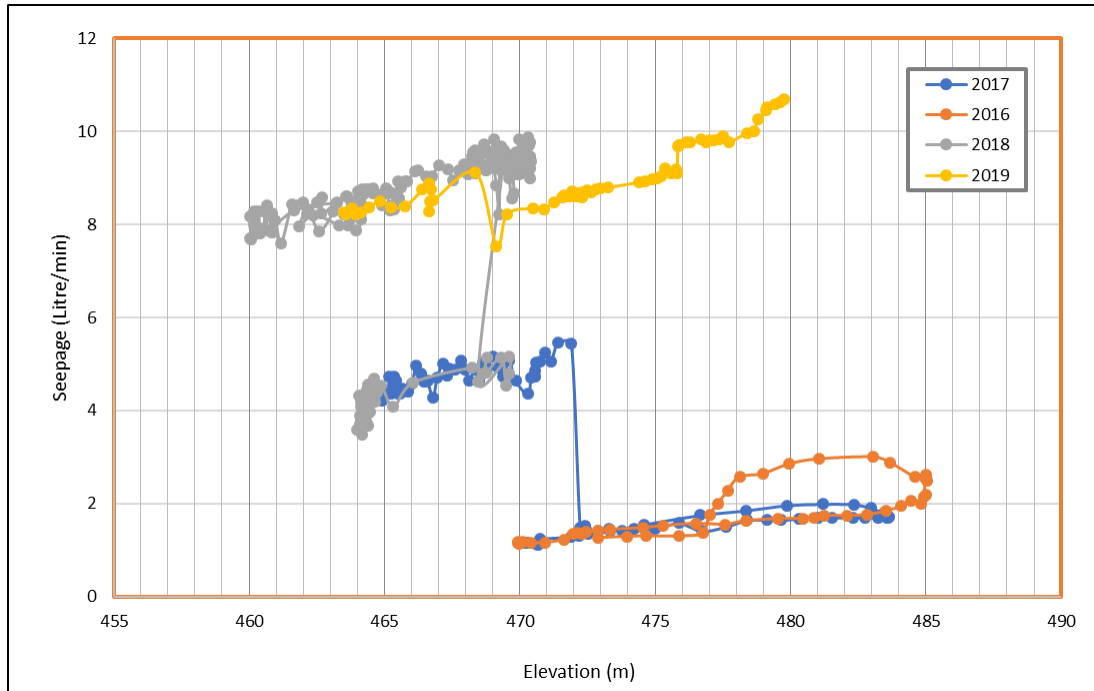
Figure 10 shows the change of seepage in the left gallery versus water elevation in the reservoir. From the figure, it can be noticed that there are two consecutive sudden increases in the seepage amount in the right bank gallery. The first seepage discharge has increased from 1.8 l/min to more than 5.5 l/min suddenly due to the November 12, 2017 earthquake. The second increasing was from about 5 l/min to more than 9 l/s, which means that the seepage quantity has increased about four times more than the seepage before the major earthquake. However, it is believed that the second increase might be due to another earthquake of Mw of 6.0 on December 11, 2017. The dam will be safe, provided that there is no turbid flow and that these amounts of seepage discharge are still low compared to the size of the dam's reservoir. However; as far as the seepage doesn't contain turbid water, and as far as it does not concentrate to a specified point, it can be concluded that the increased seepage will endanger the safety of the dam.

Figure 10: Right abutment gallery seepage versus pool elevation.

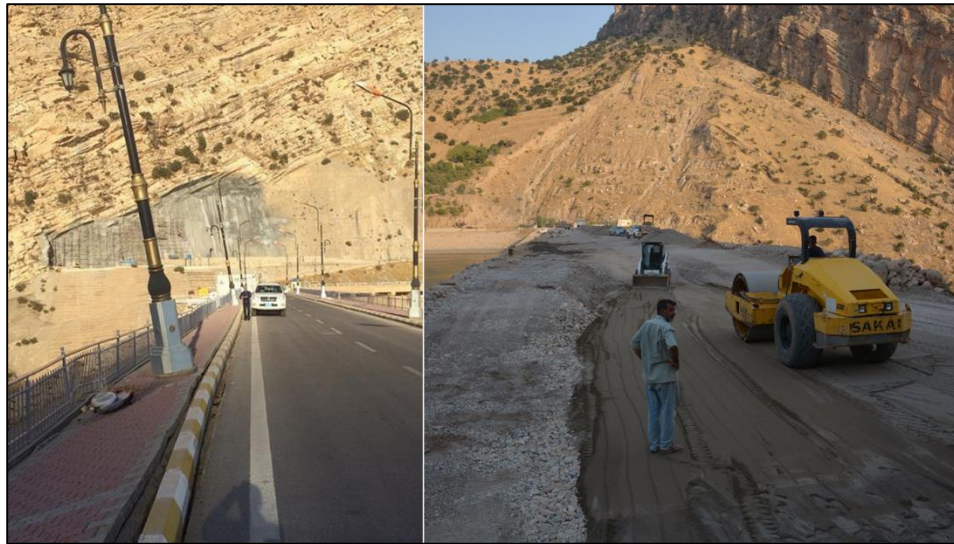
Figure 11: The crest of the dam before and after removing the damaged parts.

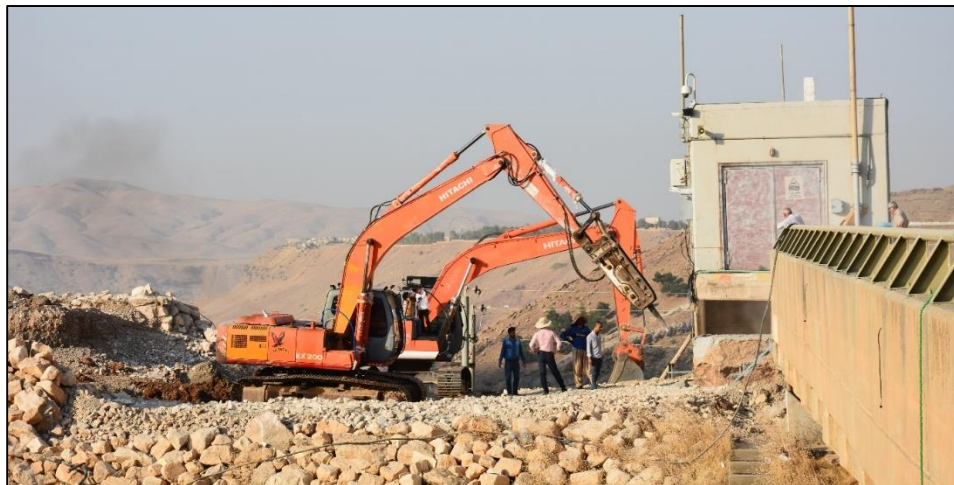
Figure 12: Excavation next to the spillway wall.
