# Evaluation and Optimization of the Instruments Installed on the Crack in Dam Block No. 9 - Karun 4 Dam & HPP Project

**Mohammad Ali Karimi<sup>1</sup>, Majid Hosseini<sup>2</sup>, Fatemeh Momeni<sup>1</sup>, Ali Dadi Givshad<sup>1</sup>**

1- AbanPazhouh Consulting Engineers, Tehran, Iran

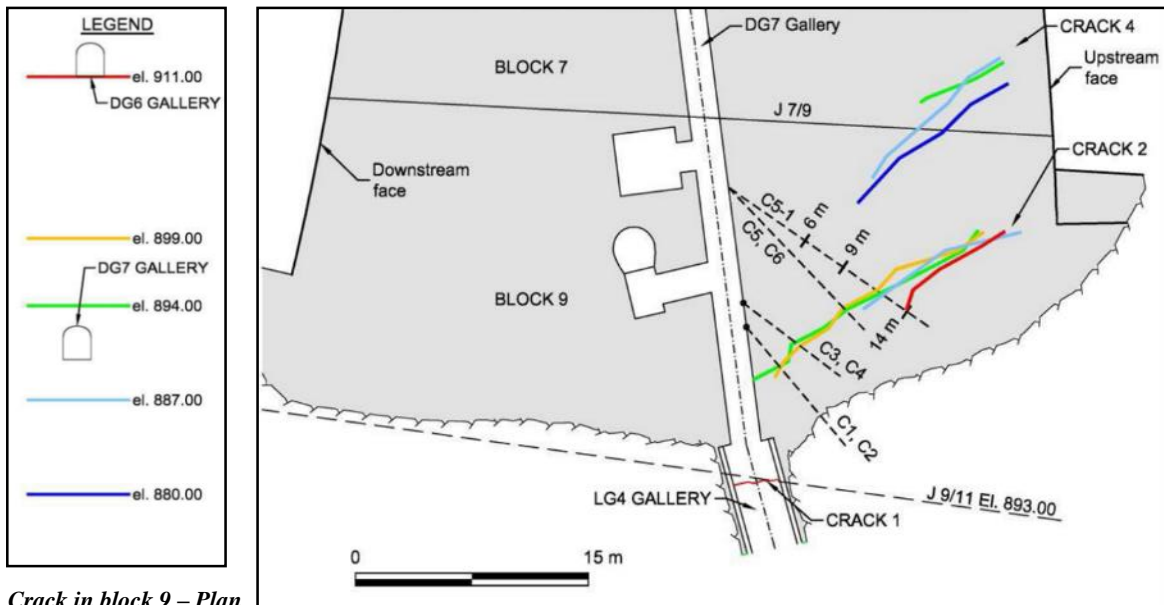
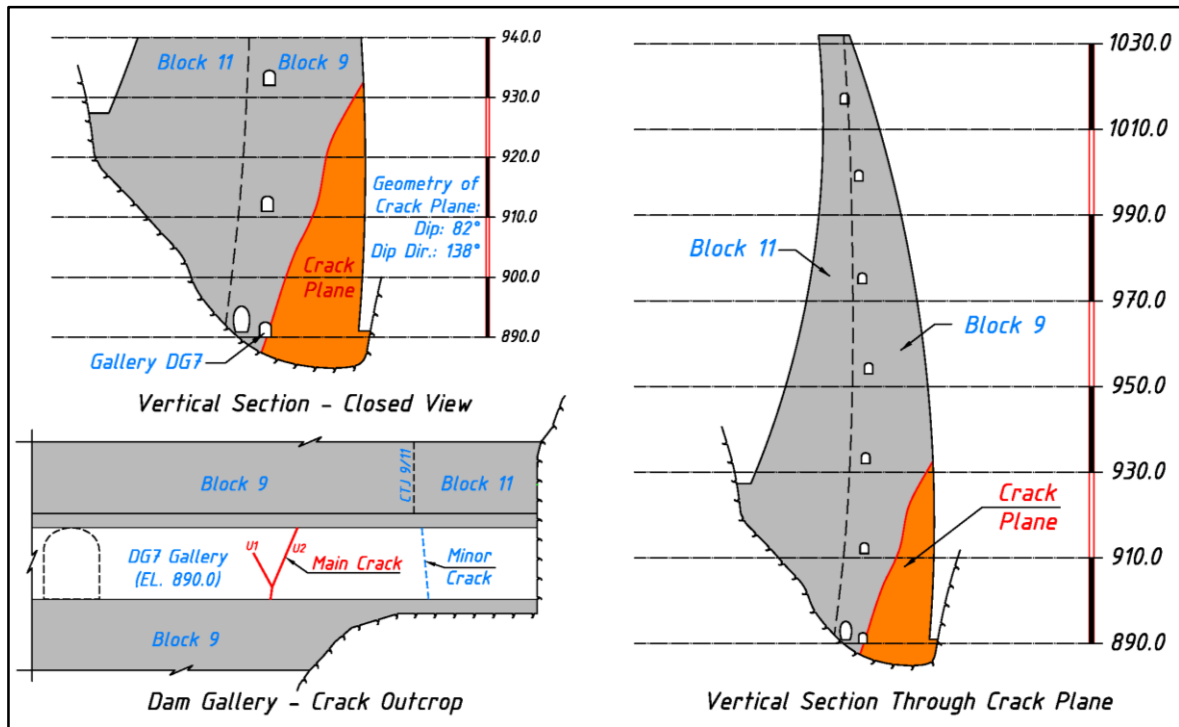
**Figure 1. Crack in block 9 – Plan (top), Crack outcrop and vertical section through crack plane (down)**

(Figure 1) [4]. As indicated in Figure 1, the crack outcrop is visible in upstream wall and partially in roof and bench of the dam gallery DG7 at elevation 890 masl.

It is worth noting that a minor crack was occurred early after impounding, almost at the extension of the dam contraction joint 9/11, which was terminated just above the gallery DG7, at elevation 893 masl. This crack is of minor importance and repaired by local sealing materials (Figure 1) [4]. The main crack in dam block 9 has two outcrop lines in upstream wall of the DG7 gallery, named as “U1” & “U2” by their observation time (Figure 1). Despite the early observation of “U1”, this branch of the crack outcrop is partially extends in the gallery upstream wall and exhibits limited response during the monitoring [3].

The next and main branch of the crack outcrop line, “U2”, was observed in less than two days after “U1”. This outcrop line extends in all whole height of the upstream wall and partially in the bench and roof of the DG7 gallery. Most of the further monitoring activities and assessment studies had been performed on this branch of the crack outcrop [2] [4].

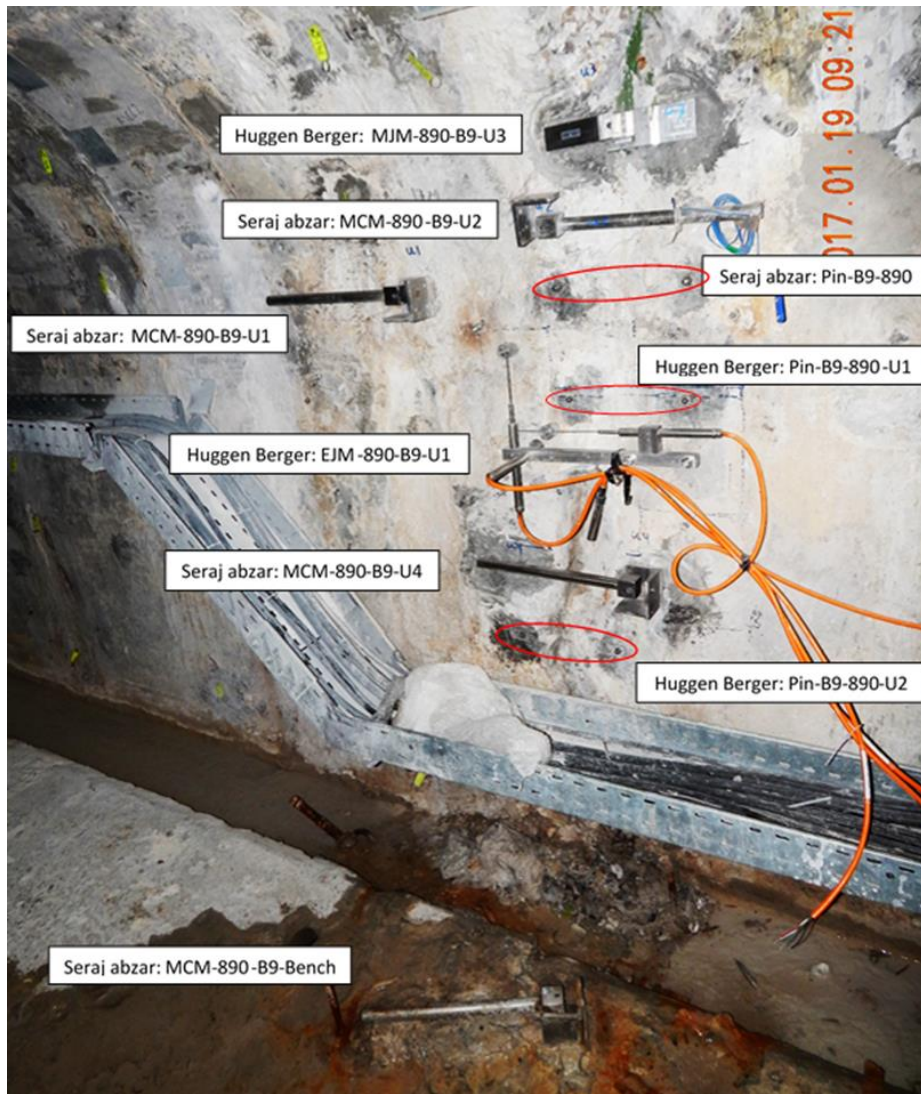
Figure 2. Instruments installed on the crack outcrop (1<sup>st</sup> & 2<sup>nd</sup> branches, left & right) - Gallery DG7, block No. 9  
 Table 1. Instruments installed for monitoring of crack in block No. 9

As indicated in Figure 2, crack-meters and jointmeters installed on the 1<sup>st</sup> and 2<sup>nd</sup> branches of crack outcrop on DG7 upstream wall, are almost parallel together. Therefore, related components of the measured movements could be compared to each other, after unification of the instrument local coordinate systems. Regarding the different installation times of the instruments on 2<sup>nd</sup> branch of the crack outcrop, for better understanding and comparability of the measured results, instrument measurements are superimposed to related measurement values of the oldest instrument (MCM-890-B9-U2), as the index baselines. The comparative graphs of movement components in “X”, “Y” and “Z” directions are plotted in Figure 5 [3]. In this Figure, the periods of first and second stage of “resin grouting” through the crack plane are also indicated (Grouting of the crack plane by appropriate resin materials was intended as the primary rehabilitation treatment which could dry out the crack surface and make it more stable by providing a reasonable bonding between the crack faces).

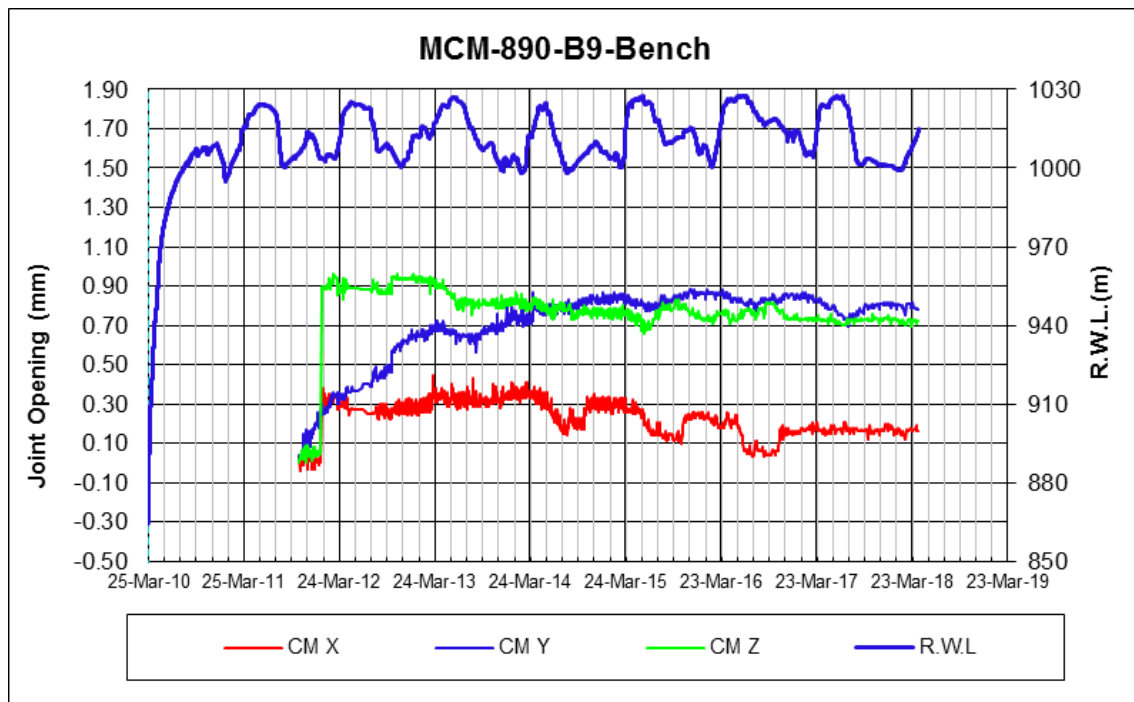
Figure 4. Results of the crack-meter “MCM-890-B9-B” installed on the crack outcrop in DG7 gallery bench

This crack-meter, according to its installed position, was completely exposed to traffic inside the gallery, therefore, the risk of collision with the instrument and causing shock to the measured result is high. The measurement results of this instrument are indicated in Figure 4. According to the obtained results, there was some stepwise increase in “Y” component and two sharp and concurrent shocks in the “X” and “Z” components of the measurements. Logically, such high and sharp movements (with a magnitude of about 1.0 mm) should be along with the appearance changes in the crack outcrop; furthermore, similar (not the same) shocks expected to be seen in the other instrument. Inspections of the crack outcrop and review of the other instrument measurements did not support such a high shocking movements. The trend of the following measurements shows almost no sensible movement [3]. Finally, it was decided to remove this instrument because of its high-risk installation location and the potential for unreliable performance [3].

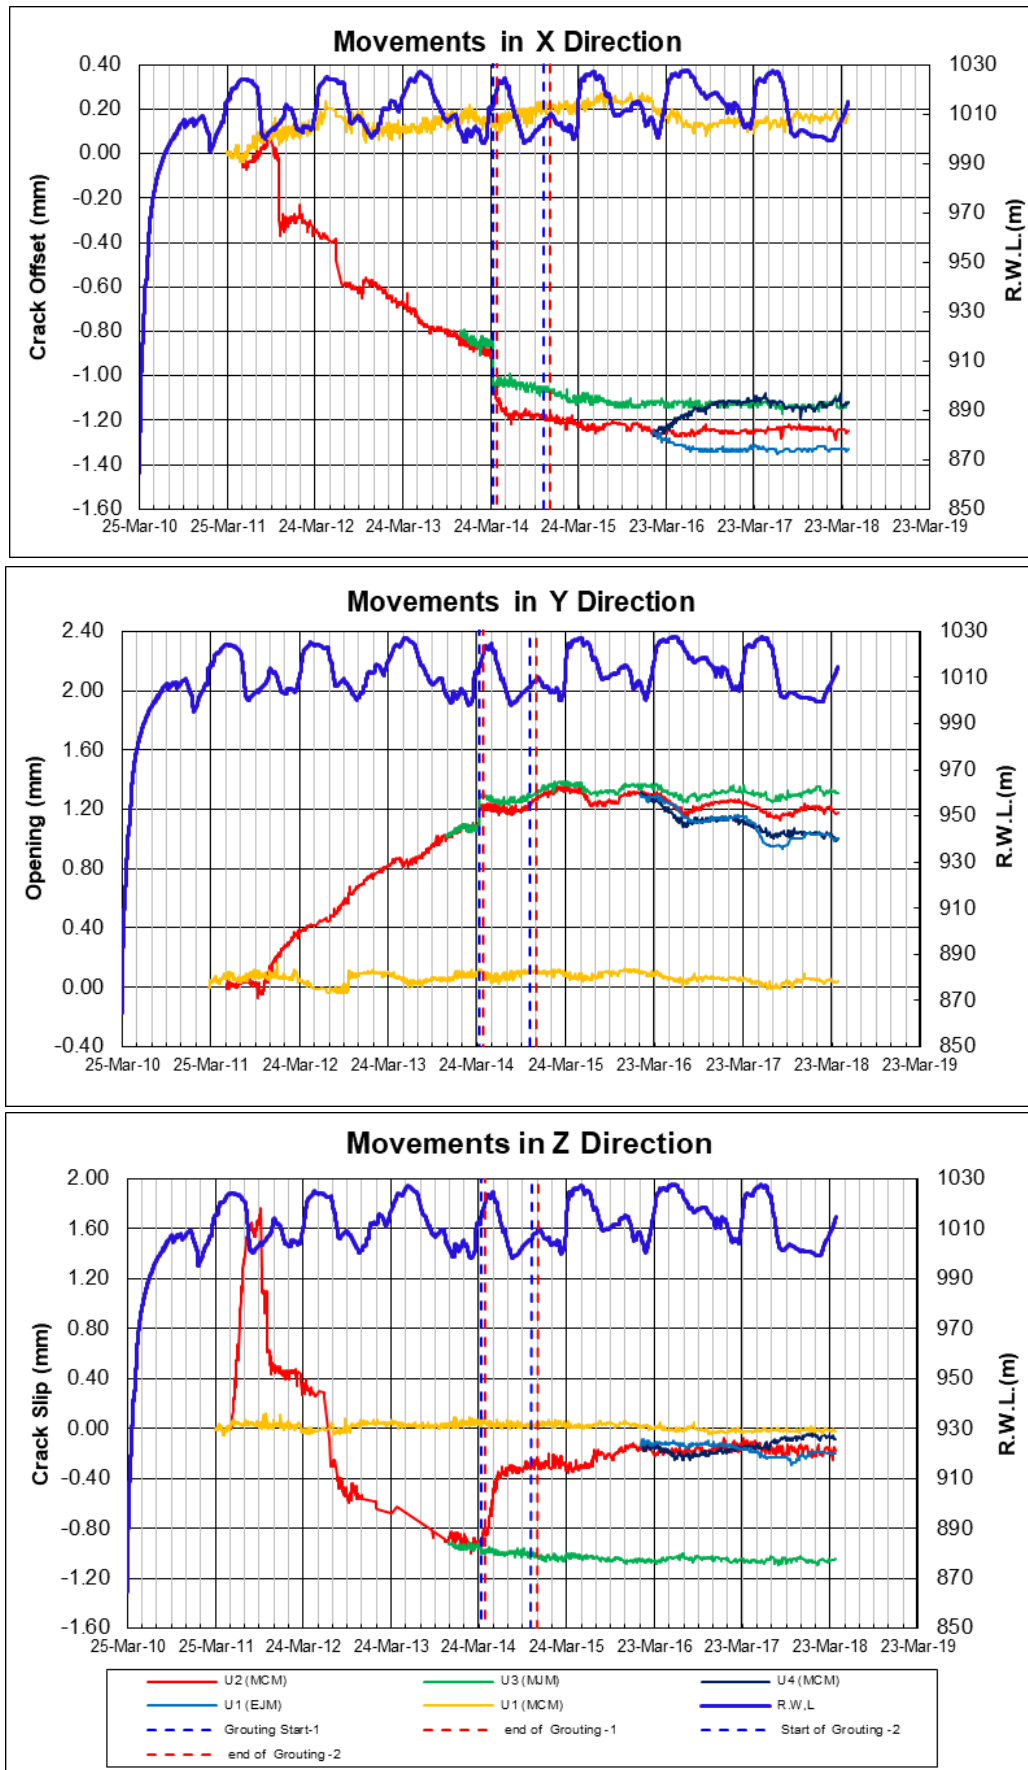
Figure 5. Results of the crack-meters and jointmeters installed on the crack outcrop in DG7 gallery U/S wall

According to the graphs presented in Figure 5, jointmeters “MCM-890-B9-U1” and “MCM-890-B9-U2”, the two early installed instruments on the 1<sup>st</sup> and 2<sup>nd</sup> branches of the crack outcrop, exhibits fully different movement values and trends of the crack plane. “MCM-890-B9-U1” indicates moderate and soft movements in all directions; the only potential movement of the crack plane is some “offset” type displacement (in “X” direction) by magnitude of about 0.2 mm. In the contrary, “MCM-890-B9-U2” represents very sharp and rough movements through the crack plane in all directions. According to the obtained results, there would be gradual opening through the crack plan up to a magnitude of more than 1.3 mm, and sharp and stepwise slipping and offsetting movements through the crack plane.

It was quite strange that vertical slipping movement more than +1.6 mm was depicted by this instrument and after a while, this slipping movement trend is reversed and its magnitude reduced to about -1.0 mm. These abnormal and doubtful movements were not justified by visual inspection and appearance of the crack [3] [4]. These rough and ambiguous measuring results would imagine the possibilities of “malfunctioning of the instrument (due to damages, potential hitting, etc.)” and/or possible active movements of the second branch of the crack outcrop. To clarify this, a number of new instruments were installed on the 2<sup>nd</sup> branch of the crack outcrop for verification of the measurements given by “MCM-890-B9-U2” and investigating the potential movements of the crack plane. The results obtained by the new installed instruments were not follow the sharp variations indicated by “MCM-890-B9-U2”; this is more clear by comparing the movement lines of the “MJM-890-B9-U3” and “MCM-890-B9-U2” for movements in “X” and “Z” directions. The interesting event is that by resin grouting of the crack plane, the rough variations in the measured movements by “MCM-890-B9-U2” were removed and trends of the results become more or less similar to the results obtained by “MCM-890-B9-U1”. It is worth noting that resin grouting of the crack plane was not sensible effect on the trends of displacement lines resulted by “MCM-890-B9-U1”. Following two hypotheses could explain these results:

- Full effectiveness of the rehabilitation works (resin grouting through the crack plane) on stability of the crack, or
- Side effect of the resin grouting on fixing the potential defects of the “MCM-890-B9-U2”.

As it is explained, visual inspections and other facts, like the seepage discharges through the crack plane, were not support the sharp and rough movements of the crack showed by “MCM-890-B9-U2”. Furthermore, results of the “MCM-890-B9-U1” do not support “Full Effectiveness” of rehabilitation works (resin grouting through the crack plane) on stability of the crack; because there was no sensible changes on its measured movement trends before and after resin grouting.

Disregarding the level of validity of each of the above scenarios, the results of all of the crack-meters and jointmeters installed on the crack outcrop in DG7 upstream wall are more or less the same (Figure 5). Therefore, it was decided to [3]:

- Keep the MCM-890-B9-U2 as the representative mechanical crack-meter on the crack outcrop,
- Keep the EJM-890-B9-U1 as the representative electrical jointmeter on the crack outcrop, which provides the possibility of automatic data acquisition in the ADAS system, and
- Remove the other crack-meters and jointmeters.

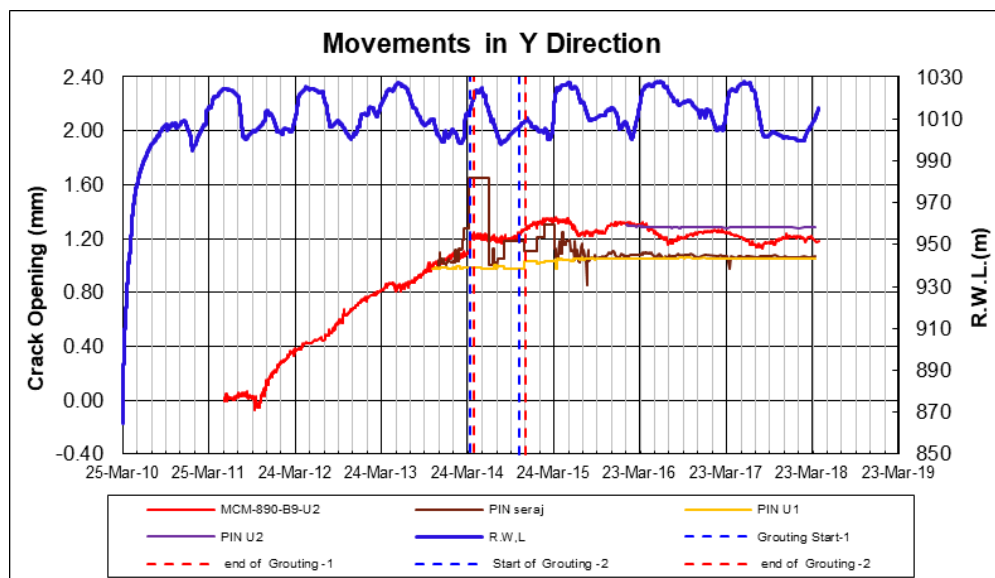
Figure 6. Results of the two-point pins compared with “MCM-890-B9-U2” in “Y” direction (DG7 gallery U/S wall)

As indicated in this Figure, the measurement results of the pins are not representing similar trends of crack opening; moreover, they do not conform to the results of the crack-meter “MCM-890-B9-U2”. This somehow might be due to relatively high sensitivity of the reading process of the pins. Anyway, it was decided to remove or stop readings of these instruments [3].

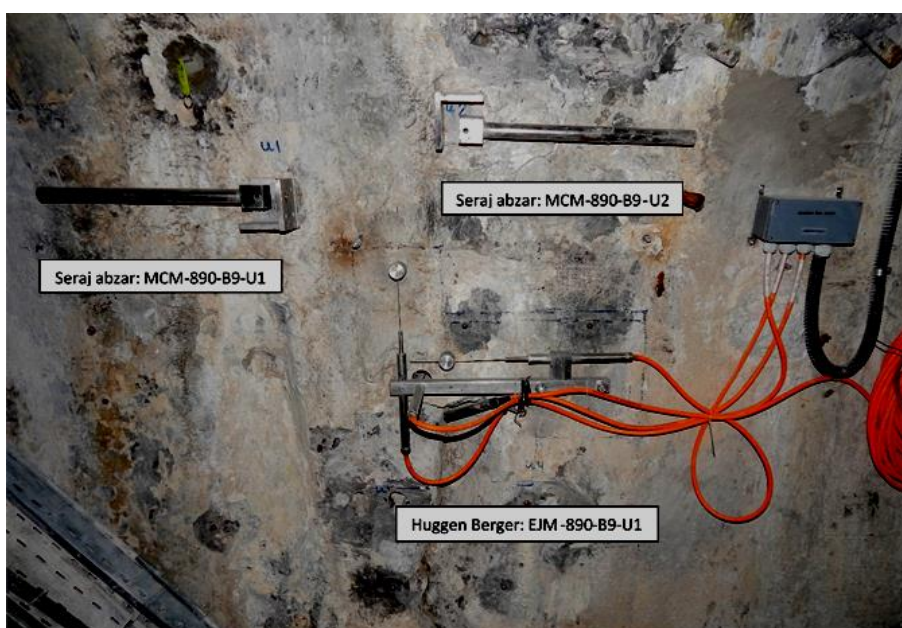
Figure 7. View of the Crack instrumentation after removal of the unnecessary instruments (DG7 gallery U/S wall)

In this paper, results of the experiences in instrumentation of the main crack in the dam block 9 are reviewed and discussed. Accordingly, among the 9 instruments installed on the crack outcrop in gallery DG7, 6 instrument were removed (Figure 7). It is worth noting that the main objective of the installed extensometers (indicated in Table 1) was controlling the grouting process of resin materials through the crack plane; however, some of these extensometers are reading as the permanent instruments.
