Monitoring of Lar Dam: Finding New Leakage Regions

Kamran Koohestani¹, Mahsa Ali-Haghezhad², Marjan Samuti³, MohammadReza Zarsazi⁴

Keywords: Dam, Leakage, Reanalyzing, Monitoring, Stability.

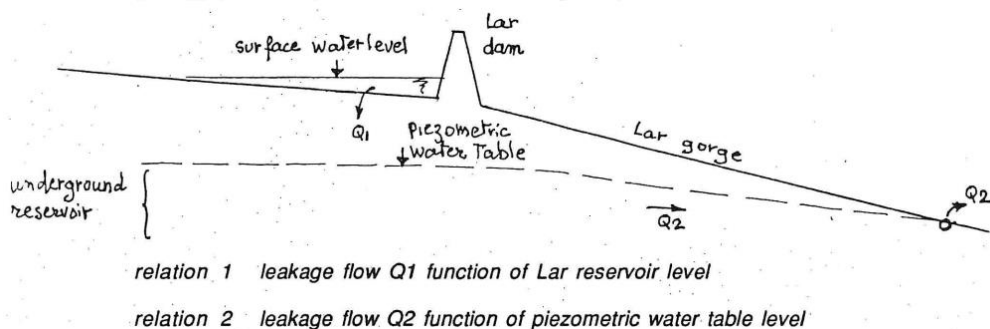
According to the geological studies of SETEC Company, the part of reservoir that has the potential of water leakage was estimated over 1 million m^2 . They believed that the most of the water leakage points are on the reservoir's walls. While the ultimate assessment depends on determination of permeability of the deposits and the structure of lake's bed (6th volume, Remedial and Alternative Works Report). Hydrologic studies conducted by analyzing the level of piezometers at the site. They identified route and direction of groundwater flows and analyzing some parameters such as geological structure, the location of piezometers, difference in time-phase between reservoir level and piezometer level to provide a good map of ground water flow status. By review on ground water elevations maps, hydraulic gradient changes are evident at different locations under the body of dam (the groundwater level in November 1986) at the junction of dam with the Tizkuh formation. There is no water leakage problem due to the high gradient of groundwater at this point, which indicates the accumulation of water behind an impermeable structure. This issue can be related to several injections and grouting curtain. Based on SETEC's reports, the main issue is impossibility of determination the south boundaries of groundwater elevation on the map. To resolve it two assumptions were defined, (1) outflow from the outlet points other than Haraz and Galugah springs and (2) there is a wider border in the study area rather than current state. SETEC described a mechanism for water leakage from the reservoir, which considers formation of a secondary reservoir under the elevation of reservoir's bed. It could store the water of reservoir after leaked into secondary dam, then the outflow will be exit from Galugah and Haraz springs (Figure 1).

Figure 1. Schematic plan of water leakage by SETEC

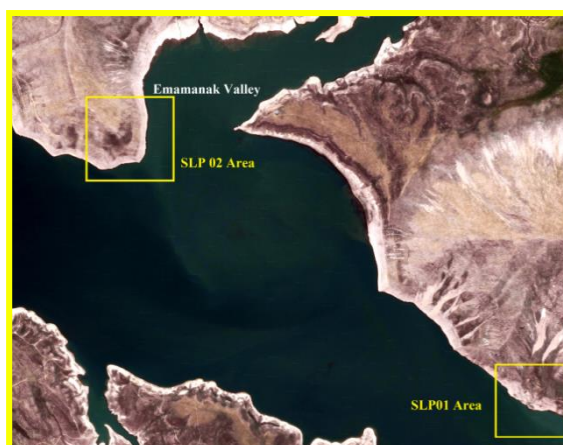
According to the table above, most of injected substances had been existed through the Galugah and Haraz Springs and this fact indicates the relation between the mentioned springs and the reservoir. Moreover, it shows that few injections did not exist and remained in the reservoir or the exact location of their outflow was unknown. This issue could be remarkable because of impossibility in determination of the south boundary of counter lines of groundwater. The primary focus of this study is on the available geological reports and reanalyzing the data that were obtained by Terra Company to identify potentially leakage of the area. During the studies of SamanAbSarzamin Consultant Engineering Company (S.A.S), in addition of Tiz-Kuh structure, two new regions introduced as suspicious points that need to more investigation: (1) Right bank of entrance to Emamanak Valley (SLP02 area) and (2) 1.5 Km upstream of Emamanak Valley (SLP01 area) Figure 3.

**Figure 3. Identified probable leakage points for field monitoring**

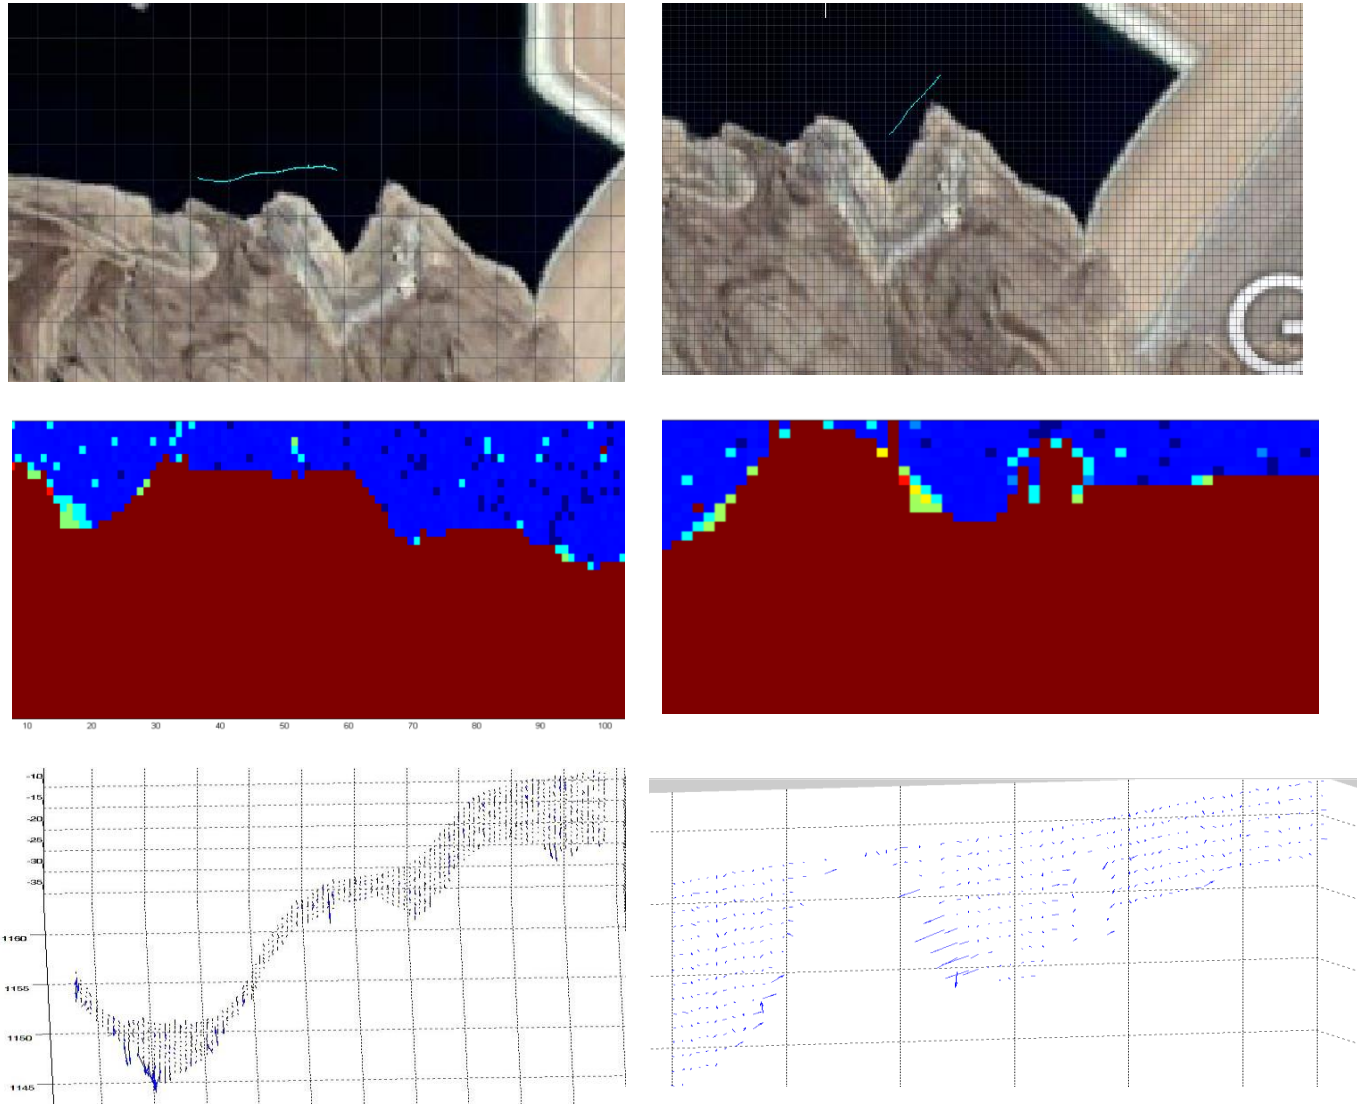
presented as a diagram (Figure.4).The weak point of these measures is related to the bad timing for surveying and surveying. At the end of the September and early of October, the water level was at 2474 m. Since many outlet points were identified at the above this level, it was more better to measure the velocity at the time of maximum level of the reservoir and more accurate information from outlet points could have obtained.

Fig 4. (a) Surveyed line, (b) 2D profile of water flow magnitude and (c) vector of stream flow in the profile

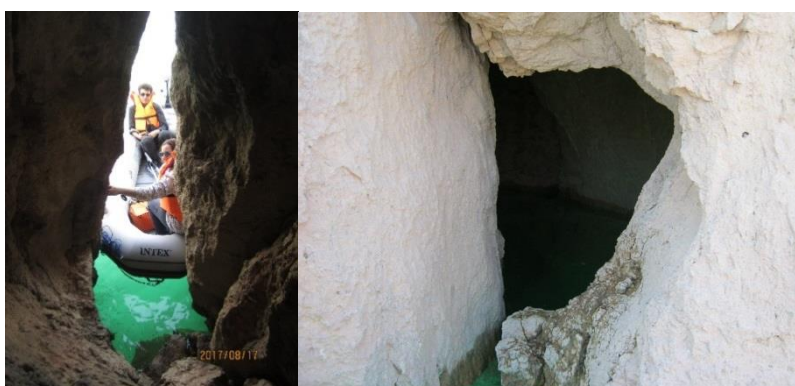
During this period, the water level raised from 2490.9 m to 2488.7 m. In addition, Tizkuh structure and the body of dam at the place of sinkholes were monitored. During the second field visit, new cases were observed. The first case was hearing loud sound of stream flow from the inside of the rock in Tiz-Kuh structure (P1 point). Injections at this point indicated the definitive water leakage in the whole range of this level and the location of injection and exiting of the injected substance for future monitoring was determined. The surveyed sites presented in Figure 6. The large karstic holes and cracks that has not been identified in previous monitoring (like C1) investigated with more details (Figure.5)

Figure 5. of C1

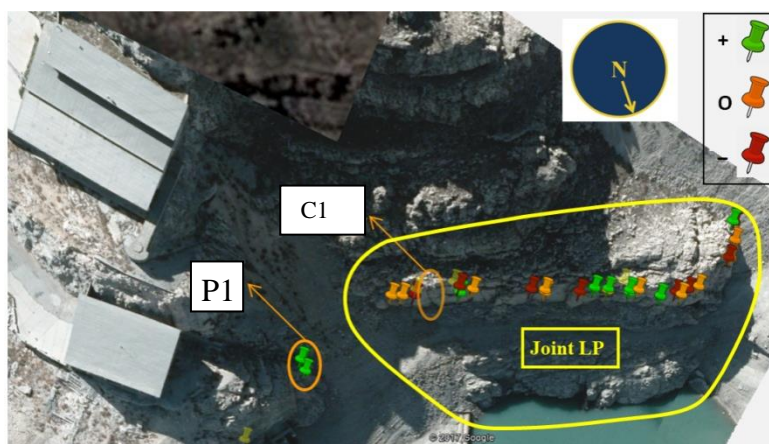
Fig6. Results of investigation and dyetest in 2017

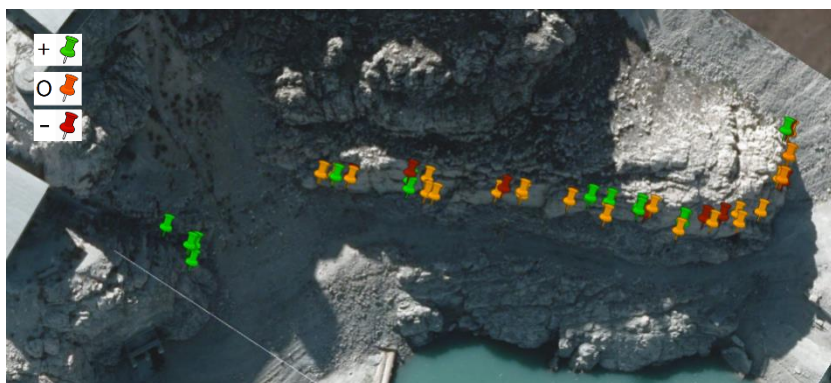
During this period, Region S1 was identified as the most complex region in that time. The structure of Joint LP is located inside of the region S1 and it has a probability of water leakage at this point. Despite several injections, still deep cracks observed in it. The result of field monitoring in July is presented in Fig 7.

Fig 7. The results of investigations and dye test in field visit in July

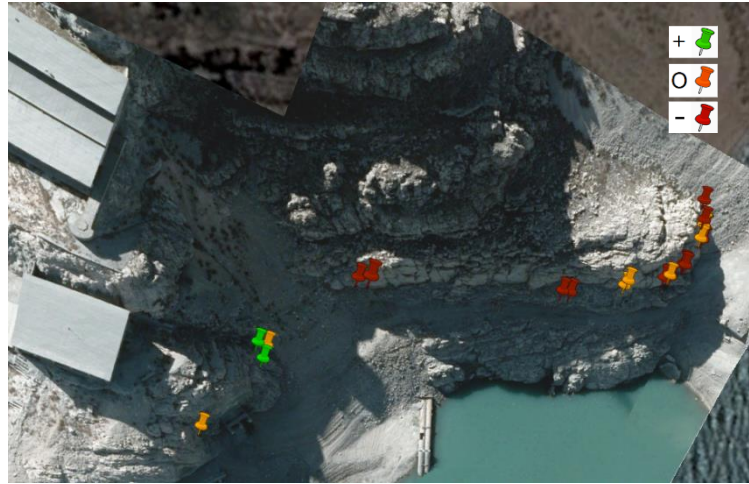
The right abutment, EmamanakValley and the upstream of it (SLP01, SLP02) monitored. In right abutment and the structure of Tiz-Kuh besides dye injection in cracks, investigations were carried out with more details on the dissolution cavities. Above the level of LP04a a new crack observed. The scouring erosion in eastward and inside of the caves, existence of wood and debris within a few meters inside of the cave were evidences of water leakage. A series of injections were carried out from 2491 m level to the lowest level 2482 m. The result of injection at this place is presented in Figure 8.

Figure 8. The results of field monitoring and dye injection in September 2017

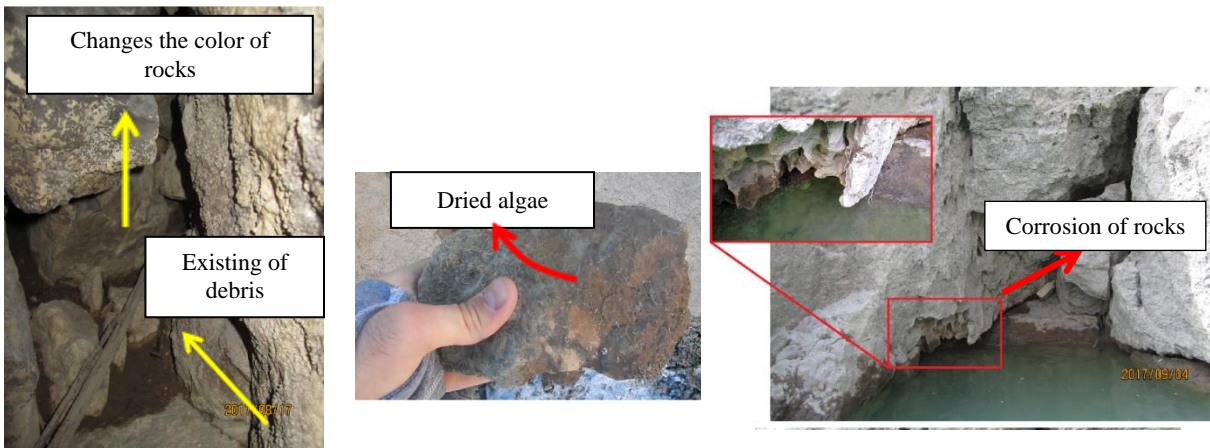
Due to the decreasing of water level and appearing suspicious water leakage points, besides common inspections, identified leakage points in previous field visits were investigated again to measure size and dimensions of the holes more accurately. In general three types of signs for water leakage were evident at these points, the first one was changes the color of the rock masses and darken them. Secondly, existence of dried algae and accumulation of them in holes and crack and thirdly, decreasing the sharpening of the edges of rock masses which were exposure of outflows. Some of these evidences is presented in Figure.9.

Figure 9. Evidences of water leakage

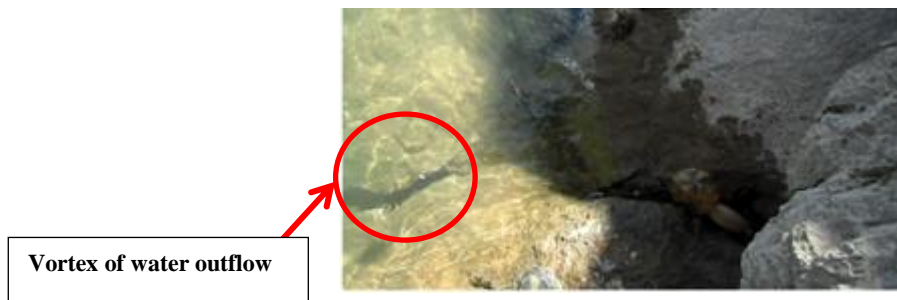
Due to the lack of remedial works at upstream of Emamanak Valley, when the surface water elevation reaches to higher level, the water leakage in this part will be by far higher and greater than right abutment of dam. As it is presented in Figure.10, leakage of water from holes and cracks clearly observed in form of vortices on surface of water.

Figure 10. Formation of vortices

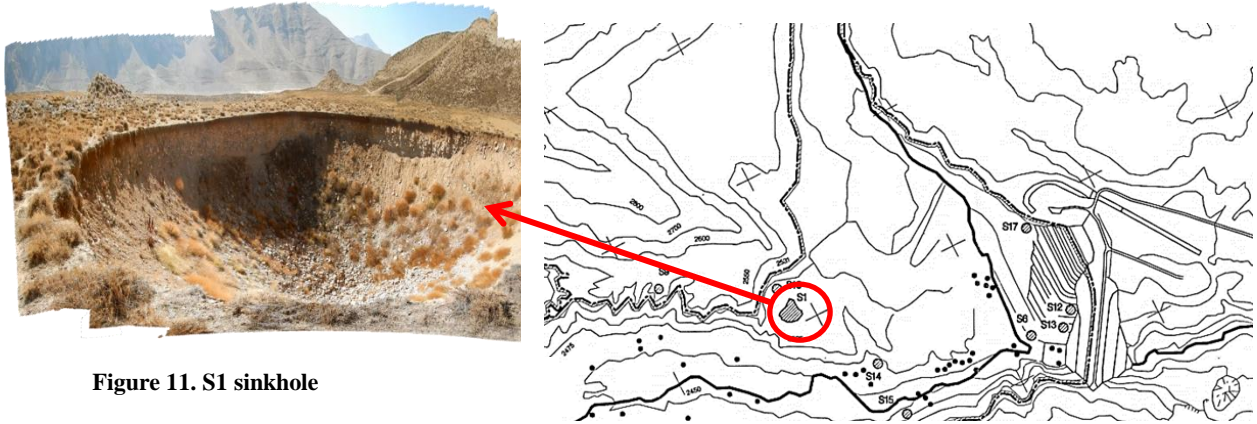
During field visiting on 12 October, dye test was performed at suspicious areas, also sampling from the surface of the rock with corrosion problem were conducted to assessment the efficient of past operations. Some sinkholes were visited such as S1 sinkhole during this series of site inspection (Figure. 11)

Figure 11. S1 sinkhole

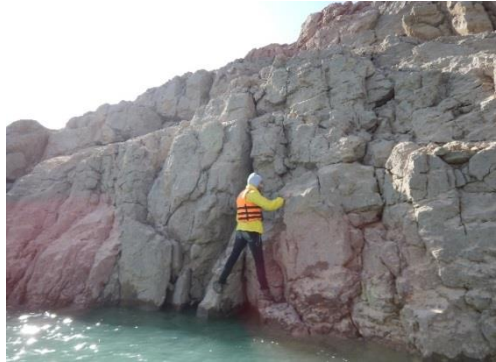
Based on the last field monitoring, some points that were under the water surface and after decreasing the level of water they appeared, accurately investigated to find more leakage points, which were not accessible during previous monitoring (Figure12).

Figure 12. Conducted measures at upstream of Emamanak Valley

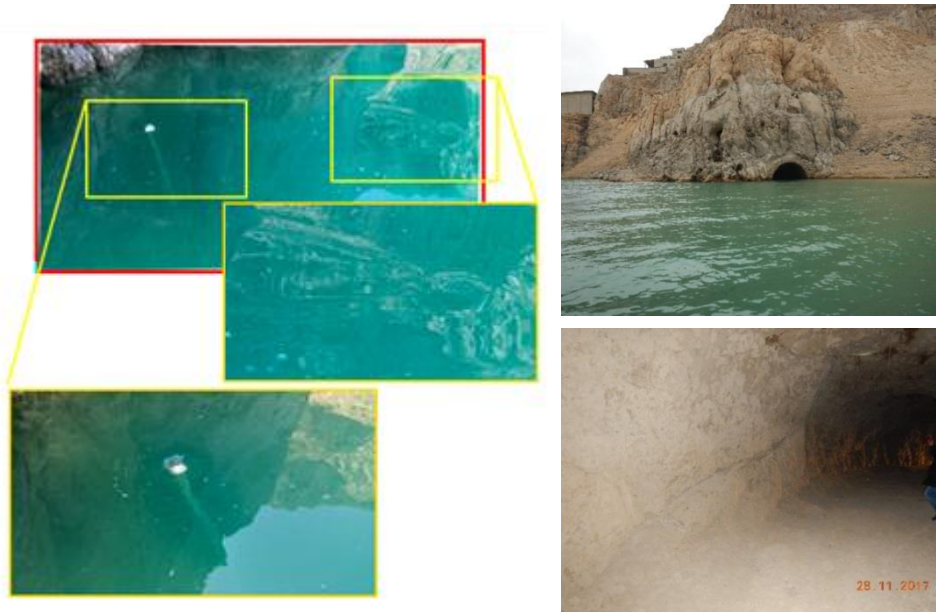
On 28 of November, the last field visiting was conducted to investigate the suspicious leakage points which had not been visited before. The elevation of surface water was about 2470.7 m. Two remarkable points were, gravel and plum stone which acts as a porous and permeable cover and a conduit for passing the stream flow also, folds and fractures in the rock structure continue to the highest level of this structure and it indicates existence of fault and cracks in whole of the structure. The diversion Tunnel 01 is one of the major leakage pints. At high water levels, when the tunnel were 3 meters below the water surface, vertices were formed which indicated suction of water into the tunnel and depth of lake. During several visits, by entering in to inside of tunnel and observing cracks on the walls of the tunnel and debris inside the holes clearly revealed that water leakage from the body of the tunnel was happened. Since the tunnel was drilled by explosion, the crack and holes become wider and the corrosion of stones has increased during these years.

Figure 13. Vertices formed on above the Tunnel 01, visiting inside of the tunnel

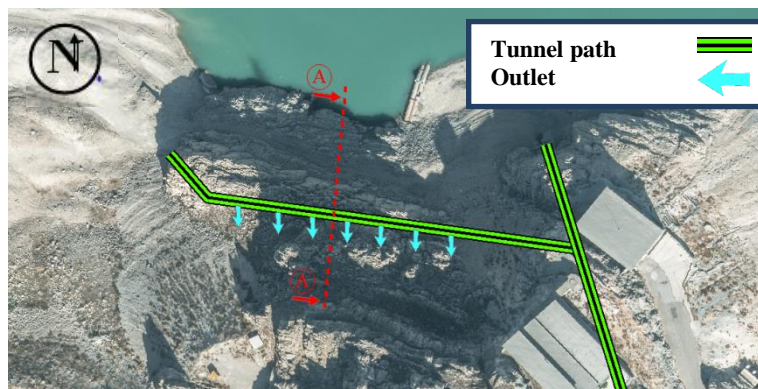
The first step for study on water leakage from the Lar Dam is theory and reanalyzing the available data and reports. The results of reanalyzing the previous research of consultancy measures showed that Setec Consultant Company had conducted very good studies in the field of geology and hydrology of the site. Terra Company has provided accurate measures on water flow near to reservoir's walls. Although they did not choose a good time for measuring and during that time the water level was at 2474 m, if they did measuring when the water level was at maximum level, the better understanding on flows and velocities will be reached. Geological studies showed that there was an old natural lake at this place, which was created by natural dam with Damavand lava. This dam was created on the Haraz River. Among of different geological structures of the area, Lar limestone rocks in contact with water are the most dangerous one. Because of the presence of natural and old lake at this place have been transformed into the karstic structure up to level of 2570 m. and these karstic holes provide some passage ways for crossing water flow. According to research of Feghhi in 2006 water flow by passing through this paths will reach to the Lar-Polour fault and Haraz and Galugah springs are outlet points for the stream flow. This shows all the field studies should be extended up to the level of 2531 m. Previous studies indicated the water leakage from the right abutment at the place of TizKuh structure. The diversion tunnel 01 as the main leakage point were monitored several times by S.A.S Company. The results of visiting indicated that presence of numerous cracks on the walls of tunnel and using explosion way to create this tunnel leads to widening and increasing these holes and water leakage at this tunnel. Presence of caverns and boreholes on the way of this tunnel to the Joint LP showed that digging of this tunnel could have a large impact on the intensifying this problem. Figure 14 shows a map of tunnel pathway.

Figure 14. Schematic location of diversion tunnel 01 and its connection to Joint LP

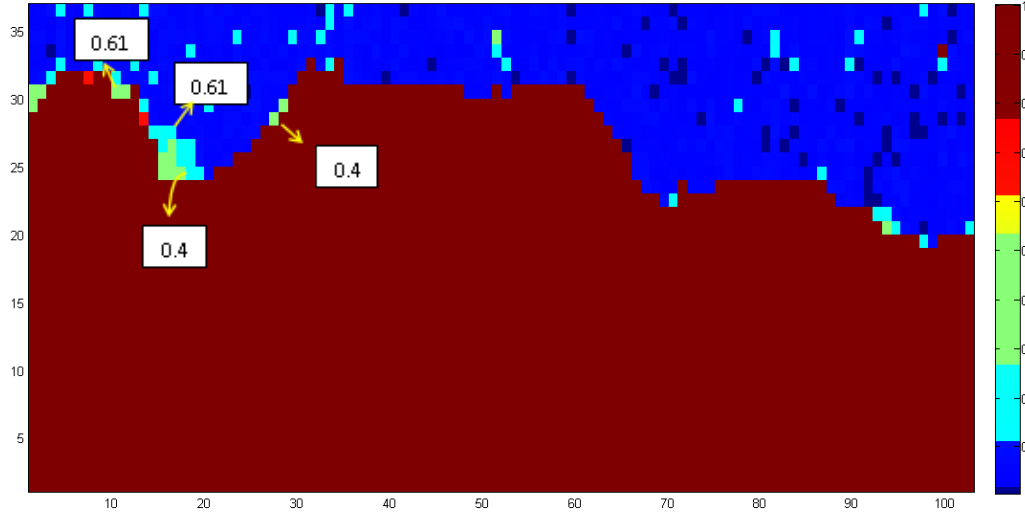
SamanAbSarzamin decided to conduct dye injections at levels under the water surface. Otherwise all calculations of the outflow velocity would be unreliable because of neglecting the head pressure and velocity in the holes under the water surface. There are 4 leakage points along with D-3 line which is surveyed by Terra company (Figure. 15).

Figure 15. velocity magnitude of flow in D-3 line (Terra Company) (m³/s)

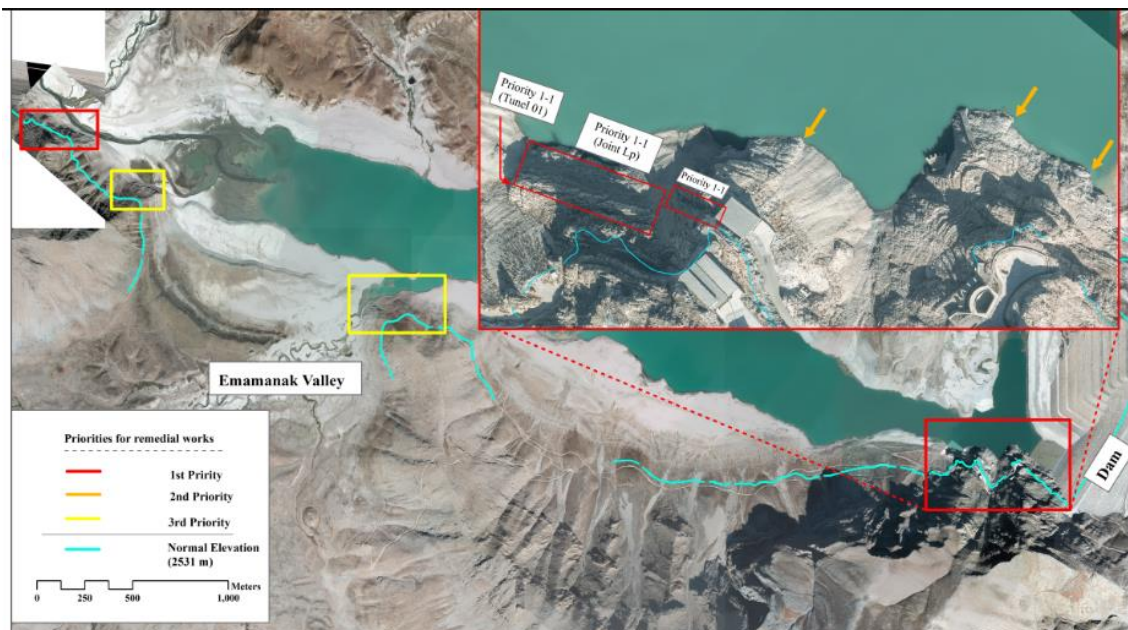
Figure 17. Prioritized treatment plan

It is necessary to identify all leakage points before implementation of remedial plans. The obtained results by S.A.S showed that two points are sensitive the first one is diversion tunnel 01 and the second one is upstream of Emamanak Valley. The tunnel has no lining and there are several long cracks and holes on the wall of this tunnel. Therefore, providing surface lining and grouting cement for the Tiz-Kuh structure without sealing lining will not so effective to solve the problem because this tunnel conduct water stream by cracks and hole into the surface water and this problem will be intensified under the hydrostatic pressure when the water level is high. Moreover, the upstream site of Emamanak valley is recommended to coverby sealing lining because when the elevation of surface water is high, this region will be a main leakage point. There is need to investigate the stability and vulnerability of dam by considering the fractures, determination the capacity of dam for current status which it is able to store water up to 2531 m level. Investigation of changes in water level at Galugah and Haraz springs as outlet points should be carrying out by doing tracing inspection and dye injections. Investigating the required strength to withstand the double hydraulic pressure at the level of 2531 m should be addressed in future. Hereis provideda prioritized treatment plan in regions at risk of water leakage (Figure. 17).
