ICOLD Symposium on Sustainable Development of Dams and River Basins, 24th - 27th February, 2021, New Delhi

SUBSURFACE INVESTIGATION OF A MAJOR DAM FOUNDED IN KARSTIC TERRAIN

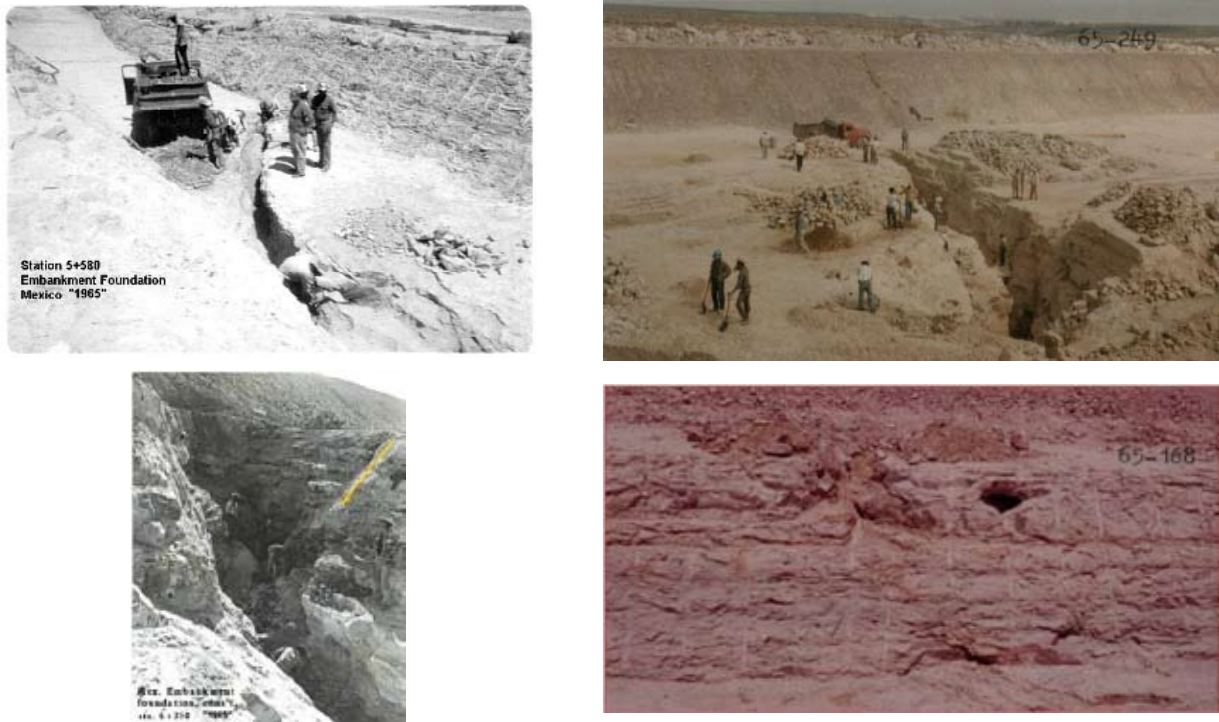
Several large cavities were encountered during construction of the Western Embankment. These large cavities were encountered at Stations 5+580, 5+760, 6+180, 6+350, 6+360, 6+460, and 6+495. Figure 2 shows photographs of few cavities from construction photographs. Foundation treatments during construction included concrete infilling of cavities, dental concrete, and a grout curtain.

Figure 2 : Photographs of Sinkholes From construction (clockwise from top-left: Station 5+580, 6+350, 6+360, and 6+495)

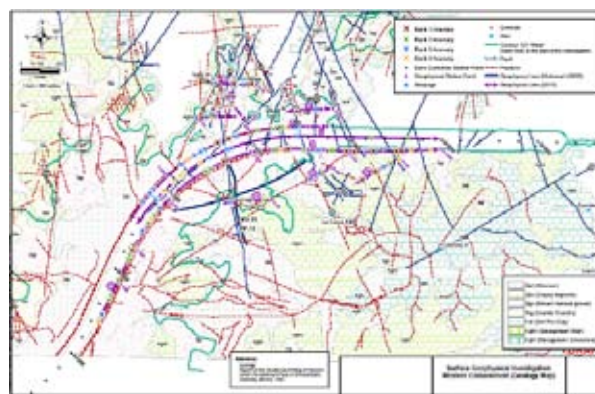
Geophysical anomalies were evaluated on the basis of their response, size, or corroboration between methods and were ranked from 1 through 4. Rank 1 anomalies represent those that were interpreted as being most critical for further evaluation. A total of 82 geophysical anomalies were identified from the processed geophysical data. These geophysical anomalies in many cases matched well with surface geologic features such as faults and mapped channels. Figure 3 shows a plan view of the western embankment with geologic mapping, surface geophysical survey lines and findings (Rank 1 through 4 anomalies), known sinkholes, and known seepage exit locations.

Figure 3 : Geologic Map with Surface Geophysical Survey Lines and Anomalies

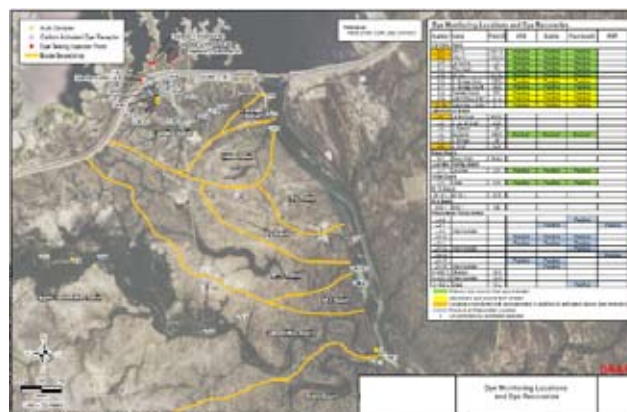
Figure 4 : Summary of Dye Tracer Study

The injected dyes were detected at all monitoring locations in Carmina Basin (C-1 through C-10), Loudres Basin (L-1), and Hilda Basin (H-1). Dye was not detected at monitoring locations in Jaboncillos Basin (J-1 through J-6), Buey Basin (B-1), M-15 Basin (M-15-1), and M-5 Basin (M-5-1).

- Clear connectivity between the injection points and the Carmina Basin;
- No clear preferential path was identified between the injection points and seeps and spring areas; and
- The broad detections of the dye at the downstream locations suggest interspersing of subsurface flow through the dam foundation.

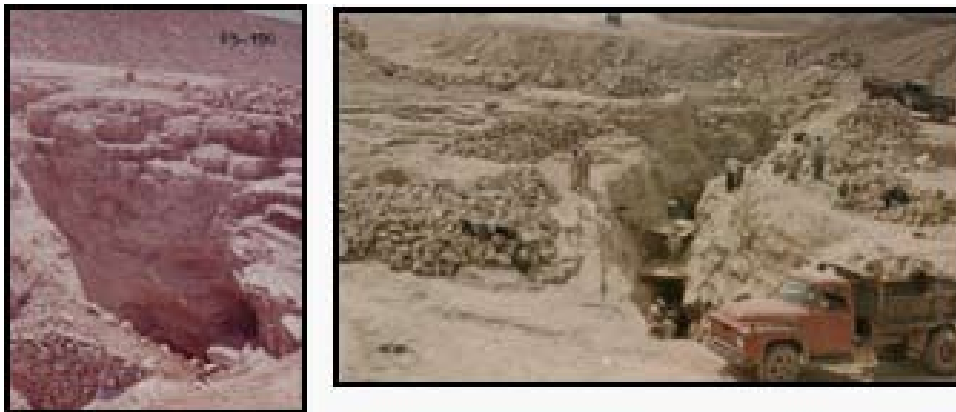
As excessive seepage was found on the western embankment since water impoundment in 1969, a French drain system was installed near Sta. 6+460 in 1973. This area is within a portion of the western embankment, where large cavities were encountered during construction and foundation treatment techniques included grouting, dental concrete, and concrete infilling of large cavities. V-4 area is also near the Georgetown Marl and Georgetown Limestone contact along the longitudinal profile and near multiple mapped faults. Figure 6 shows photographs of large cavities at Station 6+460 that were filled during construction. Figure 7 shows a map of foundation treatment in the western embankment.

Figure 6 : Photographs of Cavities Encountered at Station 6+460 During Construction

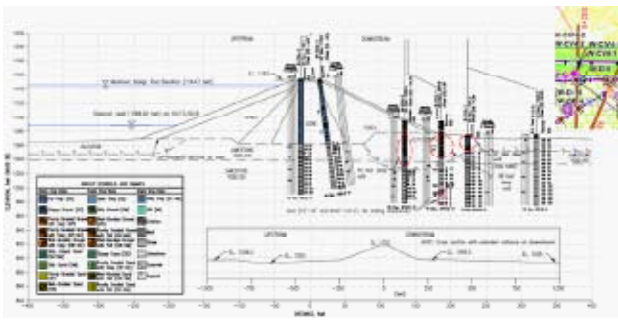
Two geologic transverse cross sections at Station 6+355 and 6+460 have been developed with crest, mid-slope, and downstream borings (Figures 8 and 9). Borings in V-4 area matched well with the understanding about this area. The crest borings indicate that the core portion of the dam is founded on limestone or dental concrete that was placed during construction. However, the mid-slope borings encountered three larger cavities with clay fill or clay and silt infill ranging between 27 feet and 46 feet. The downstream borings also encountered cavities.

Figure 9 : Geologic Cross Section in V-4 Area (Station 6+355)

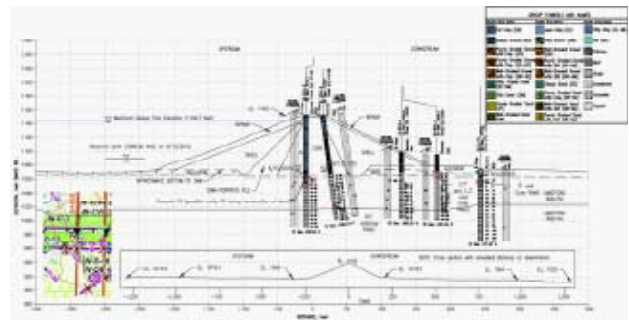
Figure 10 : Geologic Cross Section in V-4 Area (Station 6+460)

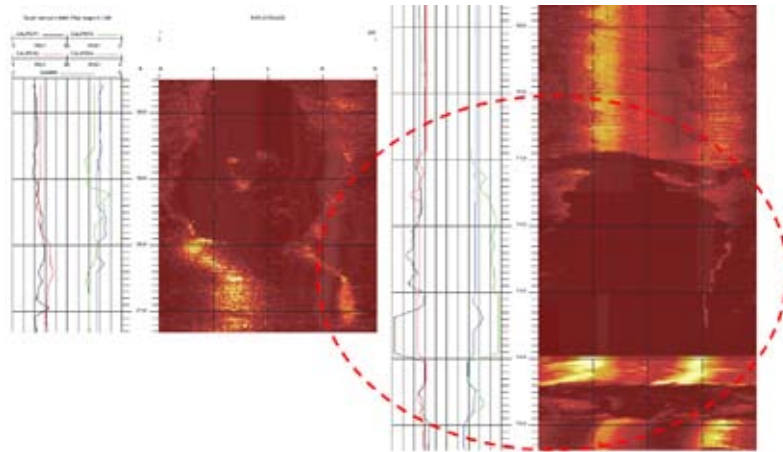
Downhole geophysical survey also provided valuable information about the cavities. The 360 degree profiles generated from televiewer were compared with caliper responses and distorted responses in calipers matched well with cavities identified from borings and televiewers. Figure 10 shows results of downhole geophysical survey results for Boring W-BV4-1, which is located in mid-slope and large cavities were encountered in this boring.

Figure 11 : Results of Caliper and Acoustic Televiewer for Boring W-BV4-1

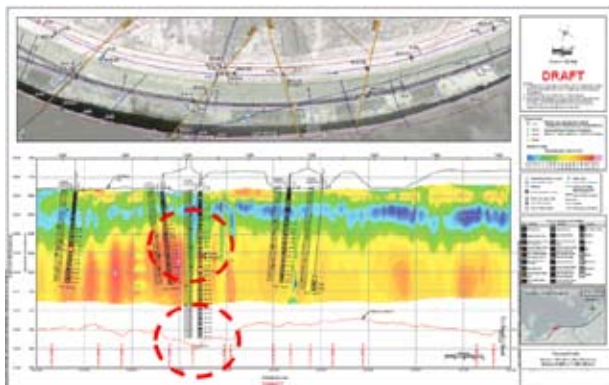
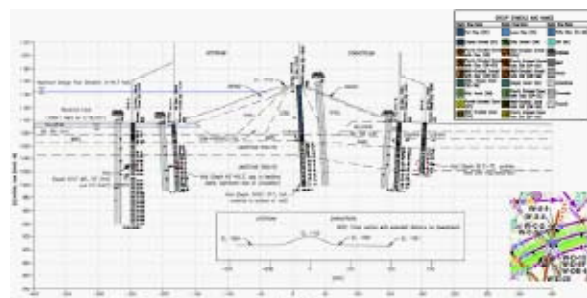
Several sinkholes were observed in upstream of dam near this area. This section is located across upstream, embankment, and downstream borings that are near geophysical anomalies and may indicate a potential seepage path, if these anomalous zones are connected [A-42 (Rank 1) in upstream, A-4 (Rank 3) in embankment, and A-26 (Rank 1)]. A mapped south-west trending fault matches well with geophysical anomalies in upstream, embankment, and downstream locations. This section is also located within Station 5+520 and Station 8+100, an area where multiple foundation treatment techniques were used during construction (grouting, dental concrete between Station 5+520 and Station 6+725, and concrete infilling for large cavities). Recent grouting programs were implemented along the upstream toe (1998-six segments of the dam within Station 6+850 and Station 7+450) and embankment of the dam (1995-Station 6+850 and Station 7+450). Figure 12 shows the plan, geologic profile, and cross section with surface geophysical survey results (ERI and Microgravity) for Station 7+121 in upstream, crest, and downstream areas. Figure 13 shows a geologic cross section through Station 7+121.

Borings in upstream, crest, and downstream encountered cavities, which match well with surface geophysical survey, geologic mapping, and past performance history in this area.

Figure 12: Geological, Geophysical Profile and cross section Near Station 7+121 through Dam Downstream
