RISK-BASED STABILITY EVALUATION OF THE UPPER SPILLWAY MIDDLE PIER – ISIMBA HEPP UGANDA

D.E MUKWANASON, W. MANIRAKIZA, M. AKURUT, J. SEMPEWO, M. KAYONDO AND H.E. MUTIKANGA

Uganda Electricity Generation Company Limited, Kampala, Uganda

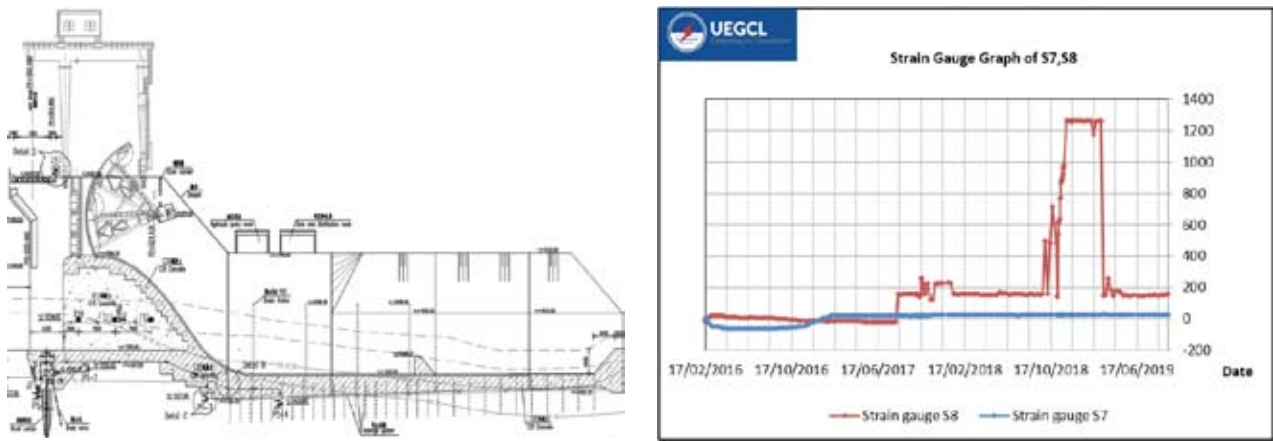
As per the Dam Monitoring and Surveillance plan, visual inspections are aimed to detect any changes that cannot be recognized with measuring instruments. During the initial reservoir impoundment visual inspections, it was observed that the upper spillway appeared to be oscillating in an abnormal way due to immense vibrations induced by large spillway discharges. This was later checked with the erratic vertical movement and rapid increase of the strain gauge (S8) installed in the mass concrete weir under the spillway gate aimed to monitor vertical strains of the concrete in response to external loads such as the hydrostatic loads from impounding. Instrumentation data processing also showed that the maximum vertical strain remained constant despite the stabilization of the reservoir water level after impounding as shown in Figure 2. Potential failure mode as defined by the Federal Energy Regulatory Commission (FERC) is, “the chain of events leading to unsatisfactory performance of the dam or a portion thereof. The dam does not have to completely fail in the sense of a complete release of the impounded water.” (Schweiger, Kline and Burch, 2019)

Figure 2 : Location of the Strain gauge S8 and the strain gauge response due to initial impounding

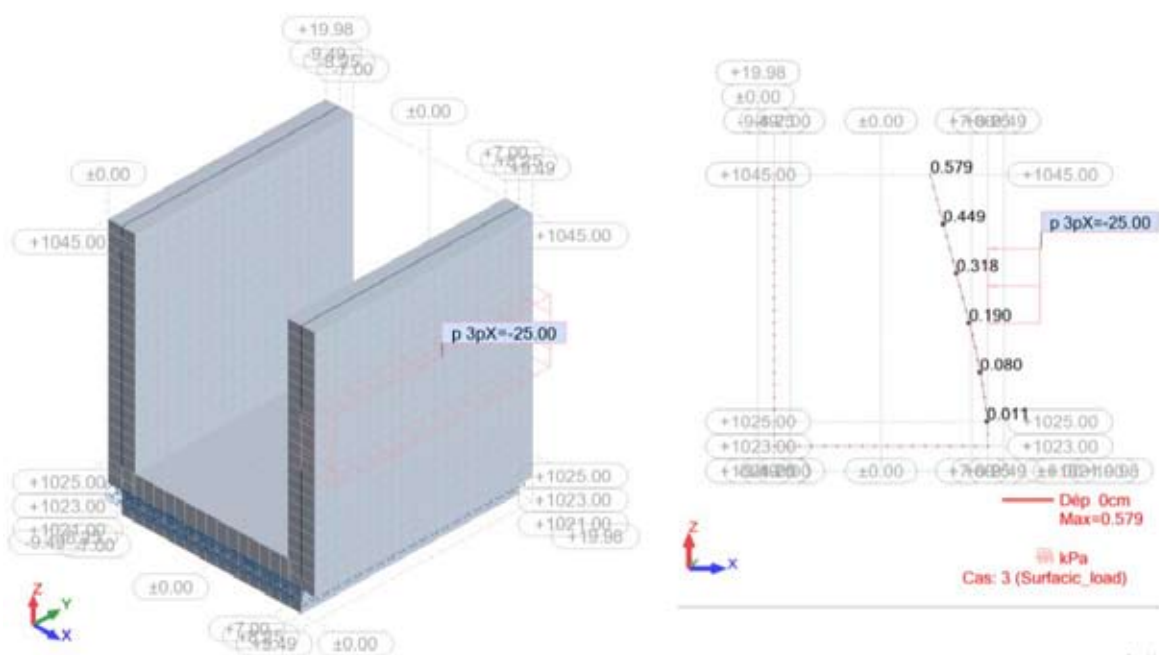
In the structural analysis of the long-term resistance of the pier under the vibrations, a 3D model composed of two 2.5m thick walls and a slab is modelled as anchored (pinned supports) see Figure 3. The set-in-place concrete reinforcement (Concrete C20, Steel rebars fyk = 420 MPa with a cover of the 0.15m) is found to have a maximum bending moment of about 1600kN.m/ml at the bottom of the wall (El + 1025.00) giving stress in concrete as; 2.14MPa (OK) and stress in steel rebars as 58MPa<336 MPa (OK) and a natural frequency of 3 Hz.

Figure 3 : 3D model adopted in the verification of the spillway pier

The fatigue of the reinforced concrete is then evaluated in order to estimate the maximum number of cycles that the pier can withstand according to Eurocode 2. Calculation of the fatigue for concrete and the fatigue for the steel rebars provides that the reinforced pier has a resistance of 42years under conditions of continuous cyclic vibrations from the discharge of the upper spillway

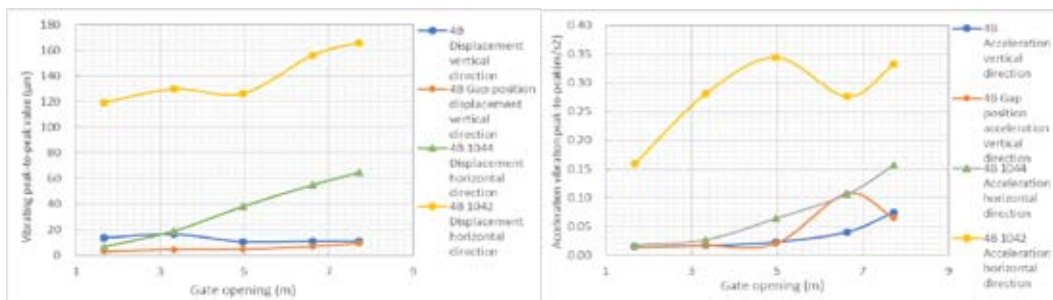
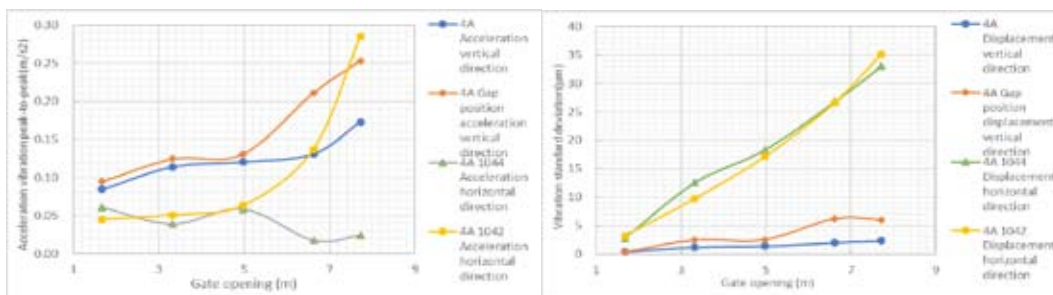
Figure 7 : Showing the acceleration response of the sensors during the vibration test

Figure 8 : Showing the displacement vibration of the sensors during the vibration

The vibration is maximum under the operating conditions in which the two outlets of the Upper spillway are opened at the same time see Figure 6 for discharge hydrograph, and the vibration value becomes larger as the gate opening degree increases; when the gate opening reaches the maximum 75%, the vertical vibration peak-to-peak value is between 0.37 μm and 29.2 μm . The "4A gap displacement vertical" value is the largest, which is 29.2 μm (Figure 8 above); the horizontal vibration peak-to-peak value is between 2.76 μm and 174.86 μm , wherein the "4B 1042 displacement level" has the largest value of 174.86 μm ; the vertical acceleration vibration peak-to-peak value is 0.061m. Between /s2~0.5209m/s², the value of "4B gap acceleration vertical" is the largest, 0.5209m/s²; the horizontal acceleration vibration peak-to-peak value is between 0.2301m/s²~0.6844m/s², of which "4B1042 acceleration level" The maximum value is 0.6844m/s² (Figure 7 above); the standard deviation of vertical vibration is between 0.14 μm and 11.88 μm , among which the value of "1A displacement vertical" is the largest, which is 11.88 μm ; the standard deviation of horizontal vibration is between 0.86 μm and 53.08 μm , among which " The 4B 1042 displacement level has the largest value of 53.08 μm ; the vertical acceleration vibration standard deviation is between 0.0143m/s² and 0.1962 m/s², of which the "4A gap acceleration vertical" value is the largest, 0.1962m/s²; horizontal acceleration vibration standard The difference is 0. Between 0143m/s² and 0.1962 m/s², the value of "4A gap acceleration vertical" is the largest, which is 0.1962m/s². In the case of the same opening degree, the noise values are basically the same, and there is no abnormal state. At 75% opening of the gates, free fall of the water was achieved (the bottom of the gate left the water surface) see Figure 9 above.

In the meantime, unnecessary spillway gate operations ought to be avoided by the operator in order to prevent development of structural fatigue in the spillway structure due to prolonged spillage. The upper spillway radial gates may be operated at less than 70% opening as per the vibration test data results until the final stability analysis of the pier is done and correctly verified.

During flood conditions, sharing of the discharge among the two upper spillway outlets is advised as compared to individual opening of the outlets for the same quantity of flow. From the vibration test data results, it is observed that using two outlets is preferable to one when discharging a flood of the same magnitude due to the reduced vibration results.

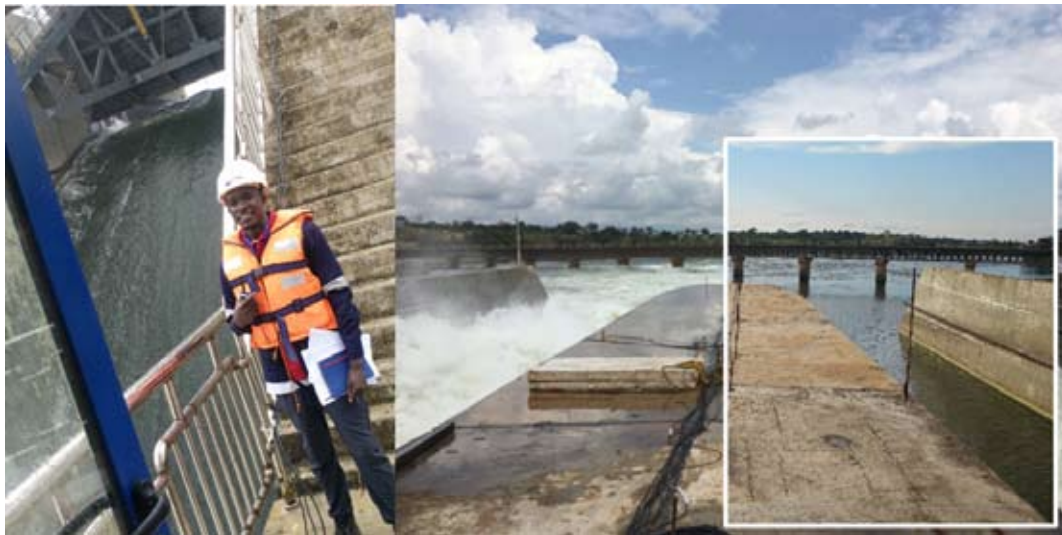
Figure 9 : Showing the right opening at 70% opening with the corresponding downstream water level rise

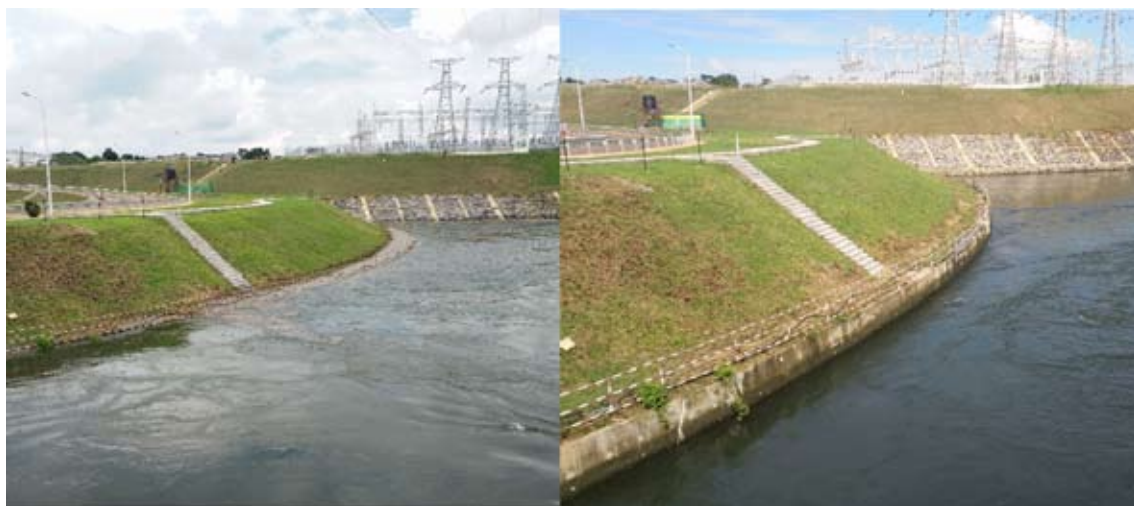
The risk informed approach used during the test was effective since there was no harm caused to the downstream residents, the ferry operation and the bridge works as verified by the post-test inspection. The concrete structure and the mechanical equipment of the spillway were not significantly affected either. Coordination with the cascade upstream dams also ensured that there was enough inflow to allow for the vibration test as well as power production. Water levels during the test and after reinstatement. After successful completion of the vibration test, UEGCL embarked on a reinstatement process by operating the gates to normalize the downstream water level back to elevation 1038.7m.asl so as to allow for ferry operation and bridge construction works. (Fig.10)

Figure 10 : Showing the downstream water levels during the test and after reinstatement process
