# ANALYSIS OF THERMAL CRACKS IN CONCRETE GRAVITY DAM SPILLWAY AND CONSTRUCTION CONTROLS

S. AOYAMA, T. HIRATSUKA AND N. YAMASHITA  
SHIMIZU Corporation, Japan

This is a new concrete gravity dam under construction inland in the Chugoku region in Japan, where the minimum winter temperature reaches  $-6^{\circ}\text{C}$ . Prior to commencement of construction 3-dimensional temperature stress analysis of the dam body was carried out to identify the parts where there was a risk of thermal cracks, and construction is proceeding while taking measures to reduce the occurrence of cracks. However, during construction, cracks occurred unexpectedly in the spillway at mid elevation, near the position of installation of an orifice pipe of spillway. This paper describes the measures for reduction of cracks based on the initial analysis, the analysis performed after the occurrence of cracks, and the countermeasures taken.

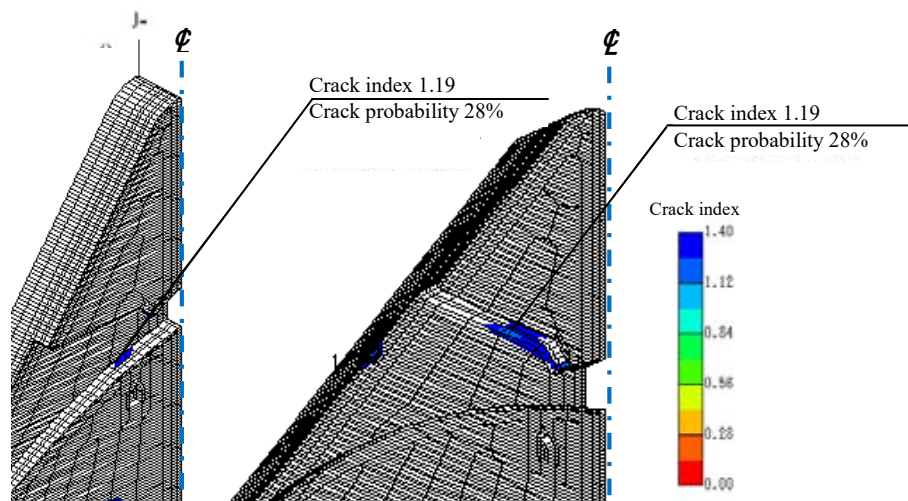
**Fig. 3 :** Temperature stress analysis results without any countermeasures (distribution of minimum values in the analysis period)

The result of the 3-dimensional temperature stress analysis was a 28% probability of occurrence of cracks (crack index 1.19) without any countermeasures, as shown in Figure 3.

The following measures were taken to reduce the occurrence of cracks so that a 15% probability of occurrence of cracks (crack index 1.40) was satisfied.

By pre-cooling the materials, the concrete temperature in summer was reduced, so that even on days with a maximum air temperature of 35°C the concrete temperature during placement was 21°C. In this way the temperature rise in the interior of the dam body was reduced, reducing the temperature difference with the external air, and reducing the probability of cracks.

Openings such as passages and spillways were covered in winter before the dam body had reached its strength, so that the concrete would not be cooled by cold air entering from the openings.

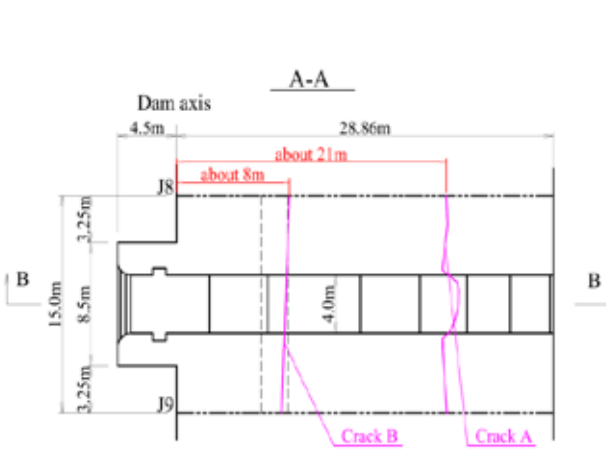
Fig. 4 : Crack location diagram (plan view)

Cracks occurred at 2 locations: near DC+8 m and near DC+21 m. In each case, cracks were parallel to the dam axis direction, and it occurred at about 1/3 and 2/3 of the dam width on the construction joint surface at EL 125.0 m.

Near DC+21 m the maximum width of Crack A was 0.6 mm, and this crack occurred on the EL 125.0 m construction joint surface, virtually perpendicular to the orifice wall surface. On November 14, 2017, there was no crack on the overflow surface, but subsequently on December 5, 2017 Crack A extended to the overflow surface. The crack width at the overflow surface was a maximum of 0.5 mm. Coring was carried out to check the depth of the crack, which showed that the crack had reached a depth of about 3 m.

Crack B near DC+8 m was found on December 7, 2017. On the EL 125.0 m construction joint surface the crack width was a maximum of 0.75 mm, and it extended to a depth of 2 m reaching a passage installed at that position. Crack location diagrams are as shown in Figures 4-5.

- The EL 125.0 m construction joint surface, the overflow surface, and the wall surfaces were protected by installing thermal insulation material ( $t = 10$  mm, polyolefin foam, thermal conductivity  $\lambda_0 = 0.031$  W/mK).
- Strict control of the opening and closing of the doors on the passage openings was enforced, and another door was added to the inside of the doors to prevent entrance of cold air with the double doors.

Chemical milk made from ultra fine particulate cement (average  $4 \mu\text{m}$ ) was injected to fill cracks and unify the structure, and the status of filling was checked using check holes. The injection was carried out as follows.

The cement milk was injected into cracks in order to unify the structure, but it was difficult to guarantee complete integrity of cracks by filling with the grout, so reinforcement was provided in addition to injection. The quantity of reinforcement was designed so that after placement of concrete the strain when the concrete temperature dropped from the maximum temperature to the final stable temperature could be borne by the reinforcement alone. Deformed steel bars D32 at 200 mm spacing were placed in 3 layers.

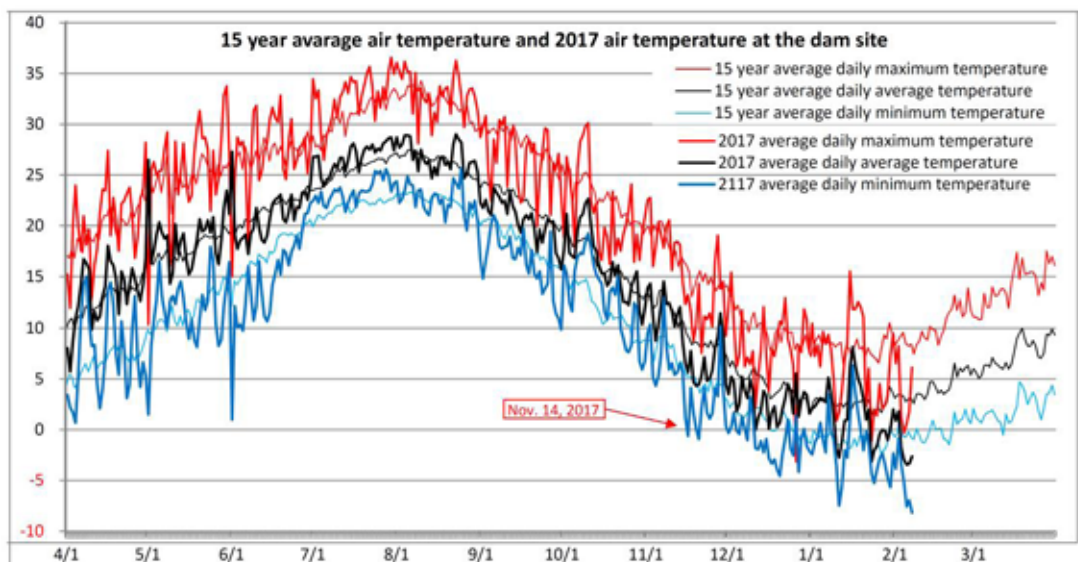
Fig. 6 : Air temperature in 2017 at the dam site

15 year average air temperature and 2017 air temperature at the dam site is as shown Figure 6. These cracks occurred on the surface at which placement had been stopped for 1.5 months, it occurred on November 14, 2017, when there was an unprecedented sudden drop in air temperature, and it extended downwards from the EL 125.0 m construction joint surface. Therefore, it is considered that the cause was thermal cracks due to internal constraint as a result of cooling the construction joint surface for a long period of time. To verify this a temperature stress analysis was performed inputting the actual air temperatures, actual placement temperature, and measured internal temperatures, and the occurrence of cracks was reproduced. Figure 7 shows a comparison of 2016 and 2017 minimum temperatures. In 2016, a low elevation spillway (conduit spillway) had been constructed in an adjacent block, and cracks had been prevented. However, temperature suddenly dropped in 2017 compared to 2016 before protection by installing thermal insulation material, and some cracks occurred.

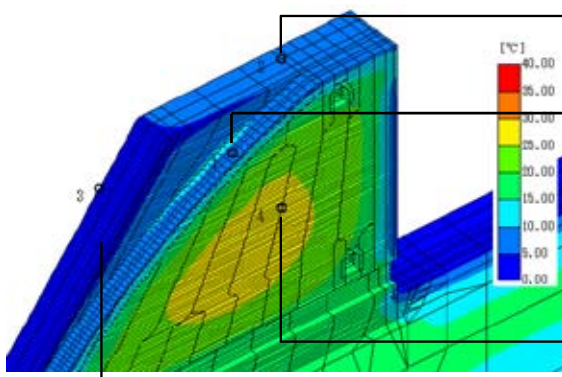
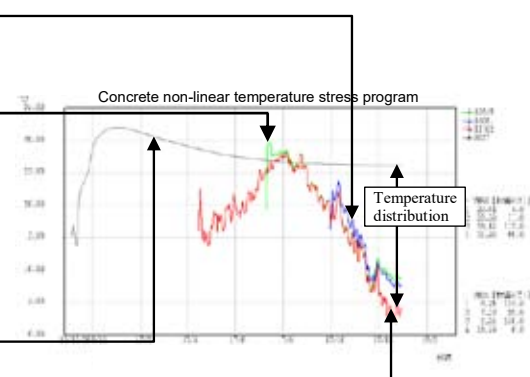
Figure 11 shows the temperature time history for point 4 as a representative value of the area colored yellow indicating a temperature of 25°C to 30°C (internal temperature) on the temperature distribution of Figure 10, and likewise point 2 as a representative value on the EL 125.0 m construction joint surface, etc. The internal temperature drops gently, whereas in contrast the external temperature drops rapidly due to exposure to the external air. The temperature difference is about 22°C. On the other hand, Figure 12 shows the distribution of the minimum values of the crack index. It was not possible to reproduce the position of cracks above the passage (it is considered that the thermal cracks occurred here because cold air entered the passage). However, areas with low crack index (crack index 1.44, probability of cracks 13.6%) were reproduced at the positions on the EL 125.0 m construction joint surface where cracks occurred. This demonstrates that these cracks were thermal cracks. Crack index time history is as shown in Figure 13.
