REHABILITATION AND STRENGTHENING OF THE DAMAGED DIVIDE WALLS AND DOWNSTREAM FLOOR OF DURGAPUR BARRAGE OVER RIVER DAMODAR AT BLOCK & P.S.- BARJOR A, DIST- BANKURA, WEST BENGAL

RAJESH D PANDEY AND SOUMYADIP PRAMANIK

Damodar Valley Corporation

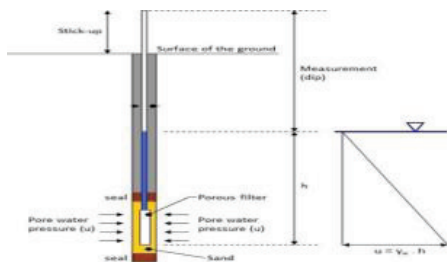
Piezometer readings

In this case, the exit gradients determined by obtaining the data from piezometer readings and existing sub- soil strata shows very favourable conditions for piping.

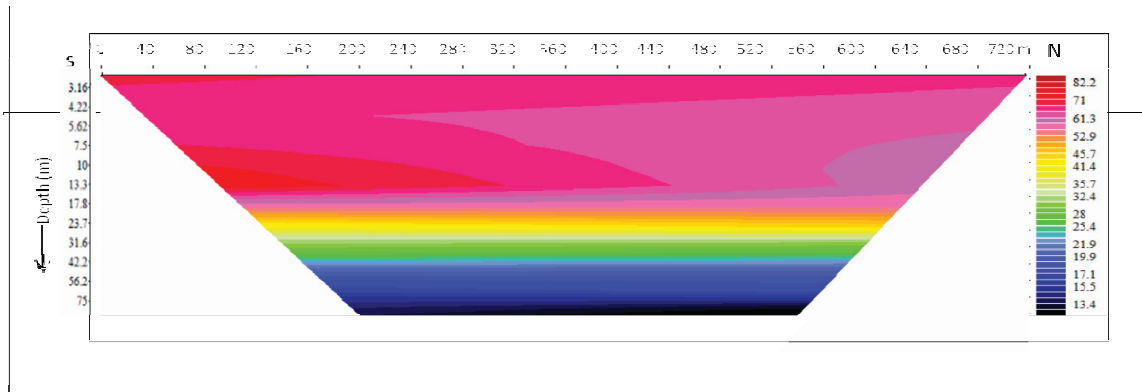
Resistivity Image of U/S (Two tests)

Resistivity data in the upstream side indicates a gradual lowering of resistivity values along depth. This is primarily due to the presence of finer sands, clay and shale at deeper levels. However, no abnormal change in resistivity has been observed, nor any significant accumulation of anomalous sand deposit could be found. However, some lenticular disposition of fine to medium sand is observed at shallow level.

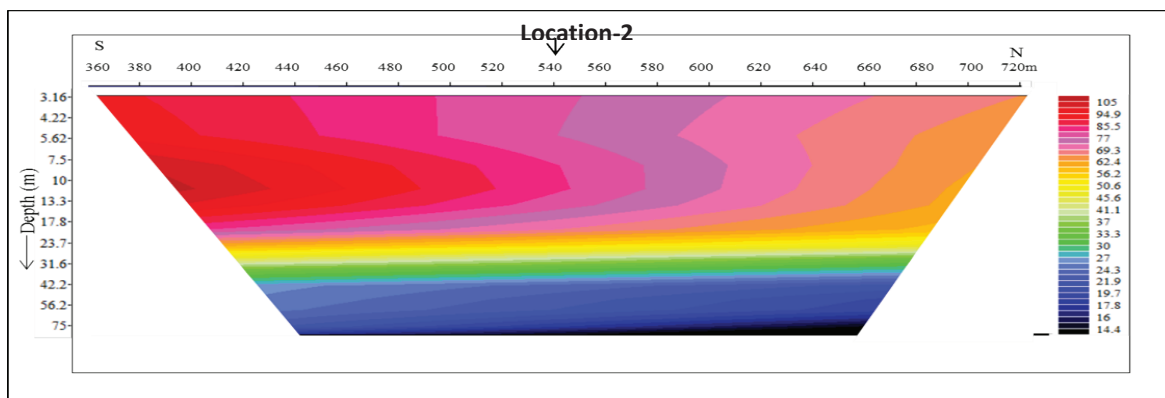
In the downstream side, in the southern side (Bankura bank), up to 400m from the bank, high resistivity values are obtained at shallow level indicating presence of predominantly medium grain sand. One higher resistivity layer interpreted as medium to coarse sand occurs in a lenticular shape up to 400m distance from the Bankura bank at a depth of about 7.5-10m. Further down, resistivity values decrease as finer sands are inferred followed by weathered shale formation at deeper level. Depth of shale is estimated at about 40 – 45 meter from ground level.

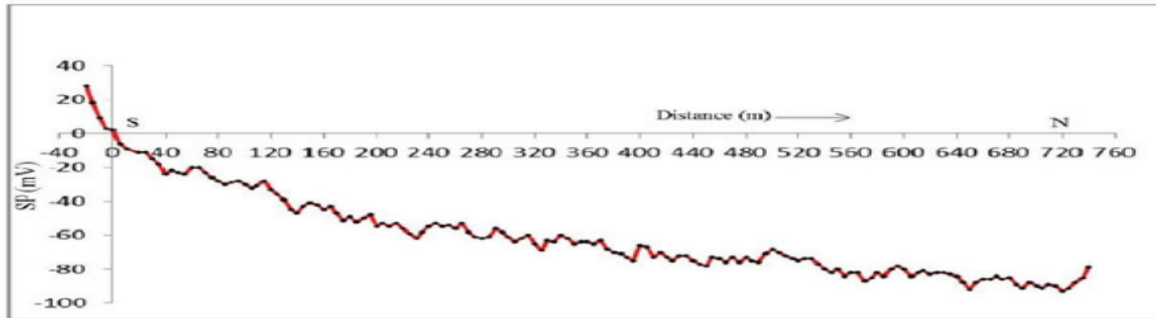
Self-Potential (streaming potential) has been recorded during resistivity survey. There is a gradual negative gradient of self-potential from South to North with a few high frequency undulations in both the profiles in the upstream as well as downstream. This reflects a regional gradient and not caused by any local river bed or local subsurface phenomena.

Steaming Potential (SP) along N-S profile parallel to Barrage axis in upstream side (N = Durgapur Bank S = Bankura Bank)

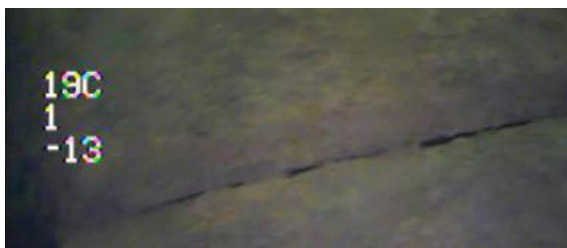
- There are cracks of width varies from 2 mm to 12 mm found in major portion of the gate piers and in the weir section.
- Honeycombs and cavities upto 5-15 mm depth are found in few areas in the gate piers and in the weir section.
- Few suction and leakage points are also observed in the structure.

Crack

1. Sealing of cracks in the weir section and in existing floor with cementitious and epoxy material
2. Pressure grouting through nozzles in the weir section and in existing floor with cementitious and epoxy material
3. Filling and sealing of cracks in partition and divide walls with micro-concrete.
4. Re-surfacing of weir section with abrasive resistant impermeable UV resistant High Performance Fibre reinforced polymer modified pre batched cementitious repair mortar of CE certified and conforming to EN: 1504-3-R4.

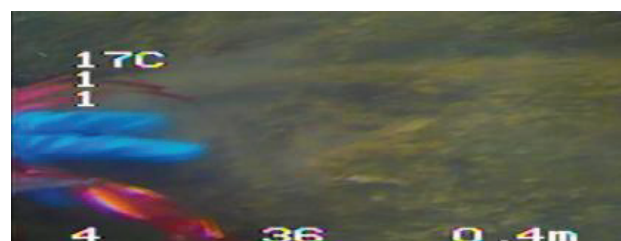
Honeycomb
