ICOLD Symposium on Sustainable Development of Dams and River Basins, 24th - 27th February, 2021, New Delhi

LESSONS LEARNED IN CLARIFYING ANOMALIES IN THE DAM SAFETY ASSESSMENT IN SLOVAKIA

3. GEOPHYSICAL MEASUREMENTS ON VEĽKÁ DOMAŠA DAM

4. GEOPHYSICAL MEASUREMENTS ON STARINA DAM

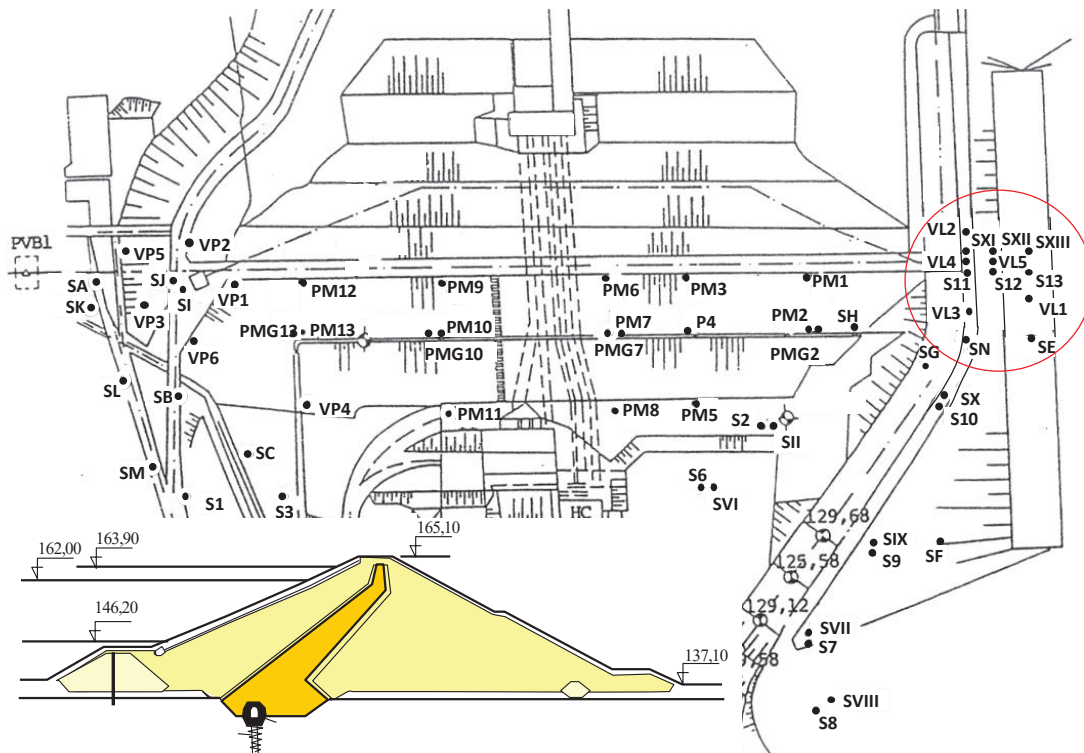
It is earth-fill heterogeneous dam with inclined sealing (Fig. 1). Dam is situated on river Ondava and create reservoir with volume 185 mil. m³. Geological composition of dam's subsoil is created by sandstones, slates and poorly agglutinated clay agglomerates sealed with grouting curtain. Hydraulic structure was put in operation in year 1967. Already in the initial stage after filling the reservoir was in the left abutment of dam (marked in Fig. 1) registered increase in underground and seepage water levels. Also geophysical measurements of filtration velocities in observation objects pointed to exceeding critical values of filtration velocities ($1.2E-03 \text{ m}\cdot\text{s}^{-1}$), which endanger the filtration stability of the rock environment. For that reason, the grouting curtain was in years 1973 -1975 in this section retightened and deepened (Fig. 1).

Figure 1 : The situation and cross-section of the Veľká Domaša dam showing local sealing of the grouting curtain

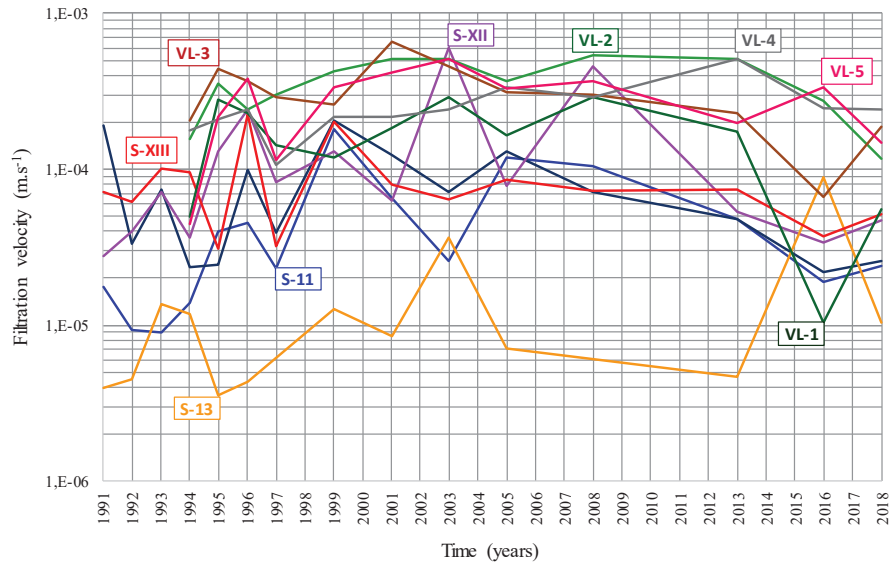
The effect of the retightening after 30 years was mentioned in the contribution to the ICOLD Symposium in Sofia (Bednárová et. al., 2008). Now we present findings on the results of measurements of the maximum filtration velocities apart 40 years (Fig. 2). The figure shows that the effect of sealing the grouting curtain on the intensity of the filtration flow in the examined area of the dam has a positive effect. Exceeding or reaching a critical filtration velocity of $1.2 E-03 \text{ m}\cdot\text{s}^{-1}$ has not been yet here recorded (Fig. 3).

Figure 2 : Trend in the development of maximum filtration velocities in the area of left abutment

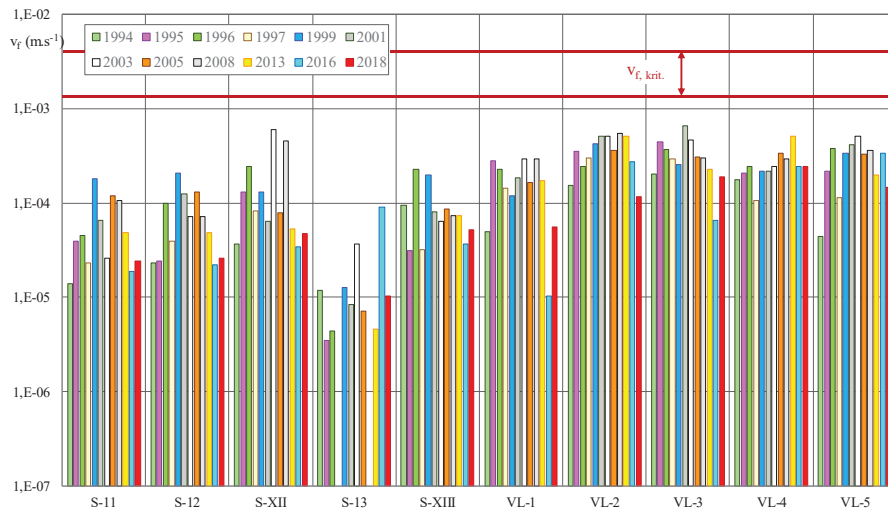
Figure 3 : Comparison of maximal filtration velocities with the critical value at the left side of dam

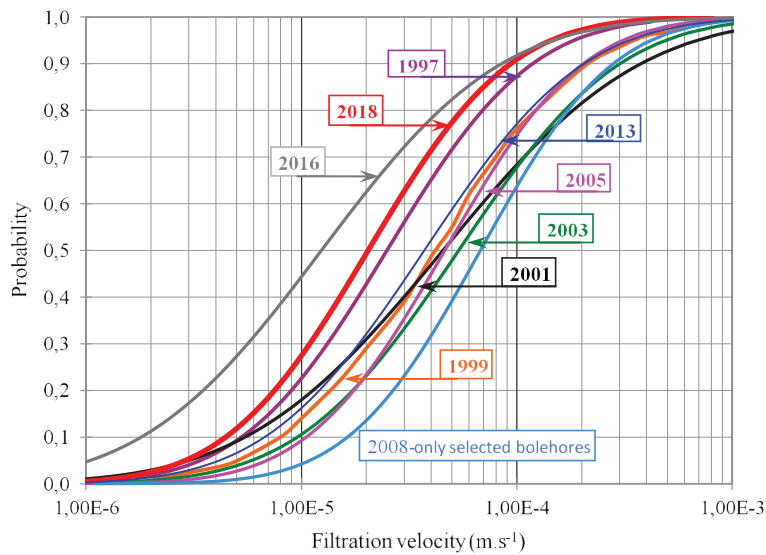
A comprehensive view of the evolution of the filter flow intensity in the investigated left-hand abutment can also be illustrated by the distribution functions (Fig. 4).

Figure 4 : Distribution functions of filtration velocities in the left abutment

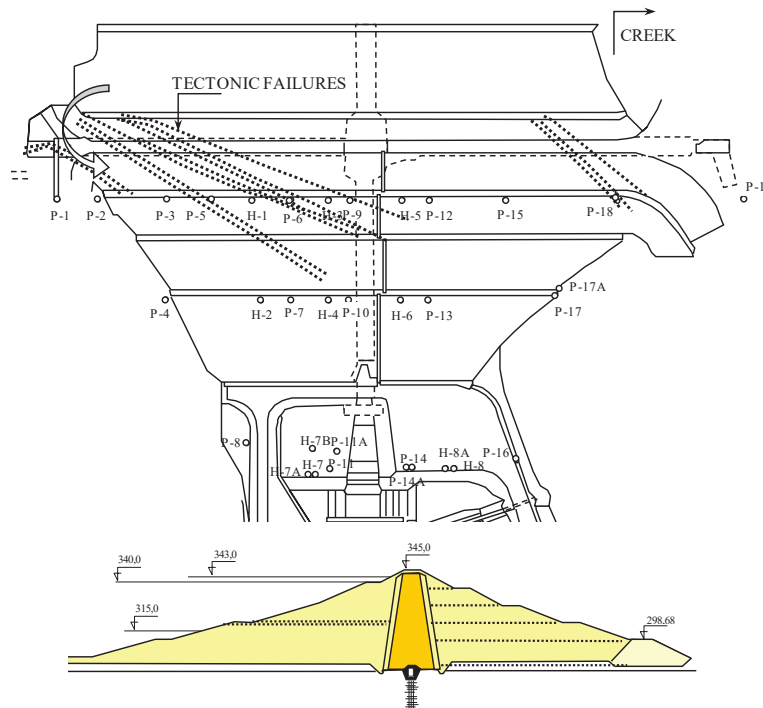
Figure 5 : The situation of observation objects and cross-section

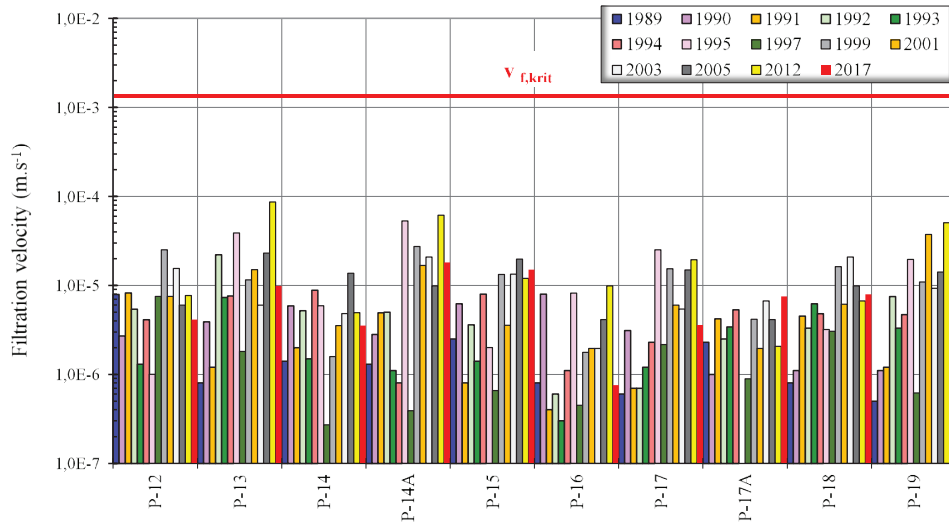
Their values are below the established threshold of critical filtration velocities (Figure 7). In other monitoring objects of the dam is the trend of filtration velocities development steady (Figure 8).

Figure 7 : Comparison of maximal filtration velocities with the critical value at the left side of dam

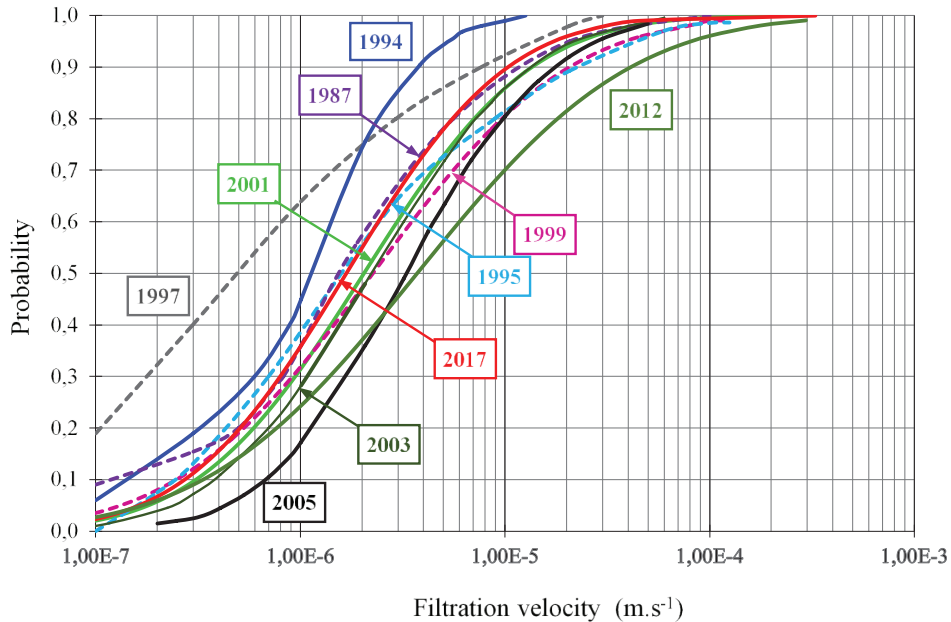
Figure 8 : Distribution functions of filtration velocities on the Starina dam
