WHALEY BRIDGE – THE DAM FAILURE AT WHALEY BRIDGE ON 1ST AUGUST 2019 AND AN OVERVIEW OF DAM SAFETY IN THE UNITED KINGDOM

RICHARD WAKELENI

Head of Asset Management, Canal & River Trust, United Kingdom

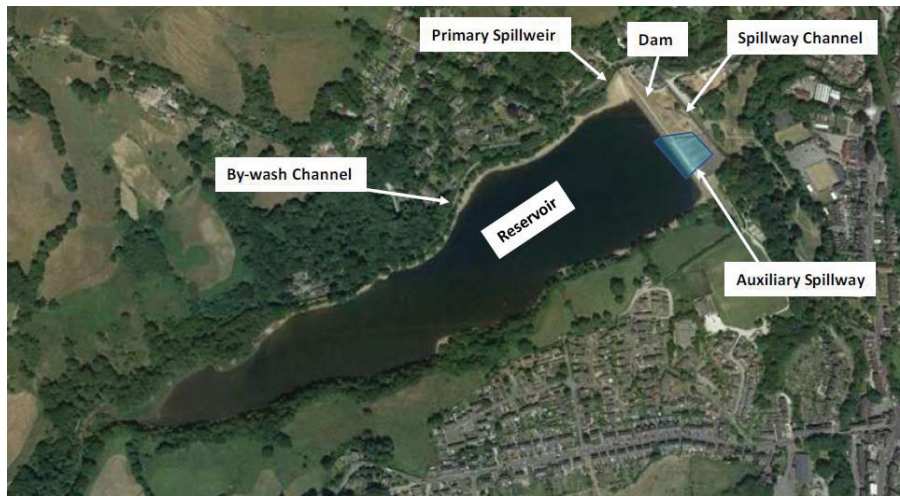
Picture 3 – The Layout at Toddbrook Reservoir

Toddbrook reservoir feeds the Peak Forest Canal. It has an inlet weir, a by-wash channel, a primary spillway, and an earth fill dam and an auxiliary spillway. The auxiliary spillway was built in 1970, over the central part of the dam embankment. The layout of the site is shown in picture 3.

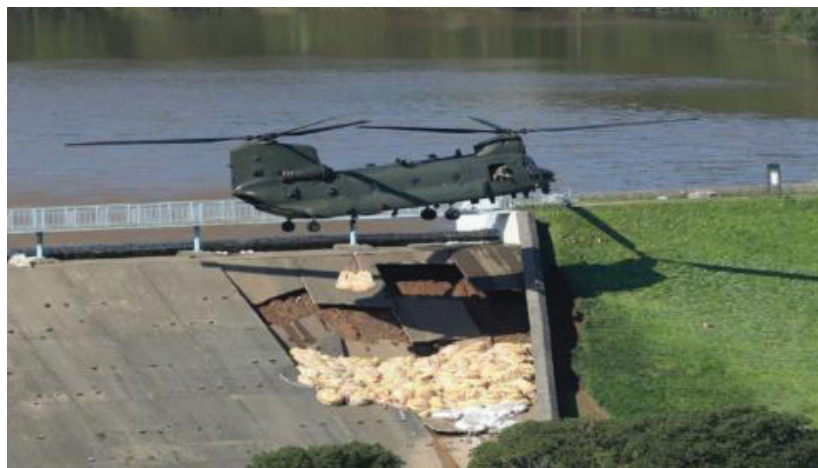
Picture 4 – The Failure at Whaley Bridge

A Royal Air Force (RAF) Chinook helicopter flew for 3 days to place over 500 tonnes of aggregate bags to stabilise the dam. Such scenes had not been seen in the United Kingdom for more than a decade. The incident has resulted in many photographs of the RAF Chinook helicopter dropping aggregate bags, as shown in picture 4. The event has raised several questions. The main question is how could this have happened?

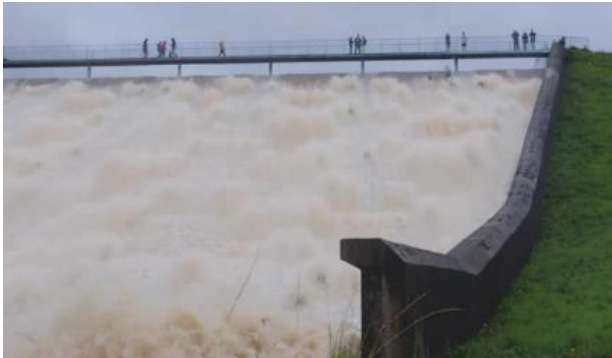
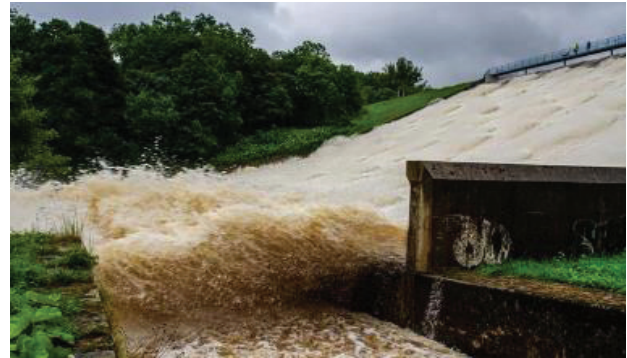
Picture 5 and 6 – Spillway in Flood on the 31 July 2019

There were two periods of heavy rainfall prior to the failure. The first event was on the 27th July 2019. During this first event 94mm of rain fell, and this equated to a 43-year return period. The second event was on the 31st July 2019. During this event 114mm of rain fell, and this equated to a 92-year return period. The spillway in flood on the 31st July is shown in photographs 5 and 6.

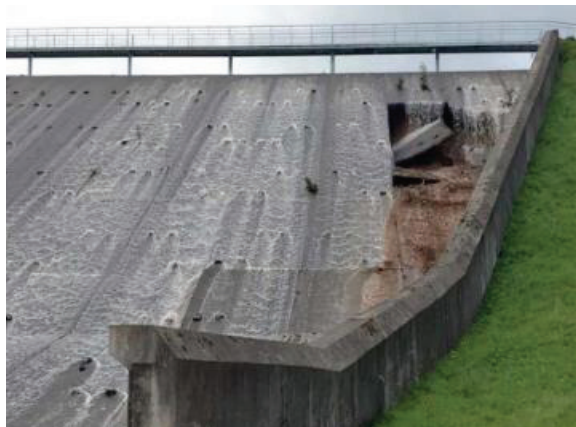
Picture 7 – Initial Failure on the 1 August 2019

Concerns were raised by members of the public early on 1st August 2019 when the flow of water over the spillway had reduced. Damage was seen to the concrete spillway. Picture 7 shows the initial spillway concrete slab that collapsed into a void that had opened under the spillway. The photo shows the fill material has been washed away, with signs of brown coloured water flowing down the spillway.

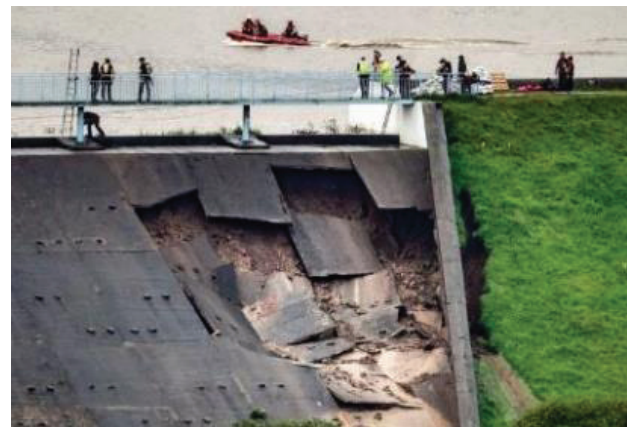
Picture 8 – Extent of Failure

Once operational staff got to site early on the 1st August 2019, the two outlet valves of the reservoir were fully opened to start to reduce the reservoir water levels. Water entering the reservoir was reduced by using the bywash channel to its maximum capacity. Opening the two outlet valves and maximising the flow in the bywash channel stopped any further water flowing over the spillway. This stopped any additional erosion to the embankment structure and the concrete spillway. The scale of the damage to the spillway is shown in Picture 8. This picture was taken late in the day on 1 August 2019.

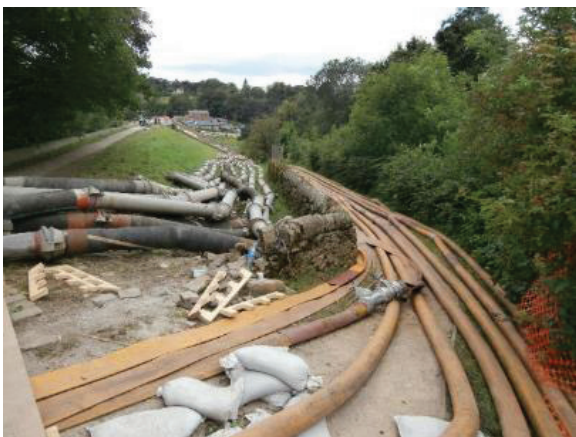
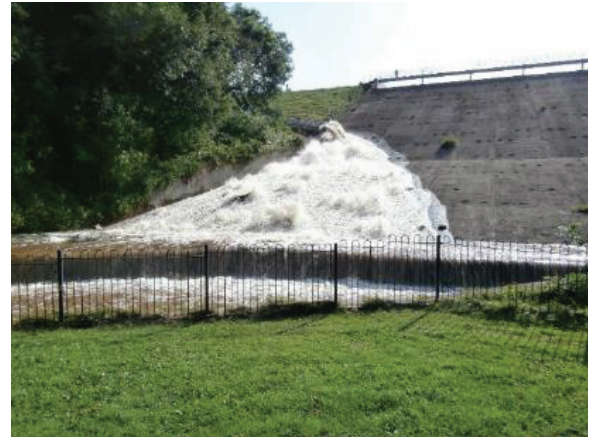
Pictures 12 and 13 – Pumping

On site assessments determined that 800 tonnes of infill material had been washed away. The pumping arrangements are shown in pictures 12 and 13.

The first action was to continue with the emergency drawdown plan by using as many pumps as possible to reduce the water levels as quickly as possible. The emergency drawdown plan assumed it would take 5 days to reach 50%. In addition to the eleven 12inch pumps, the emergency services provided ten 6 inch pumps.
