REHABILITATION WORKS FOR ISALNITA GATED DAM

D. STEMATIU

Romanian Academy of Technical Sciences, Bucharest, Romania

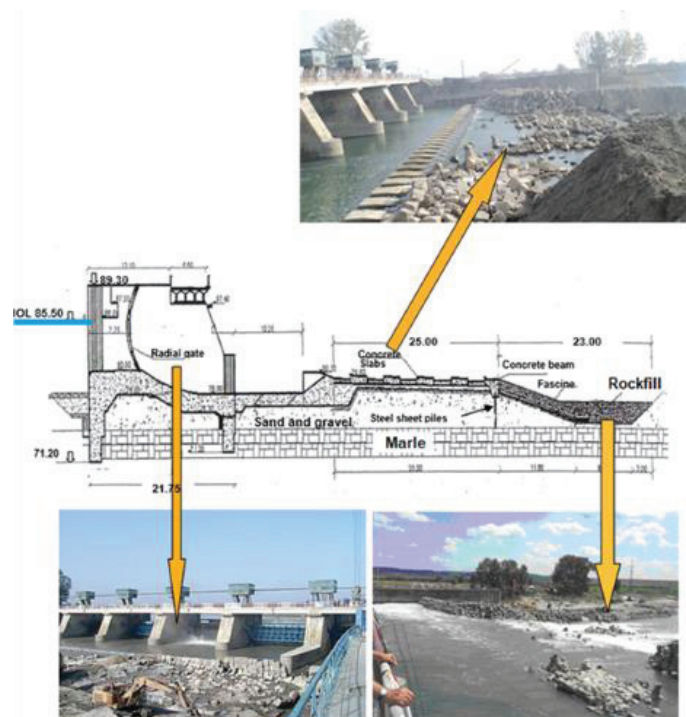
- The impossibility to provide regular maintenance of gates due to lack of means to put the gates on dry. Mention should be made that according to the original design concept each bay can be put on dry by a floating cofferdam fitted on its adjacent piers. The system never worked;
- The significant damages of the energy dissipation system; the rear apron was completely destroyed by regressive erosion and the concrete blocks placed in order to protect the end of the stilling basin were moved and washed away. Deep erosion and a general river bed lowering was also present.

The aging phenomena (quite normal after more than 50 years of operation) have also imposed rehabilitation works: - reconditioning or refurbishing the mechanical and electrical equipment; - repairing and protecting of exposed concrete surfaces; - consolidation of downstream guide walls foundation.

Figure 2 : Deficiencies

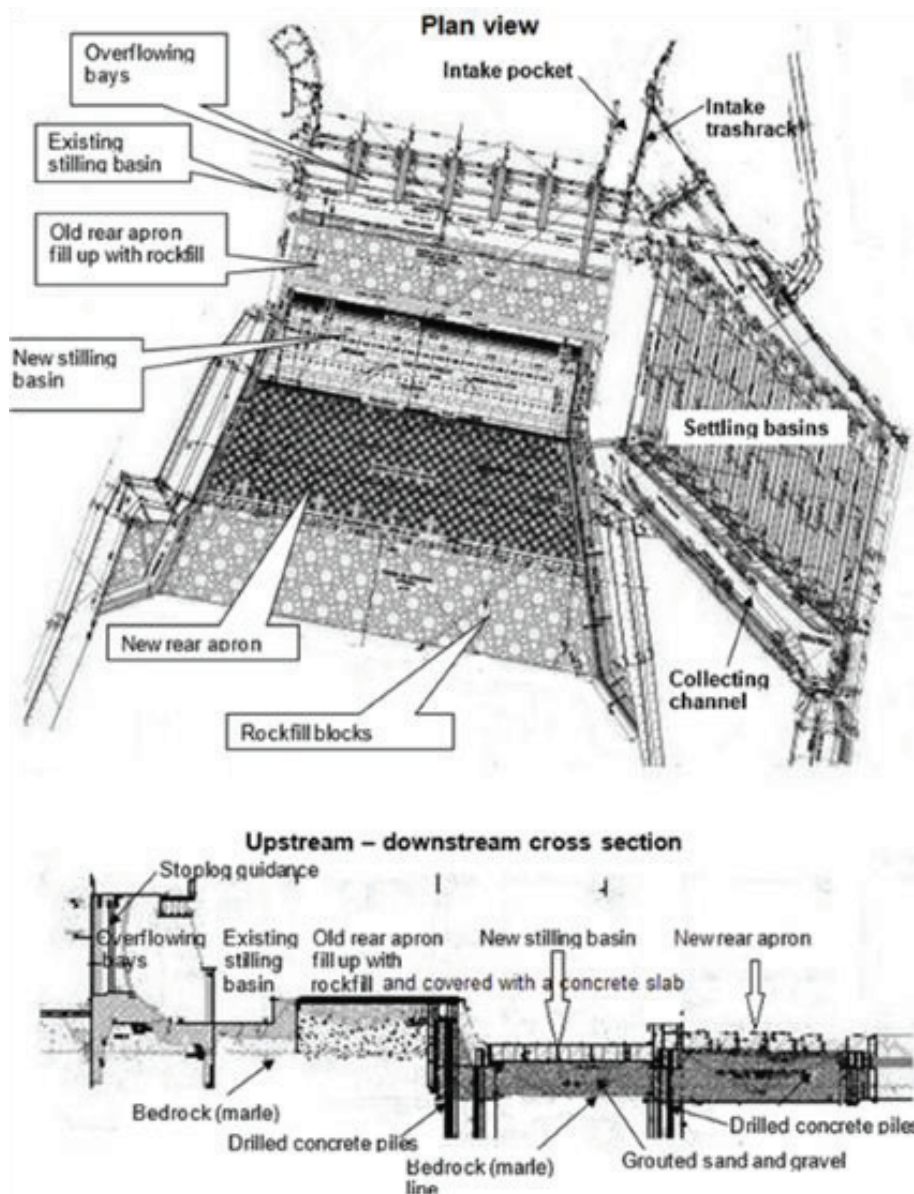
Figure 3 : Rehabilitation works

- (a) The dam was equipped with a new system of stoplogs that allows for putting on dry the gates for maintenance and eventual repairing. The new system is based on the current practice, with stoplogs. Steel stoplog guidance is placed on pier inner faces, upstream off gates. The installation was done under water, by using divers. Stoplogs will be launched into guidance by means of a special new crane. Existing reinforced concrete beams did not have the required bearing capacity for the new crane and, consequently, new beams were also provided.

- (b) The old energy dissipation system will be supplemented by a new stilling basin, some 4 m lower than the old rear apron and a new rear apron ended by a rockfill blanket.

- (c) Extensive foundation treatment (piles and jet grouting) is provided to avoid further regressive erosion and construction settlements.
- (d) Works needed to overcome the aging effects - reconditioning or refurbishing the mechanical and electrical equipment; - repairing and protecting of exposed concrete surfaces; - consolidation of downstream guide walls foundation.

- (e) Sediment removal from the reservoir and installation of permanent dredging equipment.

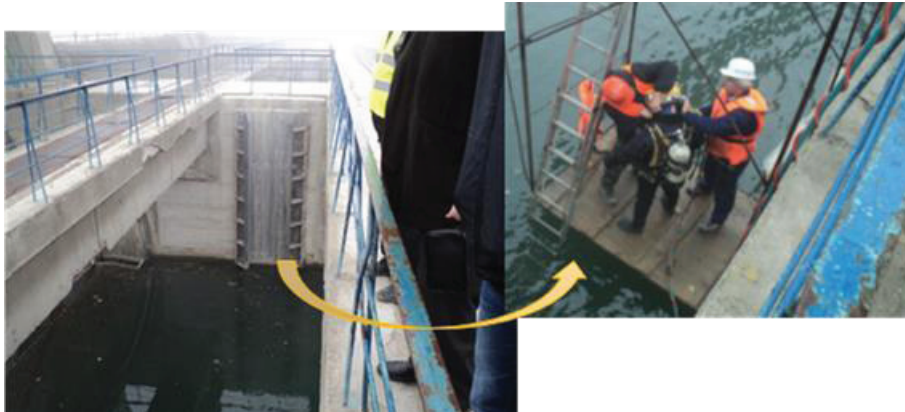
Figure 4 : New stoplog guidance

The project includes a large variety of works with significant complexity. Special remark has to be made concerning the steel stoplog guidance placement on piers. Working under water has avoided difficult water diversion and saved funds.

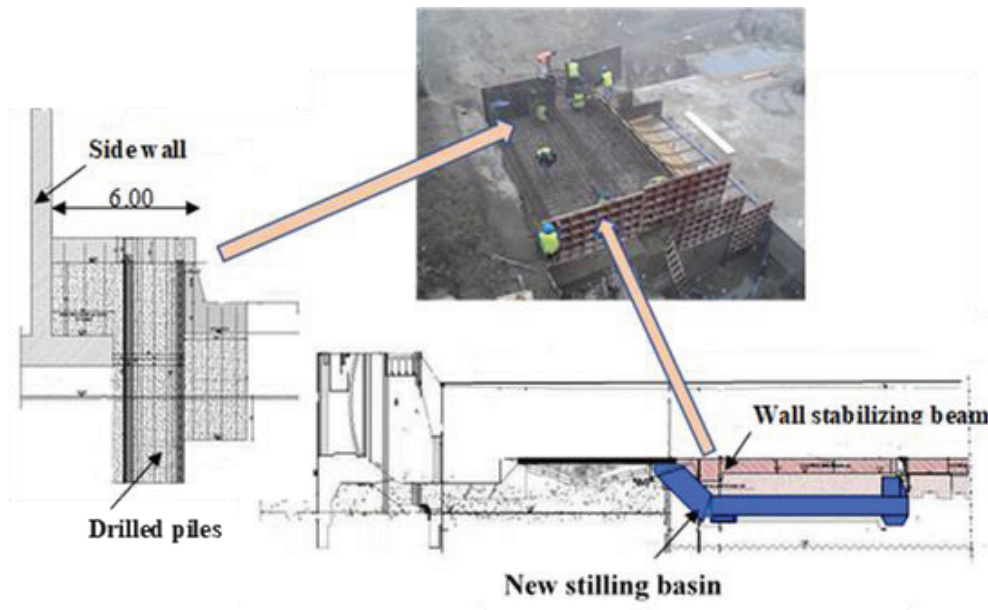
Two problems were encountered during the project implementation. The first one was induced by the actual conditions of the side walls foundation. The lowering of the river has uncovered the previous foundation and the walls were practically suspended. The design technical solutions were modified during the work implementation in order to cope with the actual site conditions. However, some of the changes have improved the foundation conditions of the new works but affected the hydraulics of the downstream flow. Concrete blocks resting on drilled pipes were provided inside the flowing area in order to support the side walls structures but they do not preserve the downstream flowing area. The concrete blocks along the side walls partly obtrude the water flow released by the spillway bay near the right bank. A similar hydraulic blocking could happen to the water flow released by the washing bay of the intake pocket.

Figure 5 : Concrete blocks along the side walls.

The hydraulics of the flow downstream of the right bank bay and downstream of the flushing bay were partly solved by adding guide wings.

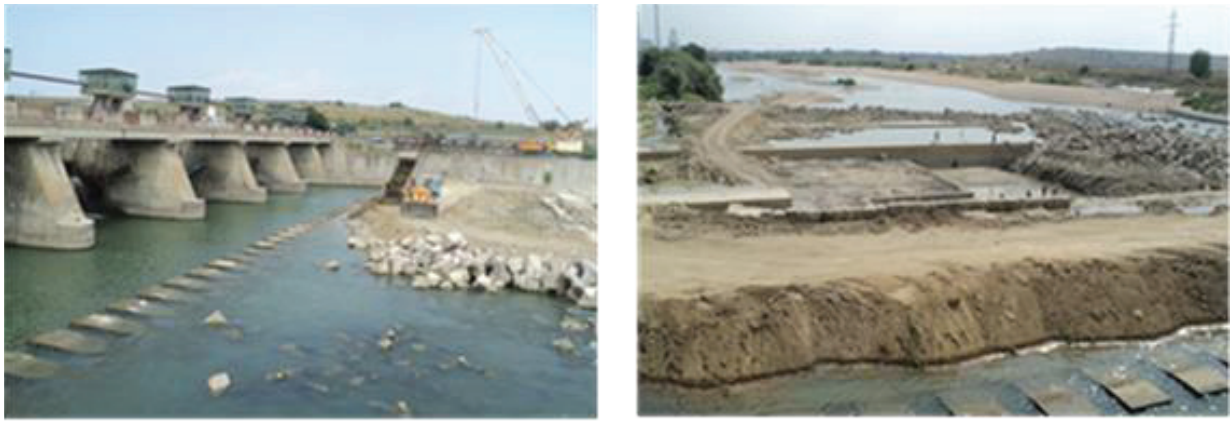
The second problem was generated by the unexpected duration of the works, mainly due to lack of funds. Several floods were routed through the reservoir affecting the construction site. The most severe one happened on 4 April 2013 when a flow of 1028 m³/s was passing the dam. The actual river bed downstream of the dam was partly closed by a diversion cofferdam. The water overflowed the cofferdam crest, the rockfill of the rear apron was washed away and at the end a large amount of debris covered the downstream area. Mention should be made that the new structures (stilling basin, concrete blocks along the side walls, the new dental sill), even still under construction, were not damaged.

Figure 6 : Construction site after the flood in April 2013.
