THE VIDEO-SONAR INTEGRATED METHOD FOR LEAKAGE DETECTION AND ITS APPLICATION

YI XU, XIAOMING ZHOU AND JINZHANG TIAN

Changjiang Survey, Planning, Design and Research Co.,Ltd., Wuhan, China and National Dam Safety Engineering Research Center, Wuhan, China)

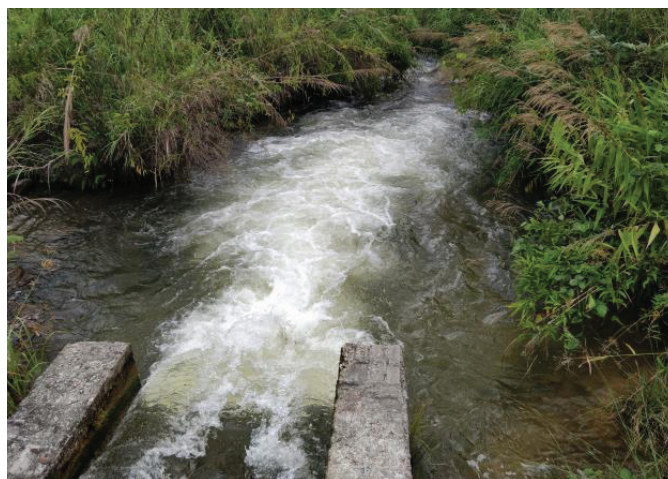
The reservoir was impounded in November 2013, and the commercial operation of the hydropower plant started in August 2014. The main dam began to leak in October 2015, and the leakage rate increased continuingly. In 2018, the maximum leakage rate has reached 1300L/s. The picture of the leakage at the measuring weir (located at the downstream dam toe) is shown in Fig.1.

Fig. 1 : Leakage at the measuring weir

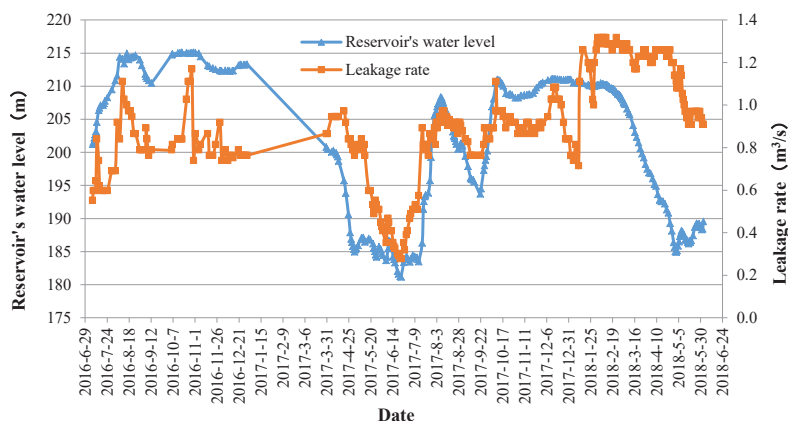
- (1) There was a close correlation between the dam's leakage rate and the water level of the reservoir (see Fig. 2). The leakage rate increased gradually with the rise of water level. And when the water level of the reservoir was lowered down, the leakage rate showed a slight decrease. From 2016 to 2018, the leakage rate of the dam generally increased at similar water levels. Such a trend is basically consistent with the observations and experiences in the leakage problems caused by the damage of concrete slabs in Baiyun Dam[8] and Zhushuqiao Dam [9] in China.

Fig. 2 : Evolution curves of reservoir's water level and leakage rate

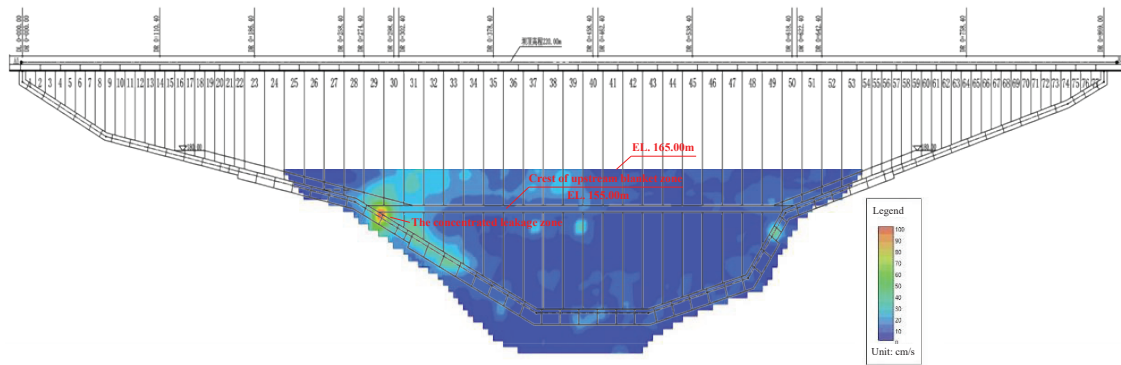
Fig. 3 : Leakage velocity contours map obtained by the underwater sonar detection

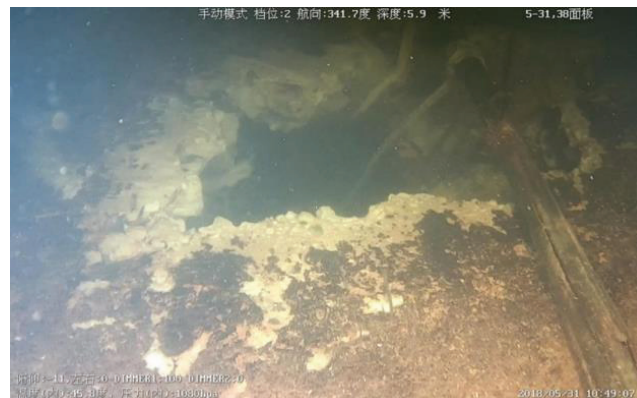
From the unmanned inspection, it was found that a leakage hole was formed on the No.38# concrete slab at an elevation of about 182.5m. The leakage hole was about 50cm in diameter (see Fig. 4), and the concrete near the hole was totally ruptured and brought away by the leakage water. The velocity at this hole was up to 0.92m/s.

Fig. 4 : Underwater high-definition photography of the leakage hole on No. 38# concrete slab

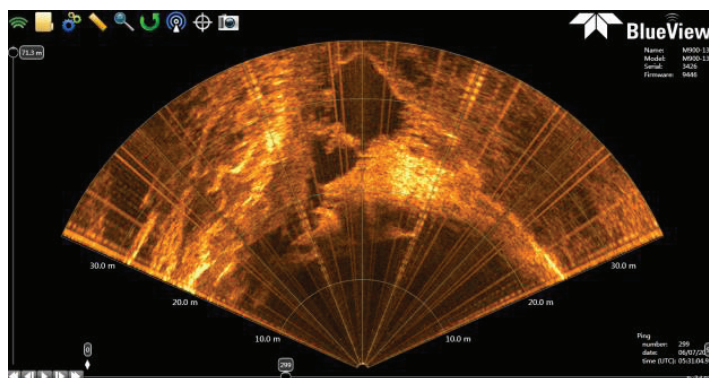
When investigating the concentrated leakage zone found by sonar detection, image sonar was used to identify the details of the leakage entrance. It was found to be a large pit on the upstream blanket zone with about 10.8 m in length and 6 to 8 m in width (see Fig. 5). The leakage entrance located at the bottom of No. 29# concrete slab, near the elevation of 150.0~153.0m. The concrete slab was severely damaged and collapsed, and the clay materials of the upstream blanket zone were washed away by the inlet water, forming a funnel-shaped pit.

Fig. 5 : Image sonar detection results of the concentrated leakage zone on No. 29# concrete slab

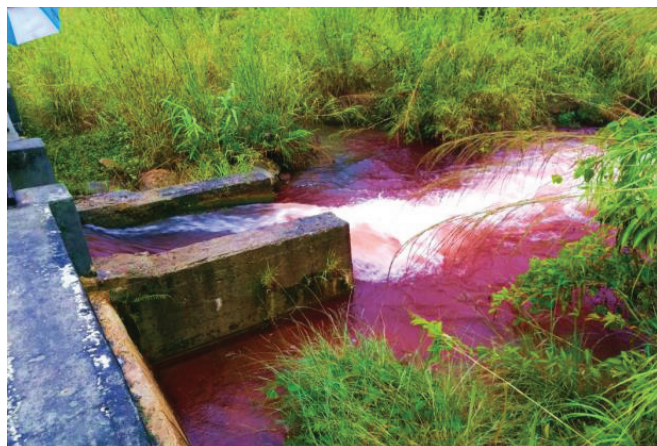
Hydraulic connectivity tests were performed on the two detected leakage entrances (one is on the No.38# concrete slab, and another is at the bottom of No. 29# concrete slab). A large amount of pigments with different colors was released at these two leakage entrances. Respectively after about 5 to 6.4 hours, the out flow at the downstream measuring weir began to change color (see Fig. 6). The tests could provide evidence of hydraulic connectivity between the leakage entrances and the leaked water at the downstream side of the dam. It was also indicated that percolated leakage routes were formed inside the dam body.

Fig. 6 : Hydraulic connectivity test
