# PERFORMANCE OF DAM AND FOUNDATION SYSTEM – CASE STUDY OF CONCRETE GRAVITY DAM OF SRINAGAR HYDROELECTRIC PROJECT, INDIA

## ABSTRACT

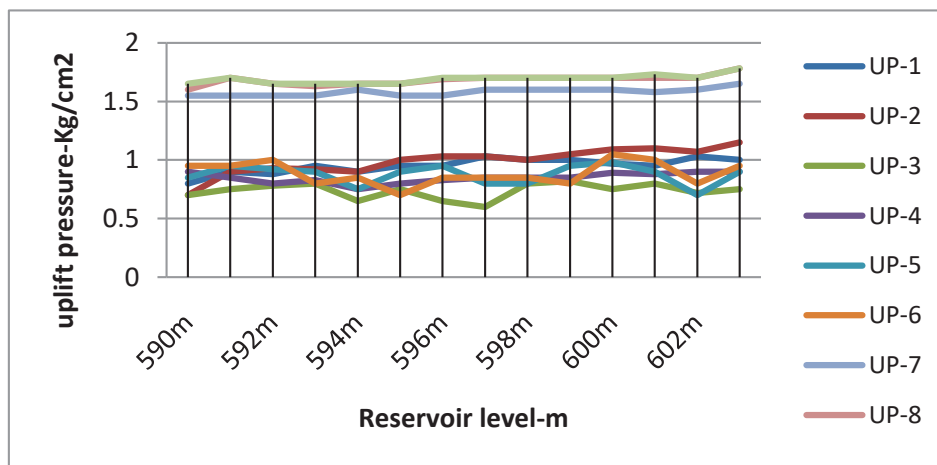
Fig. 8 : Uplift pressure at different reservoir level

Uplift-pressure at the dam foundation was analyzed with the changes in reservoir level from EL 590 to 603m. The minor increase in uplift-pressure between 0.2 to 0.23 kg/cm<sup>2</sup> was recorded near the drain-hole and the heel of the dam, and the uplift-pressure was found almost constant at the toe of the dam vis-à-vis the increased water level. This was because there were no changes in tail water level. As the seepage water from the drains was also found increasing, indicating effectiveness of drainage system of dam foundation

Considering the above design-operating parameters with existing head water (EL 603m) and tail water level (El 550m), the uplift-pressure at downstream toe of the dam should not be more than 2.4 kg/cm<sup>2</sup>. However the uplift-pressure near the drains should not be more than 4.1kg/cm<sup>2</sup> , when drains are functioning.

The increased uplift-pressure at, the Dam heel was recorded 0.2 to 0.23 kg/cm<sup>2</sup> and the Uplift-pressure increased at toe was recorded nil. However, recommended uplift-pressure at the heel for the existing reservoir level (603m) was 4.1kg/cm<sup>2</sup> and recommended uplift-pressure at the Toe for the existing tail water level (550m) was 2.4kg/cm<sup>2</sup>. Therefore, the uplift pressure was found safe within the design limit.

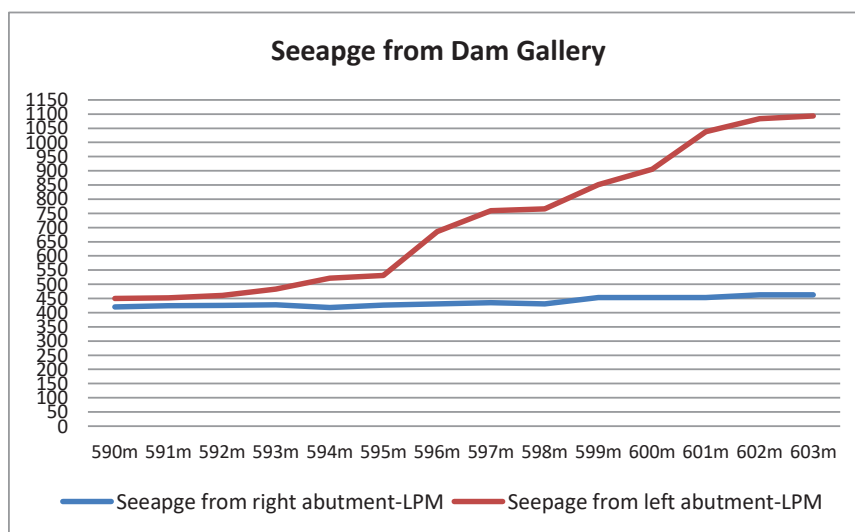
Fig. 9 : Seepage at Dam Gallery with reservoir level

Seepage from the dam body and dam foundation was recorded with the help of two seepage measuring devices installed at the dam gallery. The minor changes in seepage were recorded vis-a-vis the increasing reservoir level 590 to 603m at the right abutment. However, the seepage rate with increased reservoir level, was found on the higher side, at the left abutment. The maximum increased seepage, recorded was 688.2LPM, The total seepage at the dam gallery for the reservoir level EL 603m was recorded as 1558.2LPM.

The maximum share of seepage has been recorded from the foundation drain holes and porous drains provided in the dam body. Seepage from few block joints was also recorded at the dam gallery and the D/s face of the dam. The status of all the drainage holes below 603m was also checked and it was found that out of 42 drainage holes, 32 drainage holes were found in flowing condition.

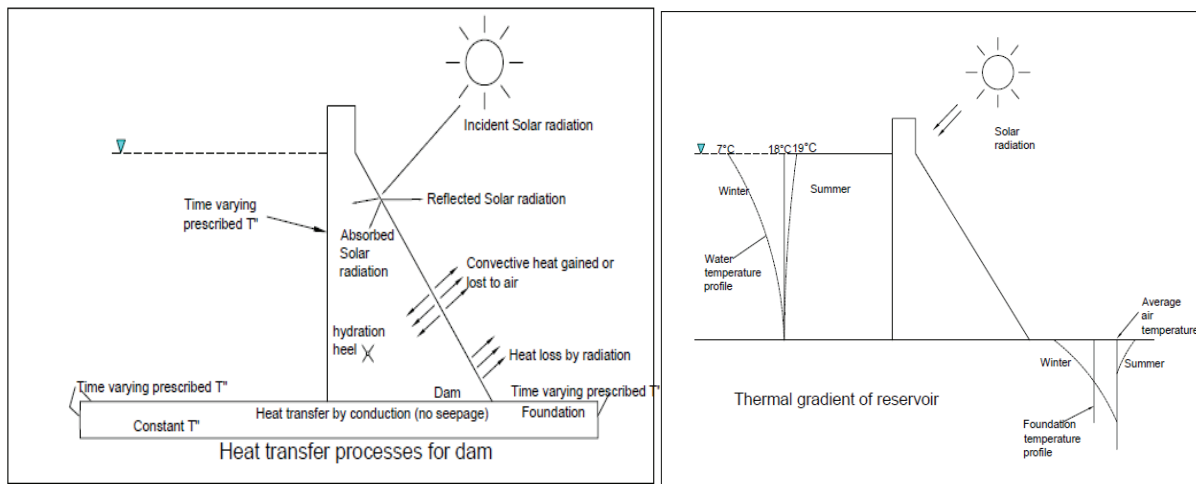
Fig. 10 : Thermal Gradient of Reservoir

The thermal gradient of the reservoir was checked, with the recorded temperature of the seepage-water from the porous drains at different levels in the dam gallery, and it was found that the temperature of the reservoir, increasing with depth, varied from reservoir level 603 to 528m, found almost 12°C during winter season. However, during the summer, the temperature variation in reservoir level was recorded from 603 to 528m, found almost 1°C. It was also observed that up to initial 10m depth, there were no major changes in reservoir temperature. This was due to impact of air temperature and inflow of water.

Considering the general trend of annual reservoir temperature, it was found that the temperature fluctuation was higher at the top surface (considering winter & summer air temperature), whereas, at the middle to bottom level, the temperature variation was minor.

Air temperature difference on the analysis day was 10 to 23°C. Reservoir temperature difference from EL 593 to 526m was recorded 13.2 to 17°C. The dam body upstream faced temperature difference from EL 593 to 526m, recorded 13 to 17°C. Maximum temperature at the dam core was recorded as 20°C. The dam body downstream faced temperature difference above TWL (EL 592 to 550m), recorded 13 to 14°C. and the dam body downstream faced temperature difference below TWL (EL 550 to 526m) recorded as 8 to 17°C.

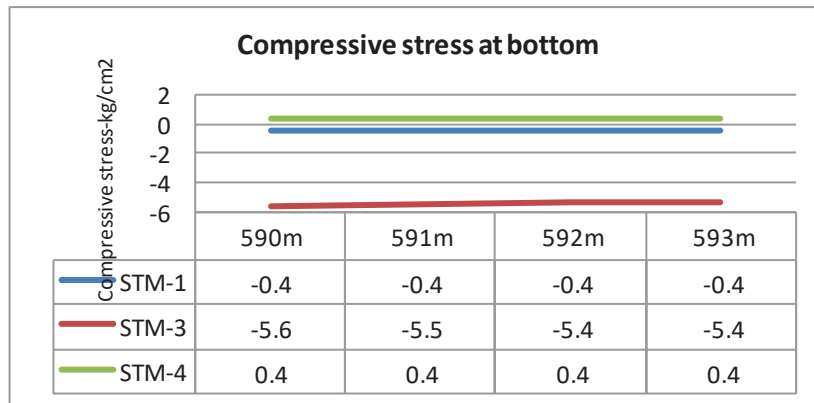
Fig. 11 : L Thermal Gradient of Reservoir

Compressive stresses decreased by 0.2 to 0.3 kg/cm<sup>2</sup>. The maximum compressive stress at the bottom (El 526) was recorded 5.6 kg/cm<sup>2</sup>. Prescribed limit of compressive stress (M15 Concrete) was 50kg/cm<sup>2</sup> for the usual loading condition. One limit of compressive stress (M25 Concrete) was 83 kg/cm<sup>2</sup> for usual loading condition.
