# CASE STUDY ON UNDERWATER INSPECTION METHOD FOR TAILRACE AREA IN HYDROPOWER STATIONS

*China Three Gorges Corporation, Beijing, China*

### 3.1 Underwater inspection case in Three Gorges hydropower station

### 3.2 Underwater inspection case in Gezhouba hydropower station

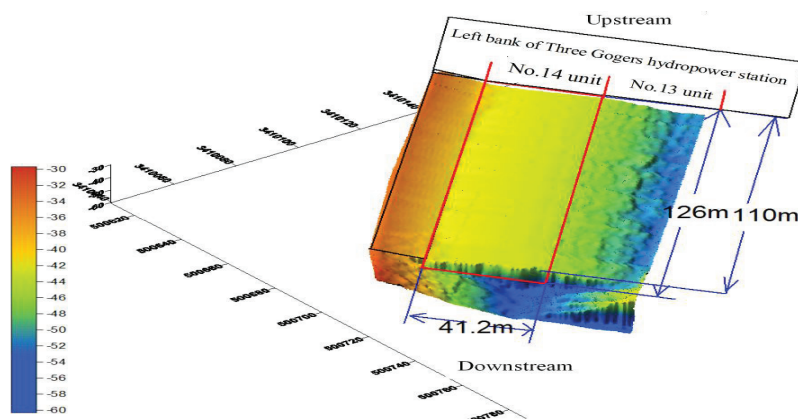
Figure 2 : Scanning image of No.14 unit in tailrace area of left bank in Three Gorges hydropower station

The results of the underwater inspection in tailrace area showed that the shape and scope of the tailrace area of the left bank in Three Gorges hydropower station were consistent with the design drawings. The concrete surface in this inspected area was basically intact, without obvious uplift and collapse, the overall condition was good. The 3D scanning image of No.14 unit was showed in Figure 2, and the 3D image of No.7 unit was showed in Figure 3.

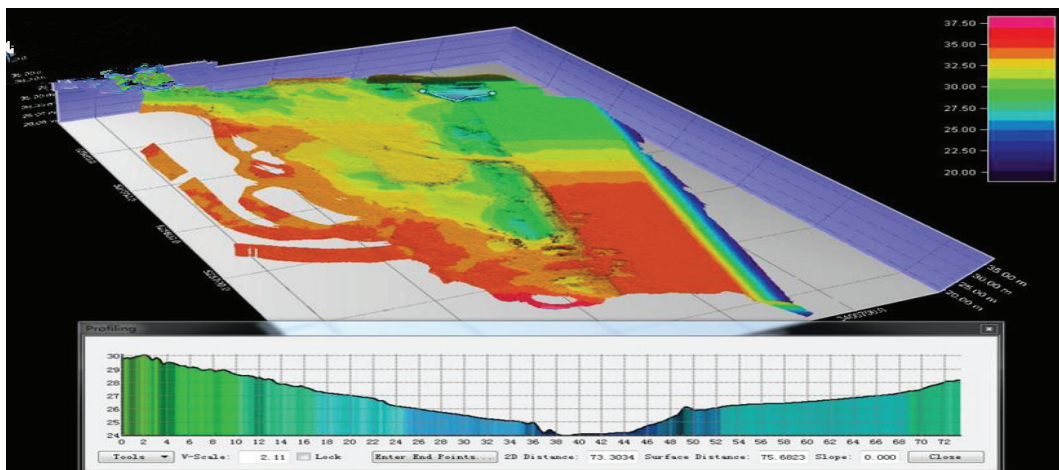
**Figure 3** : Overall scanning image of tailrace area in Gezhouba hydropower station

As a whole, the tailrace area of Gezhouba hydropower station was in good condition, which was shown in Figure 3. Due to long-term scouring, scoured pits had formed in some area with a diameter of 6-10m and a depth of 2m, as shown in Figure 4. The phenomena of scouring did exist in some area of tailrace area, but the overall topography in tailrace area did not fluctuate much.
