RISK-BASED STABILITY EVALUATION OF THE UPPER SPILLWAY MIDDLE PIER – ISIMBA HEPP UGANDA

D.E MUKWANASON, W. MANIRAKIZA, M. AKURUT, J. SEMPEWO, M. KAYONDO AND H.E. MUTIKANGA

Uganda Electricity Generation Company Limited, Kampala, Uganda

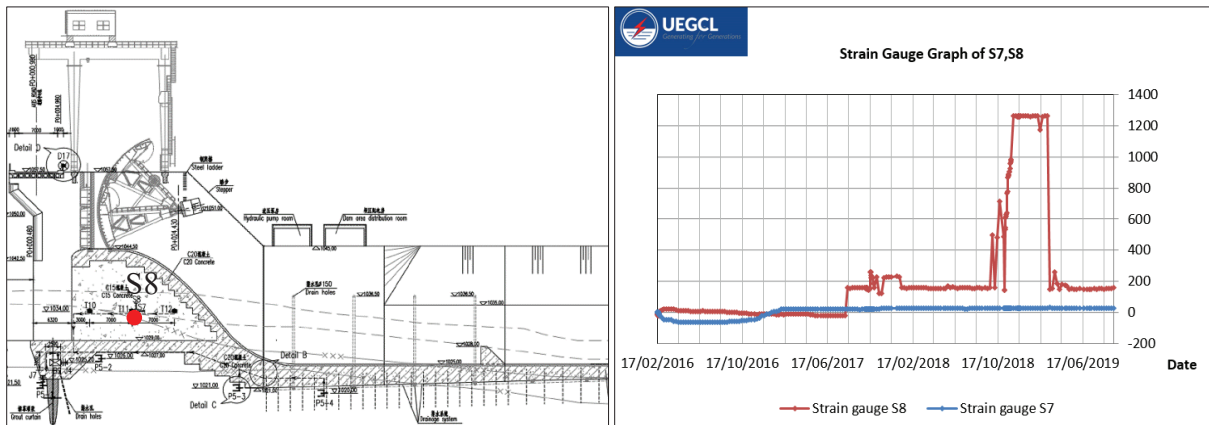
Figure 2 : Location of the Strain gauge S8 and the strain gauge response due to initial impounding

As per the Dam Monitoring and Surveillance plan, visual inspections are aimed to detect any changes that cannot be recognized with measuring instruments. During the initial reservoir impoundment visual inspections, it was observed that the upper spillway appeared to be oscillating in an abnormal way due to immense vibrations induced by large spillway discharges. This was later checked with the erratic vertical movement and rapid increase of the strain gauge (S8) installed in the mass concrete weir under the spillway gate aimed to monitor vertical strains of the concrete in response to external loads such as the hydrostatic loads from impounding. Instrumentation data processing also showed that the maximum vertical strain remained constant despite the stabilization of the reservoir water level after impounding as shown in Figure 2. Potential failure mode as defined by the Federal Energy Regulatory Commission (FERC) is, “the chain of events leading to unsatisfactory performance of the dam or a portion thereof. The dam does not have to completely fail in the sense of a complete release of the impounded water.” (Schweiger, Kline and Burch, 2019)

In reference to the above mentioned observations, potential failure modes of; possible Uplift of the stilling basin and flexural failure of the pier were identified in a site risk workshop, quantitatively assessed and subsequently ranked as extreme risks (E) in the Isimba Dam safety risk register due to the inherent consequences they posed to the owner. This called for a need for further investigation and analysis of the looming state of the spillway for reevaluation of the posed risks. It is well known that a high percentage of dam safety incidents occur within the first five years of operation; the initial impounding and the first years of operation are the most dangerous and therefore dam failure prevention must be efficient during the life cycle of the dam from impoundment to decommission (Mean et al. 2019)

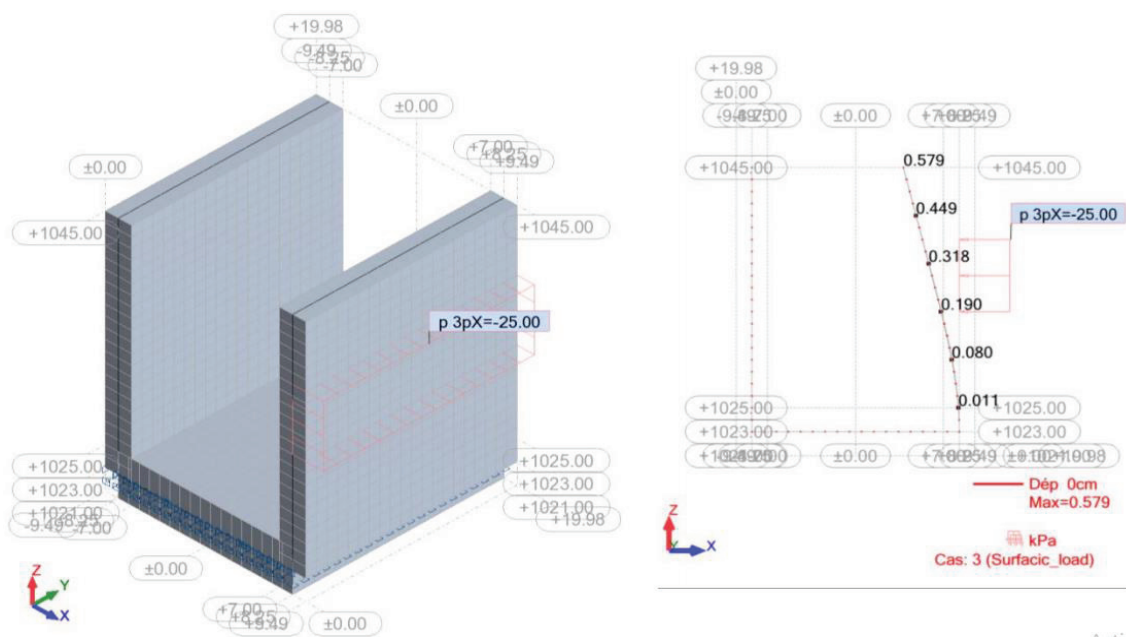
Figure 3 : 3D model adopted in the verification of the spillway pier

In the structural analysis of the long-term resistance of the pier under the vibrations, a 3D model composed of two 2.5m thick walls and a slab is modelled as anchored (pinned supports) see Figure 3. The set-in-place concrete reinforcement (Concrete C20, Steel rebars $f_{yk} = 420$ MPa with a cover of the 0.15m) is found to have a maximum bending moment of about 1600kN.m/ml at the bottom of the wall (El + 1025.00) giving stress in concrete as; 2.14MPa (OK) and stress in steel rebars as 58MPa<336 MPa (OK) and a natural frequency of 3 Hz.

The fatigue of the reinforced concrete is then evaluated in order to estimate the maximum number of cycles that the pier can withstand according to Eurocode 2. Calculation of the fatigue for concrete and the fatigue for the steel rebars provides that the reinforced pier has a resistance of 42years under conditions of continuous cyclic vibrations from the discharge of the upper spillway

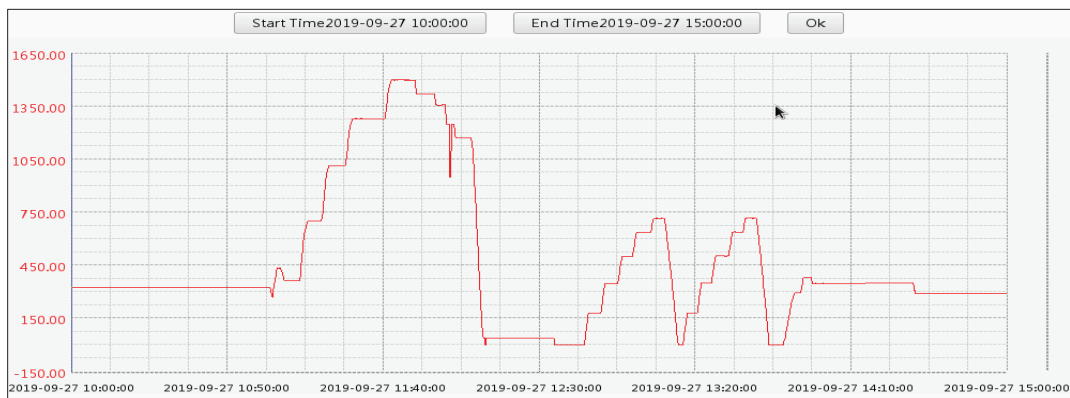
Figure 6 : Showing the discharge hydrograph of the spill way during the vibration test

The vibration is maximum under the operating conditions in which the two outlets of the Upper spillway are opened at the same time see Figure 6 for discharge hydrograph, and the vibration value becomes larger as the gate opening degree increases; when the gate opening reaches the maximum 75%, the vertical vibration peak-to-peak value is between 0.37 µm and 29.2 µm. The “4A gap displacement vertical” value is the largest, which is 29.2µm (Figure 8 above); the horizontal vibration peak-to-peak value is between 2.76µm and 174.86µm, wherein the “4B 1042 displacement level” has the largest value of 174.86µm; the vertical acceleration vibration peak-to-peak value is 0.061m. Between / s²~0.5209m/s², the value of “4B gap acceleration vertical” is the largest, 0.5209m/s²; the horizontal acceleration vibration peak-to-peak value is between 0.2301m/s²~0.6844m/s², of which “4B1042 acceleration level” The maximum value is 0.6844m/s² (Figure 7 above); the standard deviation of vertical vibration is between 0.14µm and 11.88µm, among which the value of “1A displacement vertical” is the largest, which is 11.88µm; the standard deviation of horizontal vibration is between 0.86µm and 53.08µm, among which “ The 4B 1042 displacement level has the largest value of 53.08µm; the vertical acceleration vibration standard deviation is between 0.0143m/s² and 0.1962 m/s², of which the “4A gap acceleration vertical” value is the largest, 0.1962m/s²; horizontal acceleration vibration standard The difference is 0. Between 0143m/s² and 0.1962 m/s², the value of “4A gap acceleration vertical” is the largest, which is 0.1962m/s². In the case of the same opening degree, the noise values are basically the same, and there is no abnormal state. At 75% opening of the gates, free fall of the water was achieved (the bottom of the gate left the water surface) see Figure 9 above.

In the meantime, unnecessary spillway gate operations ought to be avoided by the operator in order to prevent development of structural fatigue in the spillway structure due to prolonged spillage. The upper spillway radial gates may be operated at less than 70% opening as per the vibration test data results until the final stability analysis of the pier is done and correctly verified.

During flood conditions, sharing of the discharge among the two upper spillway outlets is advised as compared to individual opening of the outlets for the same quantity of flow. From the vibration test data results, it is observed that using two outlets is preferable to one when discharging a flood of the same magnitude due to the reduced vibration results.

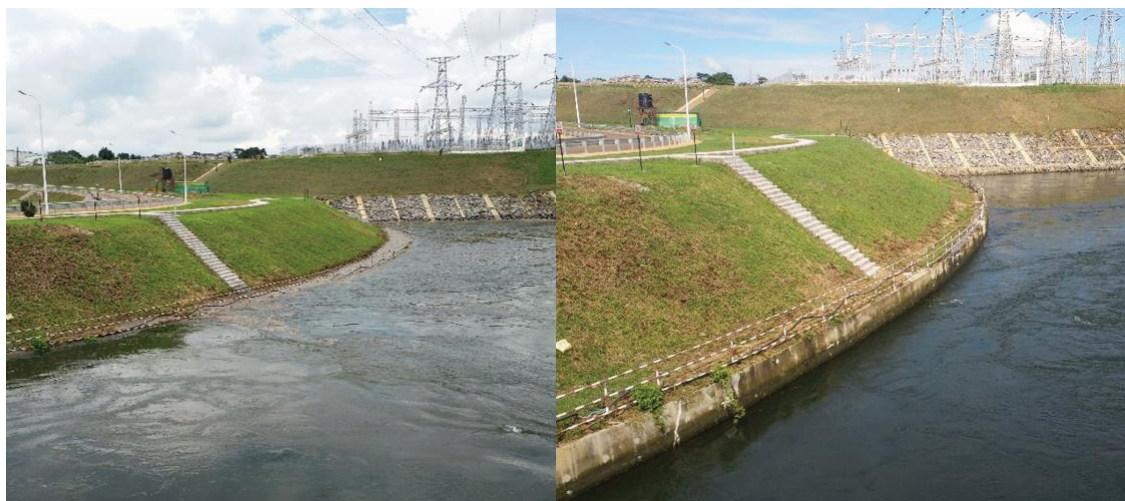
Figure 10 : Showing the downstream water levels during the test and after reinstatement process

The risk informed approach used during the test was effective since there was no harm caused to the downstream residents, the ferry operation and the bridge works as verified by the post-test inspection. The concrete structure and the mechanical equipment of the spillway were not significantly affected either. Coordination with the cascade upstream dams also ensured that there was enough inflow to allow for the vibration test as well as power production. Water levels during the test and after reinstatement. After successful completion of the vibration test, UEGCL embarked on a

reinstatement process by operating the gates to normalize the downstream water level back to elevation 1038.7m.asl so as to allow for ferry operation and bridge construction works. (Fig.10)
