ICOLD Symposium on Sustainable Development of Dams and River Basins, 24th - 27th February, 2021, New Delhi

AN OVERVIEW ON SEEPAGE INVESTIGATION DURING IMPOUNDING BY INSTRUMENTATION DATA – A CASE STUDY

The Cheragh-vays dam is located in the north-western of Iran at Kurdistan province, and is rock-fill dam with 62 m in height, 30 m curtain final depth. The first filling phase of the reservoir started on 2017 May. In This paper, detailed attitude on grouted curtain data in terms of performance has analyzed with respect to instrumentation data which is including dam foundation piezometer, observation wells, and V-notch, during impounding. Besides, conditions of the dam foundation geoengineering, relationship of any probable seepage media by the cement injected data on curtain grout holes in the course of construction is analyzed briefly.

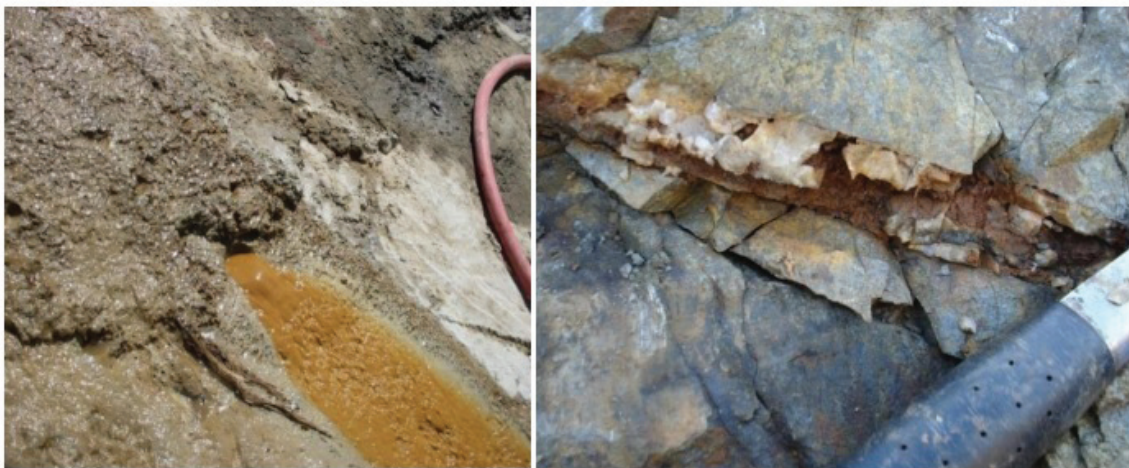
Water pressure test results during implementation phase decelerated that clay in-filled joints are capable to wash-out potential. Special (pressure) washing is used before cement injection for wash out of weak clay infilling which there were in the rock foundation joints aligned dam curtain (see Fig.2), (Hafezqurn, 2017).

Figure 2 : Wash-out of clay filling joints by pressure washing (MGCE, 2016).

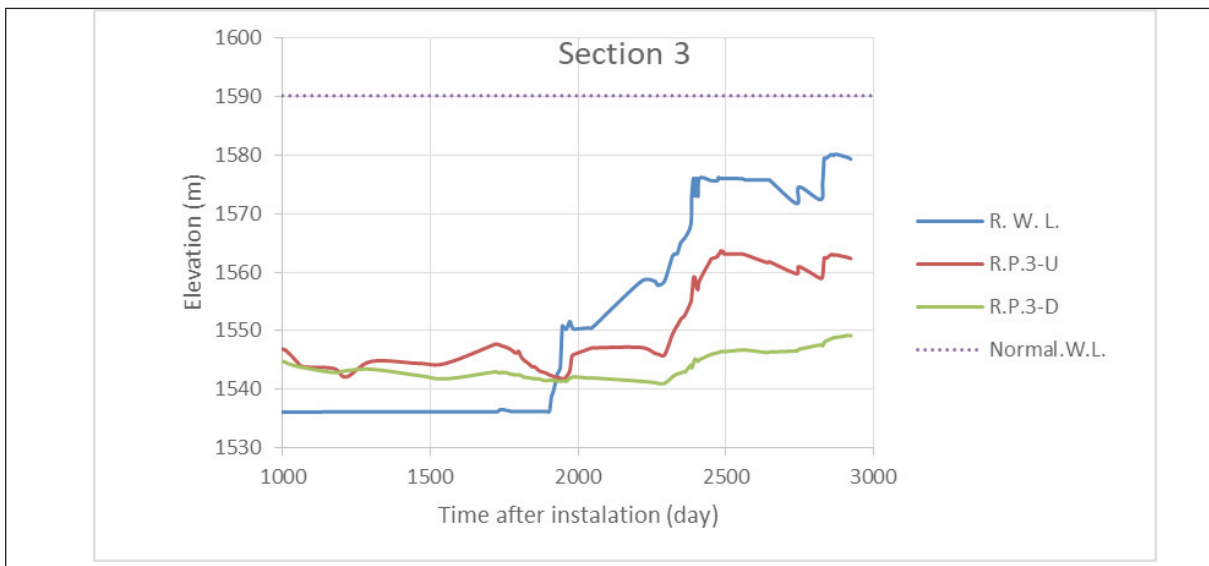
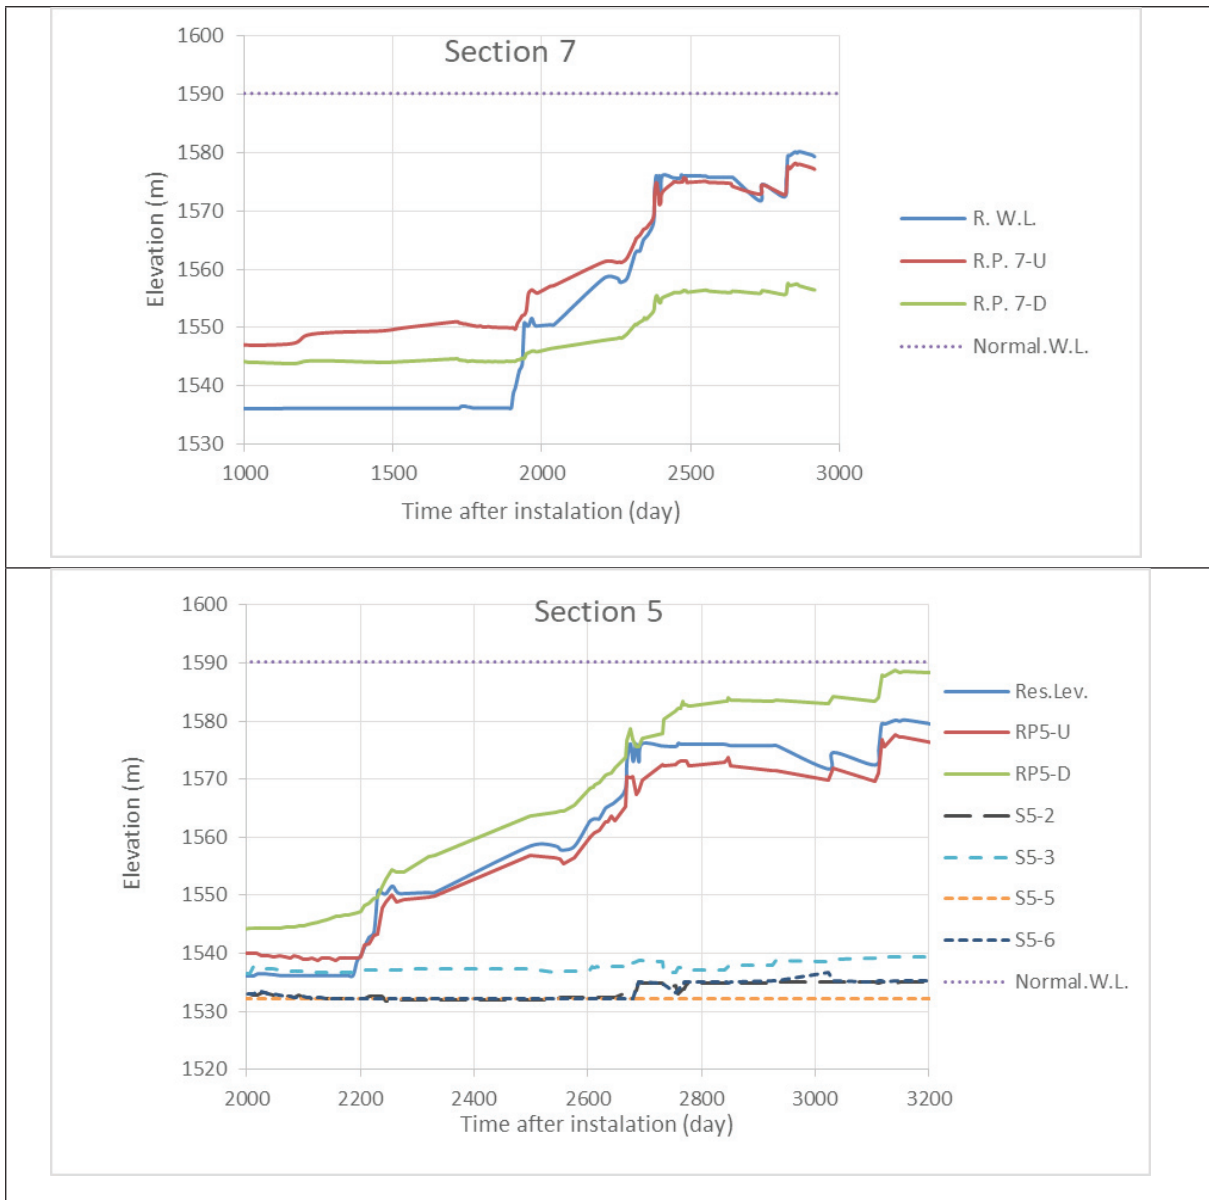
Figure 8 shows the results of rock foundation piezometer for sections 3, 5 and 7. According to this figure, there is a significant difference between the upstream and downstream piezometric levels for section 3 and 7, which indicates the good performance of the curtain at these sections. But for section 5, the downstream piezometer shows higher piezometric level than the upstream piezometer level and also the reservoir water level, which indicates an abnormal case in the piezometers behavior or curtain performance. Downstream standpipes and V-notch weir system are used for interpretation of this rock piezometer.

Figure 8 : The results of rock foundation piezometer for sections 3, 5 and 7.

- For instrumentation section No. 5, the downstream piezometer shows higher piezometric level than the upstream piezometer level and also the reservoir water level, which indicates an abnormal case in the piezometers behavior or curtain performance. Downstream standpipes and V-notch weir system are used for interpretation of this rock piezometer. Currently, the supervisor team's recommendation is careful monitoring of this section, because unusual behavior not seen in other related instruments.
- Water level fluctuations in the observation wells before and during impounding are approximately the same behavior. This indicates that the dam abutments have normal conditions in terms of seepage status.
- Seepage values in downstream of the dam is normal. Unusual springs or seepage points have not been observed downstream of the dam.

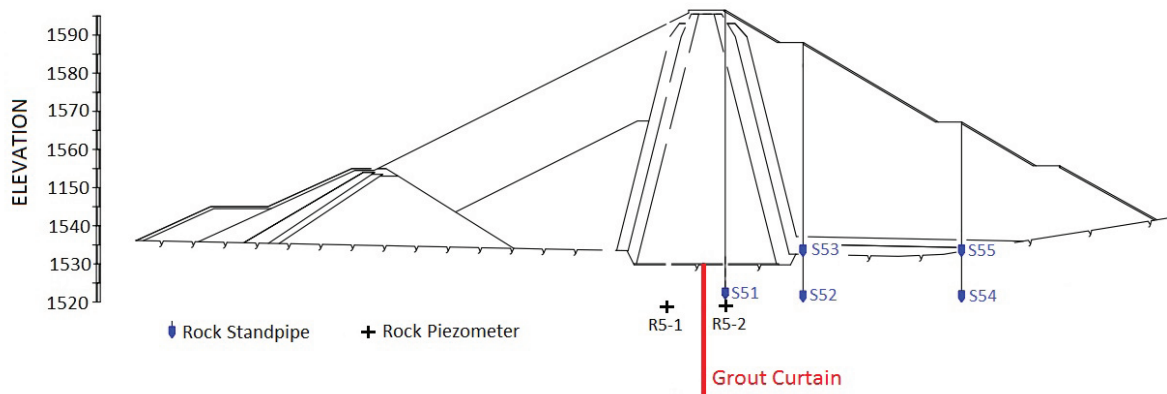
Figure 9 shows the position of the rock foundation piezometers and standpipes for section 5. Unfortunately, standpipe S51 that installed near this rock piezometer was destroyed during dam construction. Piezometers S52 and S53 that located downstream the clay core show little fluctuation with water level increasing (see figure 8). Currently, the supervisor team’s recommendation is careful monitoring of this section, because unusual behavior not seen in other related instruments.

Figure 9 : Position of the rock foundation piezometers and standpipes for section No.5

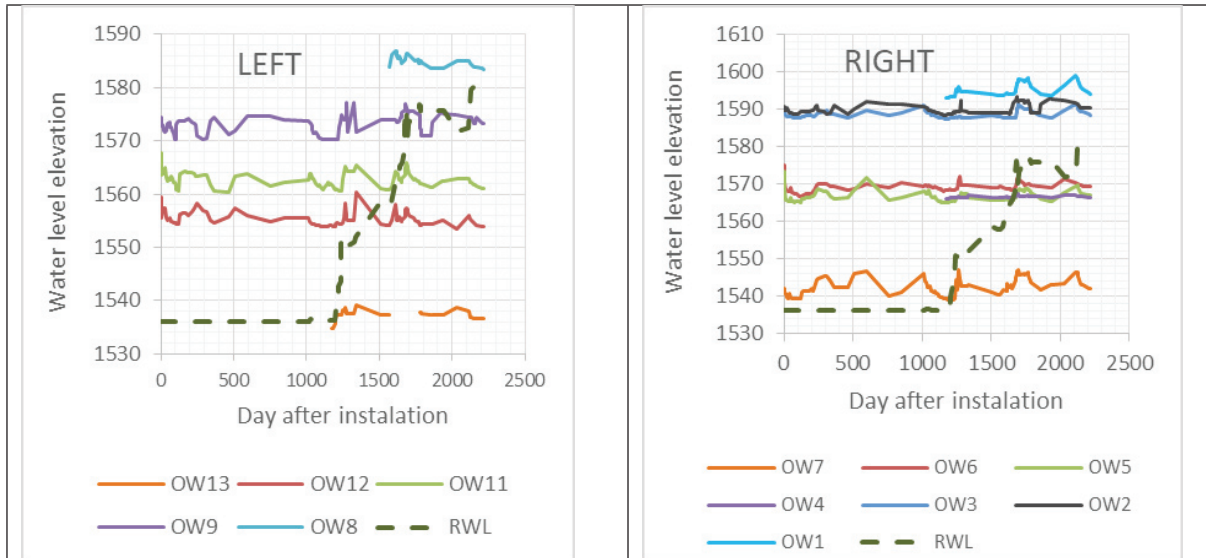
Figure 10 shows the results of observation wells of the Cheragh-vays Dam before and during first impounding (see figure 7 for well positions). Water level fluctuations in the observation wells before and during impounding are approximately the same behavior. This indicates that the dam abutments have normal conditions in terms of seepage status. The sawdust peak points in these diagrams are generally due to the increase in the water level of the wells due to rainfall, which has returned to normal level after rainfall time.

Figure 10 : The results of observation wells of the Cheragh-vays Dam before and during first impounding

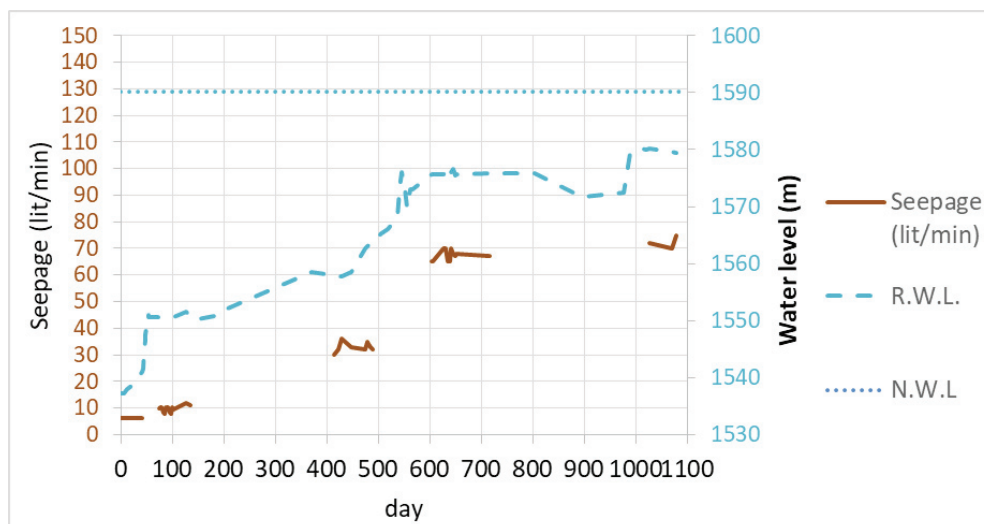
Figure 11 shows the diagram of dam seepage values in accordance with reservoir water level. Seepage values are corrected according to the method proposed by (Lee, 2015), and the effect of rainfall water on seepage values is eliminated.

Visual observations are one of the basic tasks of dam monitoring during first filling. During the impounding time, downstream areas of the dam have been continuously monitored to identify abnormal springs and seepage points. So far, abnormal springs or seepage points have not been observed downstream of the dam.

Figure 11 : The diagram of dam seepage values in accordance with reservoir water level
