ICOLD Symposium on Sustainable Development of Dams and River Basins, 24th - 27th February, 2021, New Delhi

STRATEGY FOR REHABILITATION AND STRENGTHENING OF DAM - A CASE STUDY OF TEMGHAR DAM

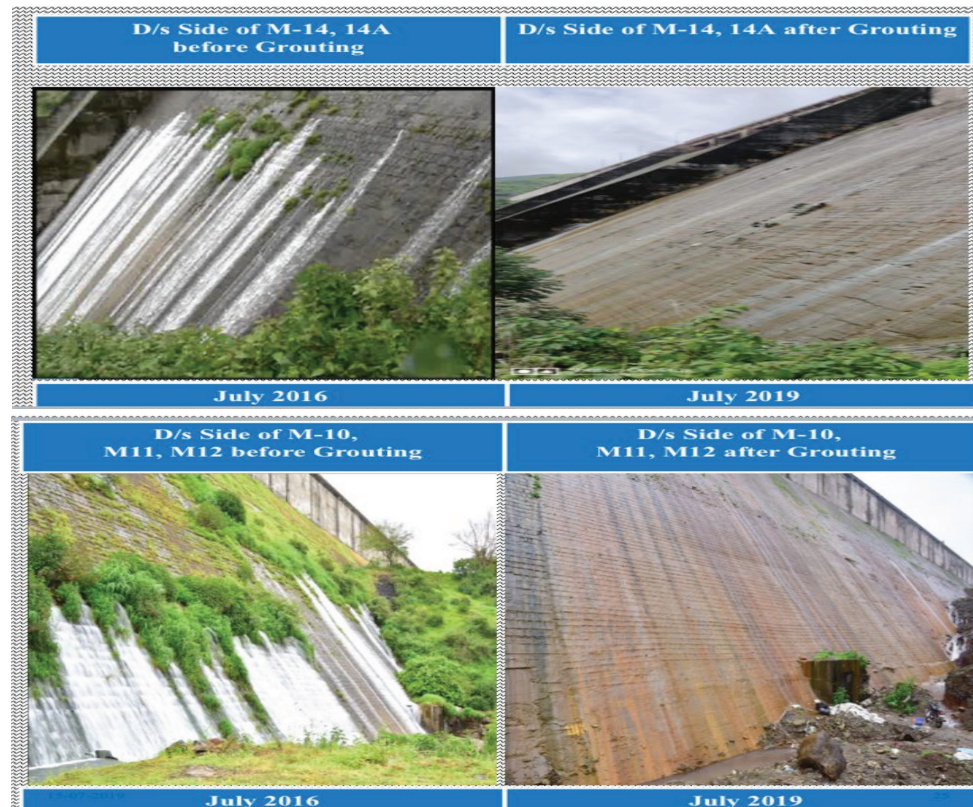
Work of grouting started in April 2017 and Work of shotcrete is started in April 2019. Before that leakage observed was 2587 lps and now in 2019 leakage observed are 265.80 lps. Monolith wise quantity of grouting and Shotcrete executed upto June 2019 is as shown in below table-

Uptill now about 65% of grouting and 10 % shotcrete work is completed and with this work about 90 % of the leakages are reduced. As per the Temghar Dam Expert Committee (TDEC) out of five short term recommendations grouting and Shotcrete that is also in a partial quantities are executed. But with this about 90% of leakages has come down. After the execution of all grouting and shotcrete work as well as remaining measures like Vertical porous hole cleaning, Curtain grouting, repairing monolith joint etc. it can be say that leakage will be reduced within the permissible limits.

Below figure shows comparison of leakage to Temghar Dam before starting repair work in July 2016 and after completing about 65% of grouting and 10% of shotcrete work at the end of July 2019.

Picture 1 : Leakage Comparison before and after repair work.

It was decided to go for exhaustive grouting. So from dam top to Inspection Gallery, Inspection gallery to foundation gallery, from D/s as well from U/s side the drilling and grouting work was immediately started from April 2017.

As per the various experiments carried out at field with help of CWPRS, it is decided to give polypropylene fibre reinforcement shotcrete treatment to upstream face of the dam. For this purpose following provisions are made for wet shotcrete treatment to upstream surface
