# EVOLVING REPAIR METHODOLOGIES FOR SPILLWAYS AND STILLING BASIN IN HIMALAYAN REGION

**BALRAJ JOSHI, KESHAV DESHMUKH, AJAY MITTAL AND  
SHRISH DUBEY**

*NHPC Ltd., Faridabad, Haryana, India*

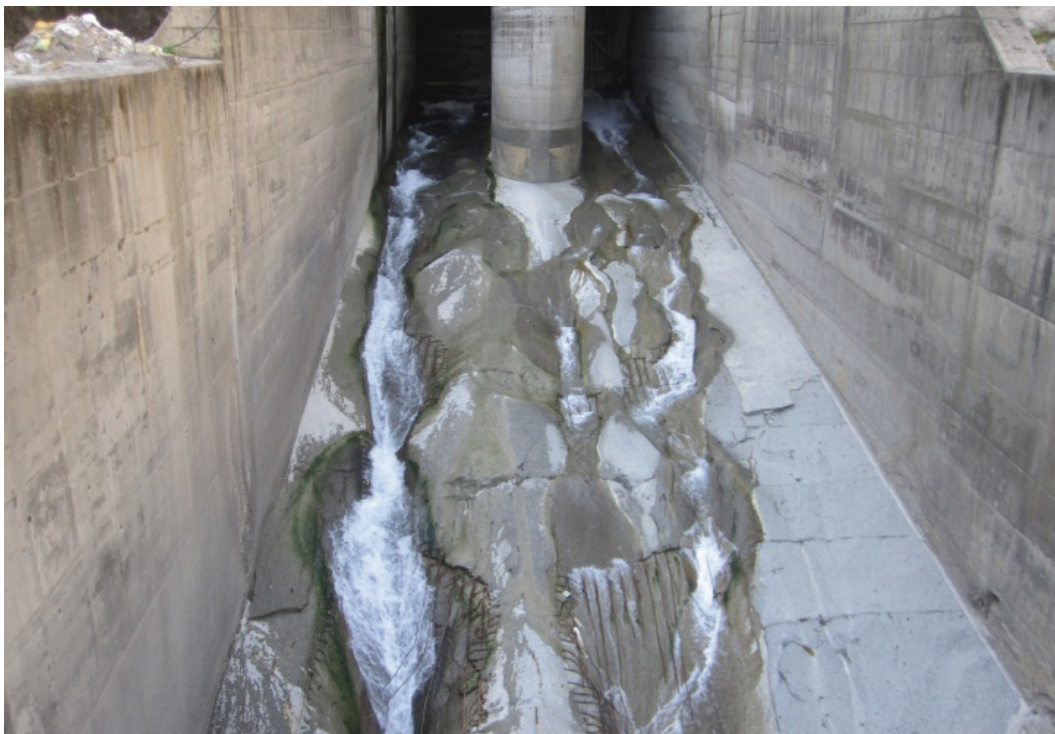
High Performance Concrete was used for the construction of Dhauliganaga & Teesta V spillways. The crest of these spillways are located 38m and 30m respectively below the FRL. The annual sediment load at these locations is 3MCM and 10MCM respectively. The boulder rolling was observed at both the locations during high floods and reservoir flushing events. Channel formation (1m-2m depth) has been observed in the concrete spillways at Dhauliganaga and large craters are formed at Teesta V spillways after monsoon. The frequency of repair at these spillways with HPC was of the order of 2-3 years only. To optimize the frequency of repair it was decided to provide steel liners at Dhauliganaga Dam two years ago. The steel liner (32mm) was fixed with counter sunk bolts @250mm c/c in the initial 18m reach from the crest. The performance has been found satisfactory with no damages in the steel liner. The damages in the lower glacis and bucket have also reduced as channel formation did not take place. Based on this experience steel liner is also being provided on Teesta V spillway surface also.

**Figure 1 :** Erosion in Glacis of Dhauliganaga Dam Spillway before providing steel liners

However anchoring of new plates with existing concrete structure was being considered difficult because of vibration of the liner plate leading to fracturing and eventual failure. Spillway crest and glacis of Dhauliganga Dam was getting damaged every year due to high head, high silt content and rolling boulders causing severe erosion conditions. Therefore, it was decided to provide 32mm thick steel liner with counter sunk bolt @250mm c/c. The space between the plate and concrete was grouted with epoxy. The liner has been provided in initial reach of 18m near gate. No damages have been observed in the first two years and the performance is found satisfactory.

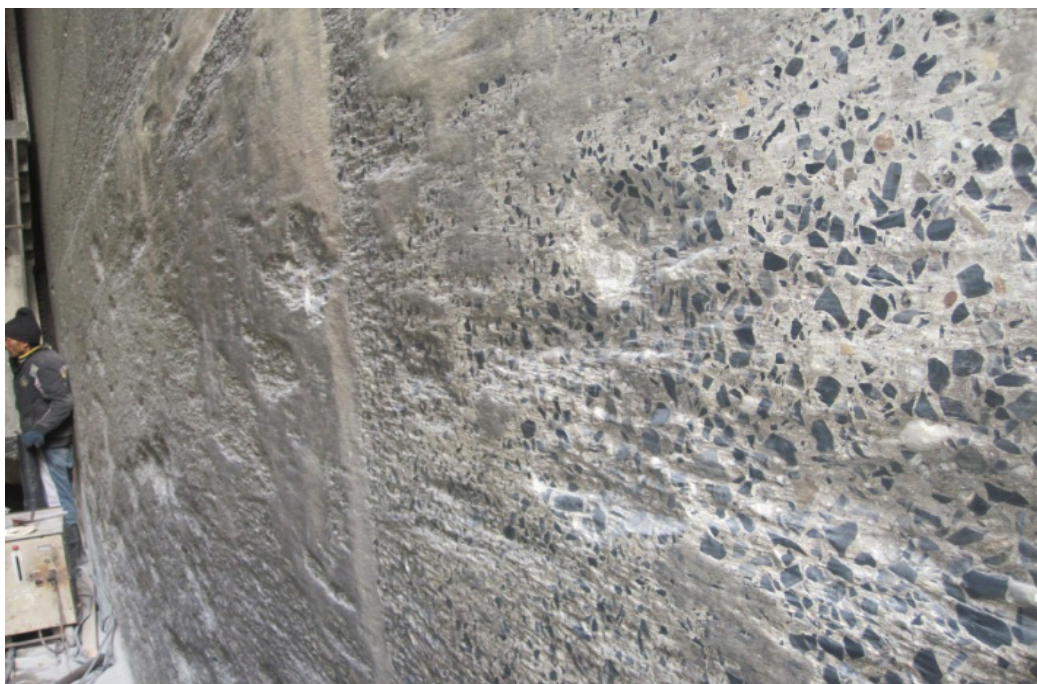
**Figure 2 :** Erosion in Pier of Dhauliganga Spillway before repair with cementitious mortar(R4)

Spillway piers of low level spillways are subjected to erosions mainly in lower reaches which varies from few to several ‘centimeters’ causing reduction in the concrete cover or exposure of reinforcement at places. Piers are structural members transferring the loads of gates and water head to the foundation therefore such damages require prompt repair. Cementitious mortars(R4) are preferred to repair such damages because the physical & mechanical properties of these mortars are similar to the parent concrete. In such repair, bonding of cementitious mortar with the old concrete is very much important. As per EN:1504-3(R4), minimum adhesive bond strength of 2 MPa has been specified. Due to this property, the repaired layer becomes integral part of the structure and the failure would not take place at the joint.

Layer thickness from 12.5mm to 50mm with cavities upto 100mm has been repaired and performance is found satisfactory at the piers of various dams even with low level spillways. Cementitious mortar(R4) could not perform for low level spillways on the glacis probably due to limitations related thickness and resistance against impact loads. The erosion forces at the piers are significantly lower in comparison to glacis, this is the main reason for its satisfactory performance on the piers of various spillways. However, it can work on the glacis for the head upto 10m with repair thickness upto 50mm in barrages and upper layer of crest spillway. In NHPC the performance of this product has been found satisfactory at low level spillway piers at Dhauliganga and Teesta V Dams. The repair cycle may vary from 3 to 10years depending upon erosion conditions. If the severity of erosion is beyond it, the steel liner is the only solution for piers also at such locations.

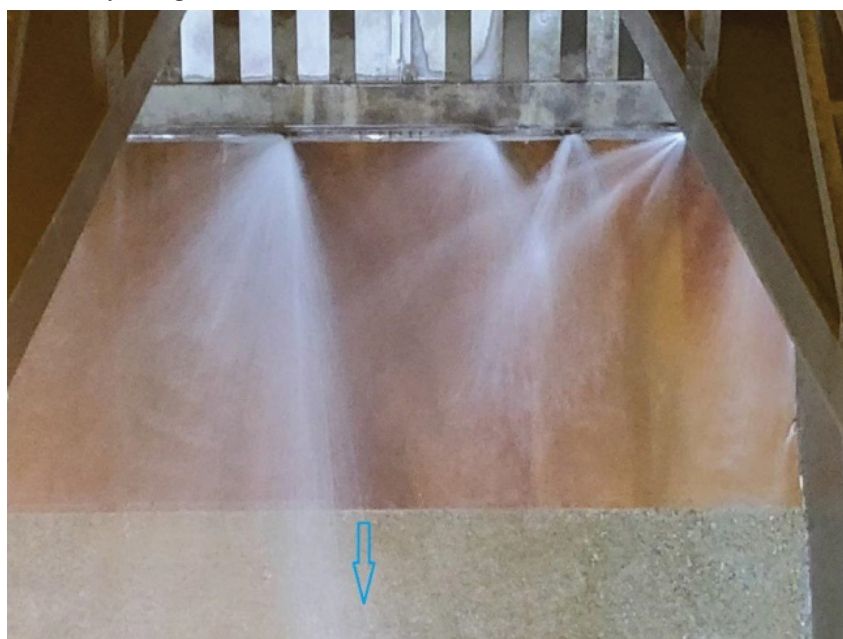
**Figure 3** : Steel Liner installed at the crest of Dhauliganga Spillway on the existing base concrete

The counter sunk bolt used for anchoring are being especially manufactured by a reputed company for dynamic load transfer to the foundation. The spacing of the counter sunk bolt was decided to reduce the vibration and effective transfer of the loads to the concrete of glacis/piers. The top of the counter sunk bolt was placed 10mm below the top surface of steel plate and the hole was filled with compatible welding material and flushed with the top surface. At the end of the steel plates a steel cut-off was provided so that the concrete beneath the steel plate is not eroded. The design and installation of steel liner need to be executed carefully as it is very difficult to repair the damaged liner once installed. If significant damage at the crest and upper glacis has already taken place during monsoon, steel liners can be installed with stiffeners by pouring concrete through holes in liner during O&M stage also.
