ICOLD Symposium on Sustainable Development of Dams and River Basins, 24th - 27th February, 2021, New Delhi

INDIAN EXPERIENCE IN FLEXIBLE GEOMEMBRANE FOR WATERTIGHTNESS OF AGEING DAMS

VINAYAGAM SUBRAMANIAN AND JAGADEESAN SUBRAMANIAN

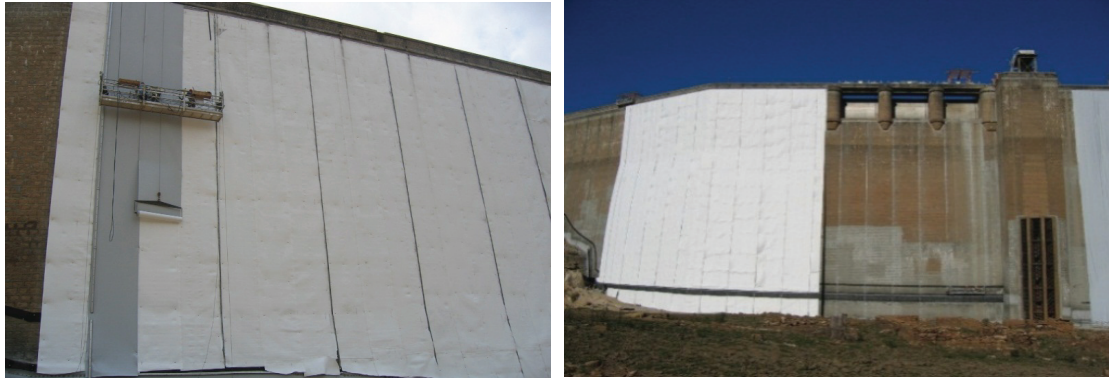
Figure 1 : Installation of anti-puncture geotextile and of waterproofing geocomposite.

The major elements included the anti-puncture geotextile layer of 2000 g/m², installed on the entire upstream face of the dam to reduce risk of puncture by the very aggressive surface of the stone masonry blocks. The nonwoven needle-punched geotextile made of pure polyester fibre was anchored to the face (Figure 1 at left).

The geocomposite sheets were lowered from the dam crest and positioned on the upstream face by crews working from suspended platforms (Figure 1 at right). On the masonry face large offsets were observed and at the bottom perimeter seal area a layer of shotcrete was done to allow even adhesion of the stainless-steel element to the dam body.

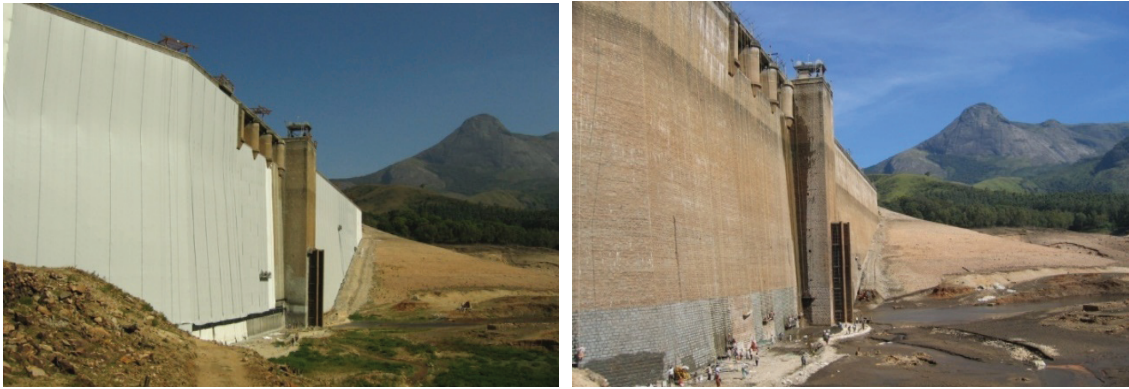
The result of the geocomposite installation at Kadamparai dam in 2018/2019 is still sound with the leakage still around the same levels. The first geomembrane project has more than satisfied the client in terms of the results, and since its installation the dam is now filled up to the FRL (Full Reservoir Level) thereby allowing full generation power of 400 MW, which was not possible before geomembrane works as the dam was operated at nearly 10 metre below FRL

Figure 2 : Upstream face of the dam before and after geomembrane installation.

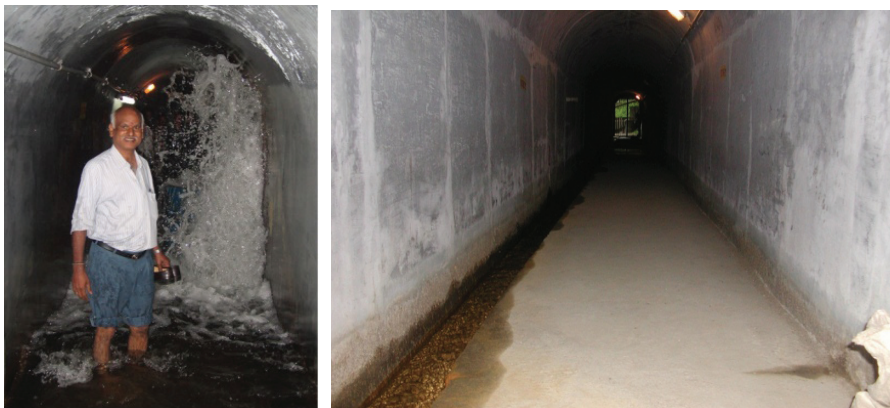
Figure 3 : Drainage gallery before and after geomembrane installation.

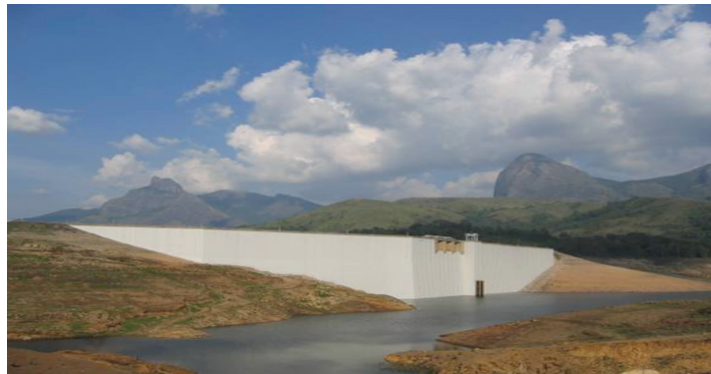
Figure 4 : Kadamparai dam after installation of the geomembrane system

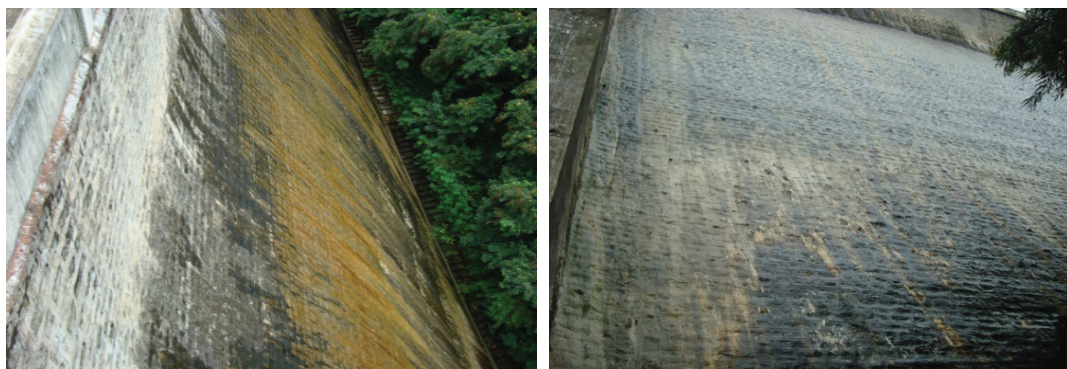
The major problem in Servalar dam is the high seepage collected inside the gallery through the vertical shafts and the extremely wet downstream side. The left flank of the dam experienced heavy seepage (Figure 5) when compared to that to the right flank, while a complete wet and oozing downstream side is visibly seen and goes unmeasured. The problem is attributed majorly to the poor quality of construction. The leakage which has been continuing for many years now has resulted in many of the drainage shafts getting choked, and heavy calcination was observed both inside the gallery as well on the downstream side of the dam.

Figure 5 : Heavy seepage on left flank.

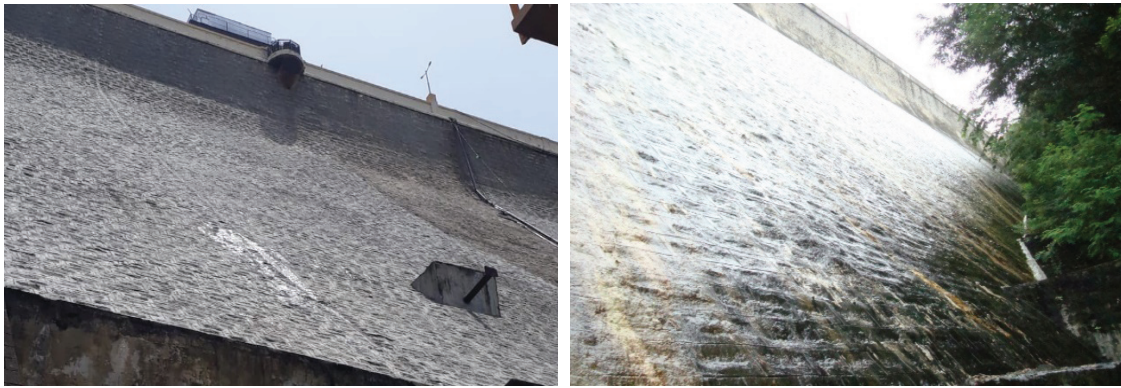
The last recorded leakage by DRIP in 2014, before the remediation works, was 743 l/minute and a complete wet downstream side (which is unmeasured – which can be approximated as around 6,000 l/minute). Most of the vertical drain shafts were choked. This continued leakage resulted in bulging of the entire dam on the left flank downstream which posed a serious risk to the dam.

Figure 6 : Downstream side before and after geomembrane installation.

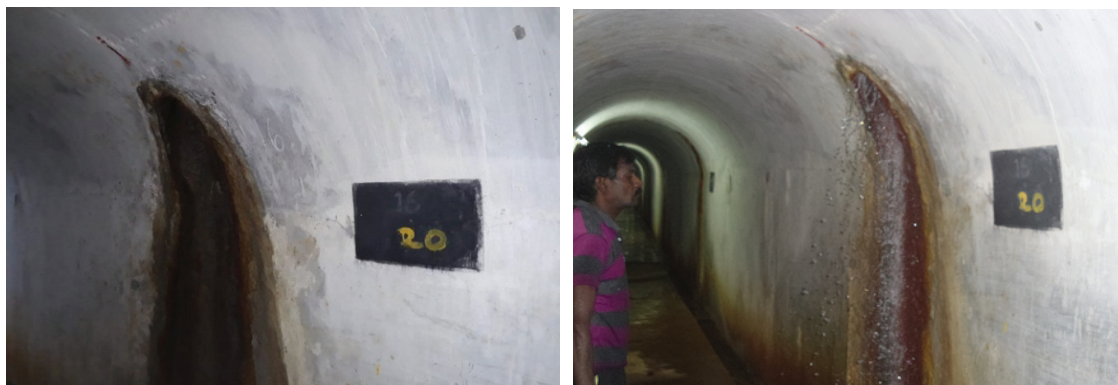
The entire work was completed on 14th of October 2018 and an inspection of the gallery was done on 15th of October jointly with the client and Carpi. Leakage from shaft reduced from 1,200 litres/minute to 1.31 litres/minute. The downstream face is now completely dry with water level almost close to FRL. The recorded leakage through the vertical shafts is 1.31 litres/minute on 09.11.2018 at water level 257.14 m.

Figure 7 : Vertical shaft leakage before and after geomembrane installation.

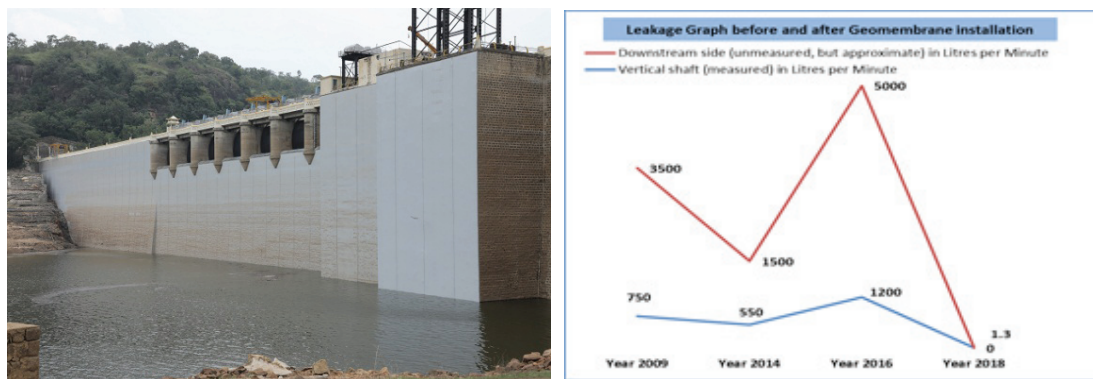
The results achieved is yet another proof of effective and professional design of geomembrane waterproofing system on large dams. A dam which was leaking at a rate of > 6,000 litres/minute is now reduced to just < 2 litres/minute on the left and spillway section.

Figure 8 : Leakage pattern before and after geomembrane installation. At right, Servalar dam after geomembrane installation.

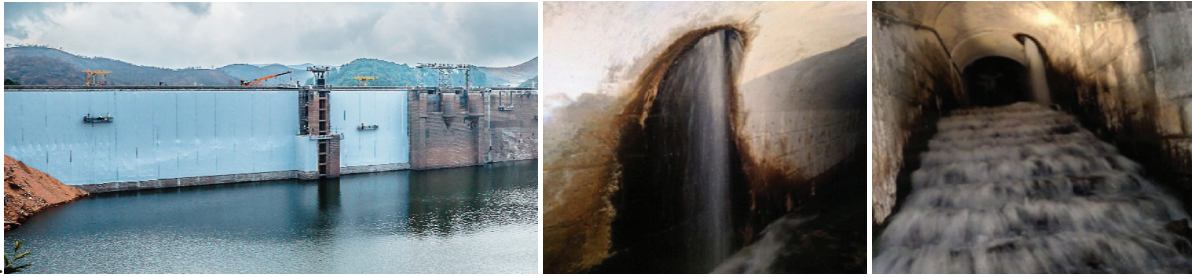
Figure 9 : Leakage in vertical shaft of drainage gallery at left. At right, geomembrane lined on the upstream face of the dam as of June 2019.
