MOSUL DAM CONCLUSIONS POST 3 YEARS EMERGENCY DRILLING AND GROUTING

G. HLEPAS AND V. BATEMAN

United States Army Corps of Engineers, Washington, DC, USA

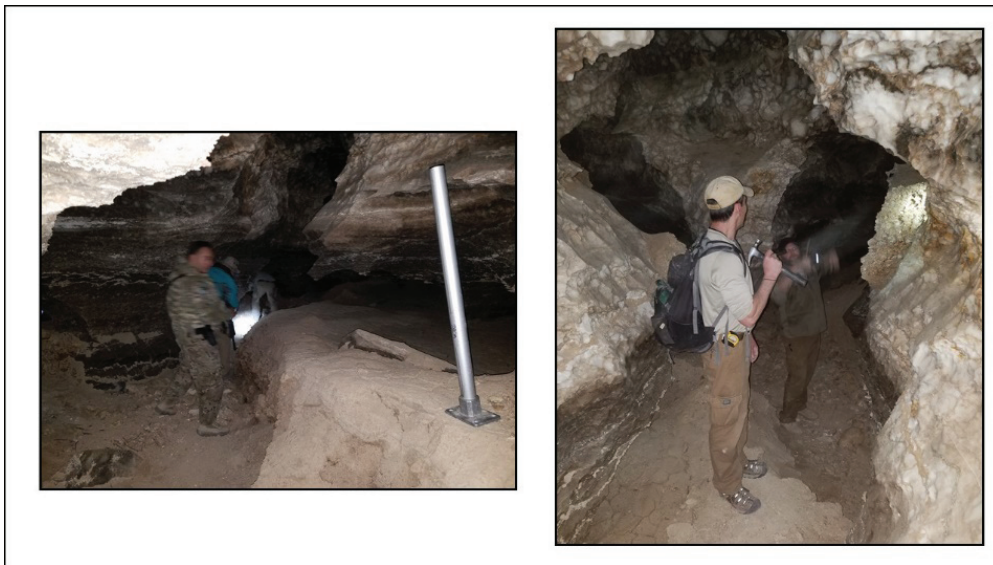
Figure 3 : Photos of large cave opening on right bank

While this cave does not pose a threat to the dam, as it is too far in the west abutment, it does represent what the foundation could look like without intervention by grouting. Indeed, drilling along the downstream left abutment of the dam near the dam toe, but within the toe weight footprint (see Figure 5 for a cross-section and toe weight feature), revealed a pattern of voids similar to what was observed in this cave. Many of the boreholes showed one to three-meter voids with one borehole having a void up to 6 meters tall.

The downstream left abutment void space took over 900 cubic meters of grout. Accessible portions of the west upstream cave would likely be closer to 400 cubic meters for comparison. However, it is unknown what other chambers deeper into the hillside or deeper into the foundation might be connected by smaller passageways that the team was not willing to enter, and grouting was not completed in the west abutment cave for comparison since it did not pose a threat to the dam.

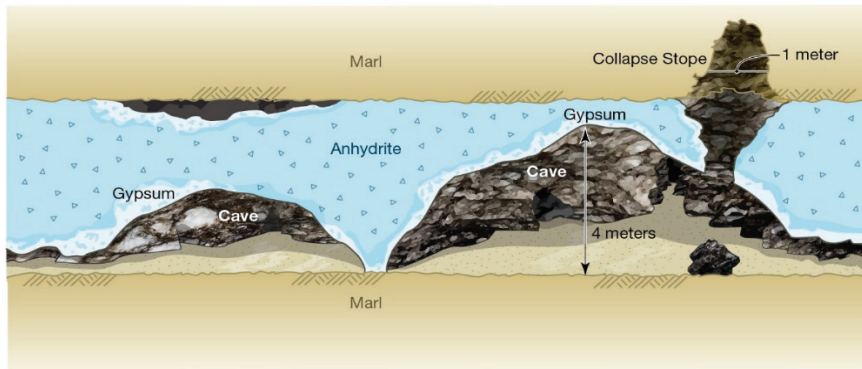
The presence of the cave, as well as evidence of surface depression features at various location in the area of the dam however, led to the conclusion that large voids could be present beneath the dam due to potential flaws and interruptions in the grouting program.

Figure 4 : Conceptual drawing of cave network and collapsing roof.

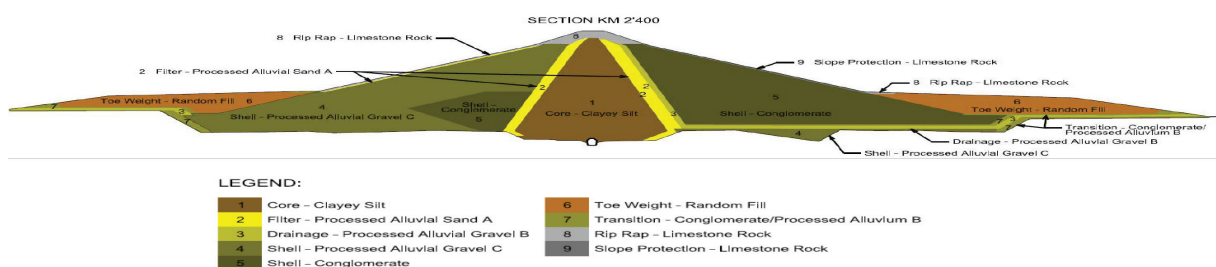
Figure 5 : General Cross-Section of the Dam

Between 2016 and 2019, an exploratory program was performed that revealed two areas of large voids downstream of identified high-risk areas. The first was located along the downstream left abutment contact near the toe of the toe weight (Figure 5 shows a typical cross-section), where an active surface depression feature was identified. The second was within the foot print of the toe weight and along the bottom outlet tunnels. Both these areas revealed voids up to 6m in height during drilling operations. Drilling and grouting efforts were concentrated in these areas to determine the extent of the void features and indicated a complex and hydraulically interconnected network of voids. These areas were extensively drilled and grouted. Grout takes in the left abutment area were in excess of 900 cubic meters of grout and near the bottom outlets in excess of 185 cubic meters. Although these areas were treated with grout, it is uncertain how far and how many more cavernous type voids may exist. Drilling under the upstream portion of the embankment was not permitted. Further, even after the significant amount of grout material placed within these voids, surficial settlement slowed, but continued. In addition, voids up to 0.5m were ubiquitous and instrumentation indicates that the downstream foundation is nearly instantaneously responsive to tail water fluctuations. This is indicative of a very permeable downstream foundation. However, the foundation treatment beneath the dam core, a satisfactorily performing grout curtain, a robust instrumentation system, and the downstream toe weight (consisting of a rock fill shell which can choke a void formation) all mitigate the potential for internal erosion.

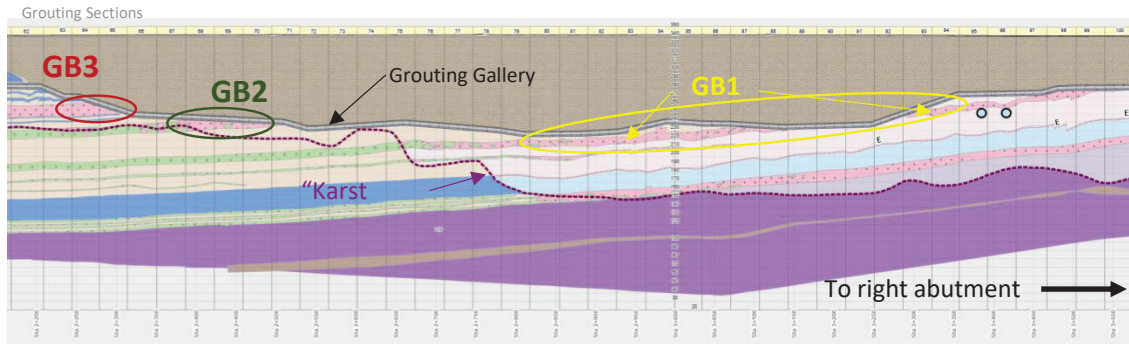
Early in the project, there was an understanding that there was a higher risk of seepage and piping potential through the foundation where undissolved gypsum was at or near the base of the embankment or where there was significant brecciation of the gypsum. The primary areas and geologic units of concern near and/or in contact with the embankment along the centerline of the dam at the grouting gallery are identified as GB1, GB2 and GB3, at the locations shown in Figure 4.

Figure 6 : Generalized geologic profile along the axis of the dam showing the locations where gypsum (GB) was near the embankment contact (after Morel, 1982)

The original designers tried to capture the difficulty of explaining the heterogeneous conditions of these GB layers by drawing a “karst line” that was a 2D dividing line between what was judged to be the more intact, vs. altered/more brecciated gypsum layers. This line was a delineation based on the drilling and grouting at the time and was a record of where higher and lower grout takes could be expected. At the time of construction of the dam, higher grout takes were above this “karst line” and lower grout takes were below this line. This distinction was also represented by the coloration of the GB layers (as shown in Figure 6). Where they are green, they were considered more intact. Where they are pink there was more developed brecciation. Thus, near the contact with the grouting gallery and embankment the GB layers were shown to have areas of intact gypsum/anhydrite within an overall brecciated and altered layer.

The recent grouting program revealed that the originally defined “karst line” has changed since original construction. The dissolution front was defined by the 2016-2019 exploratory and grouting efforts as being located further west than from the original analysis. This indicates that there is ongoing solutioning in the foundation which increases the permeability of the foundation over time. The contact between the gypsum/anhydrite units and the adjacent limestone units were also identified as having high permeability and void spaces, supporting the understanding that solutioning is ongoing. High grout takes in the brecciated limestone layers after 30 years of grouting also support this conclusion. High gradients across the grout curtain contribute to this dynamic situation resulting in ever changing foundation conditions and a continued need for grouting until all the vulnerable layers are replaced or until a foundation structural cutoff wall is constructed.

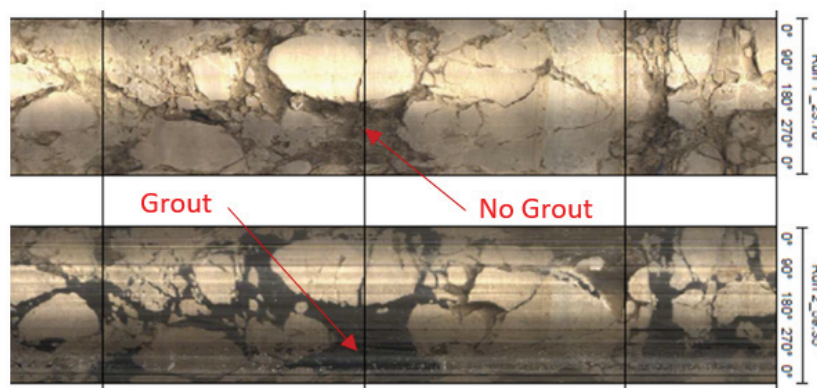
Exploration as well as drilling and grouting during the three-year emergency drilling and grouting program confirmed the designer’s interpretation and provided a much better appreciation for the foundation material properties, historic grouting efforts, and nature of void spaces. One key tool for evaluation the foundation conditions was the Optical Televiwer used in both cored and destructively drilled holes. This provided a 360-degree view of the in-situ material that was otherwise unavailable. An example image from the OPTV of a borehole before and after grouting is shown in Figure 7. (Reference Hlepas and Bateman 2018).

Figure 7 : OPTV Images of a 2 m length zone before grouting (top) and after grouting (bottom).
