ICOLD Symposium on Sustainable Development of Dams and River Basins, 24th - 27th February, 2021, New Delhi

THE TODDBROOK RESERVOIR SPILLWAY INCIDENT AND EMERGENCY RESPONSE

A L WARREN

Mott MacDonald, United Kingdom

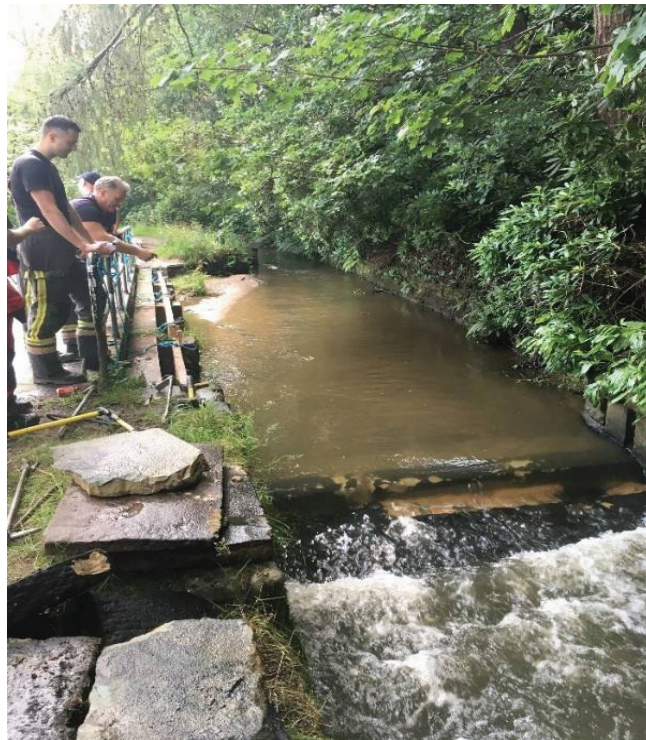
Figure 3 : Bywash side weir

Under normal operation, there are removable weir boards installed at a side weir halfway along the bywash channel. These divert flows back over a side weir into the reservoir. These boards were removed to allow full flow down the bywash channel and boards were installed across the overflow weir to prevent the channel overflowing back into the reservoir (Figure 3).

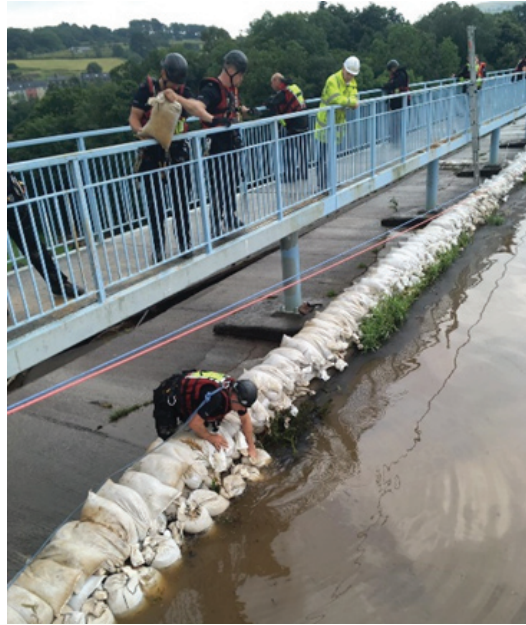
Sand bags were brought to site by Derbyshire County Council (DCC) and were used at various locations around the reservoir to begin to turn flows out of the reservoir and protect the damaged section of spillway (Figure 4). The emergency services also began to arrive on site to support the incident response.

Figure 4 : Photo of sandbagging the auxiliary weir crest

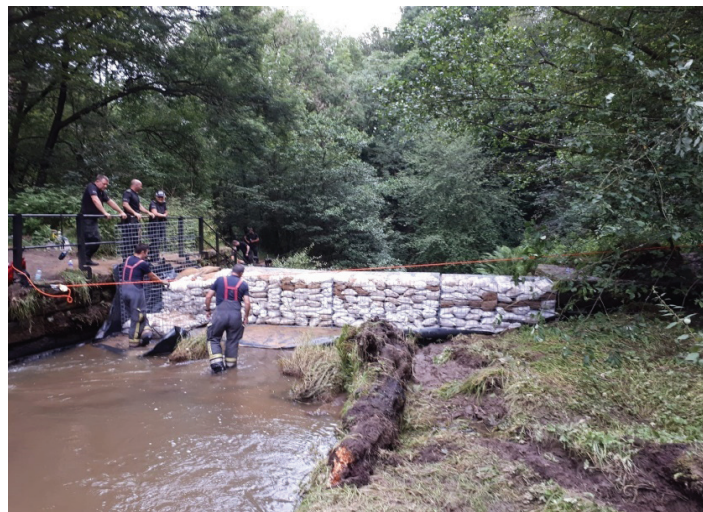
Figure 5 : Inlet weir modifications

At the head of the reservoir, a penstock controls flow into the bywash channel and the majority of flow from the upstream Todd Brook watercourse passes into the reservoir over the inlet weir and down a masonry cascade. Following the damage to the spillway, it was crucial to turn as much flow as possible out of the reservoir down the bywash channel. To this end, the inlet weir crest was raised by the construction of gabion baskets filled with sandbags, which were subsequently wrapped in plastic sheeting (Figure 5). Construction of this weir modification presented a significant challenge as access to the inlet weir is via a footpath, over a kilometre in length, which required all the materials for construction of the weir works to be transported by wheelbarrow.

It was also necessary to reinforce low spots on the embankment dividing the bywash from the reservoir to ensure that the increased flows did not overtop and erode the dividing embankment. Sandbags were used to reinforce the dividing embankment.

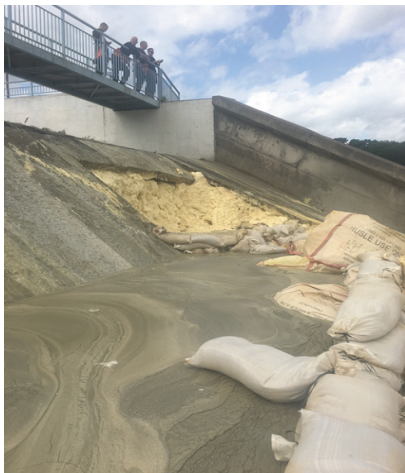
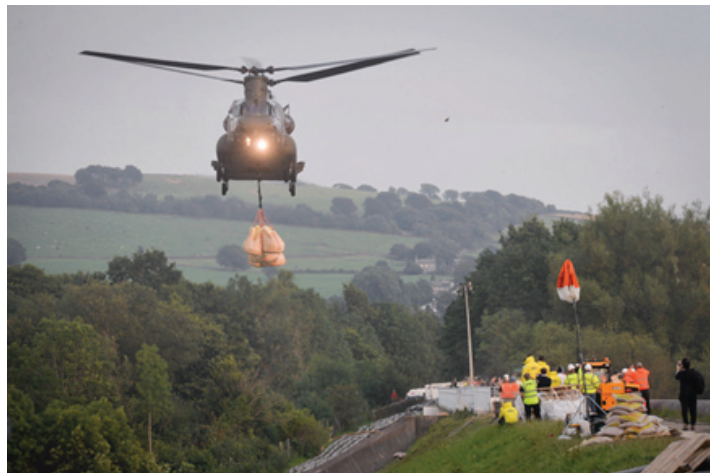
Figure 6 : Scour hole infilling

The storm event caused substantial overflow down the auxiliary spillway as well as the primary spillway. As this was an unusual occurrence, the spill over the auxiliary spillway was filmed by a number of local people. On the morning of 1st August 2019, several of the reinforced concrete slabs protecting the downstream face of the dam collapsed. The exact mechanism of deterioration is unknown and became the subject of an ongoing government investigation following the incident. In the following few hours, the scope of the collapse increased with adjoining slabs falling into the void. Through the slab collapse, water flowing over the auxiliary weir was able to directly flow onto and erode the void, enlarging it further. The void extended under the slabs forming the downstream side of the spillway weir, eroding the fill on the downstream side of the puddle clay core.

The stability of the upper part of the dam could not be determined due to the nature of the damage. Although the reservoir dewatering plan was in place to reduce the pressure on the damaged section of the embankment, it was recognised that any further storm event could cause the reservoir to again spill over the auxiliary spillway and cause further damage to the scour hole, potentially leading to failure of the dam.

Access to the scour hole area to transport, place and compact fill material was poor. There was no suitable location at the toe of the embankment to erect a crane. It was therefore decided to commence filling the scour hole with bags of aggregate transported by helicopter. The Royal Air Force provided a Chinook helicopter for the purpose which was capable to transporting six 1t bags at a time. By stockpiling the material close to the reservoir, the helicopter could complete its run at 10-minute intervals. A second helicopter was discussed but dismissed as two helicopters flying over the dam would be difficult to manage and would be unlikely to bring efficiencies. The helicopter was able to place the bags with high precision.

To maximise the support to the upper part of the scour hole, grout was specified to infill the interstices of the aggregate bags. A sufficient quantity of bentonite grout could not be delivered to the site in a short time. Therefore, a cementitious grout was adopted.

The uppermost part of the scour hole could not be filled with grout as the aggregate bags could not be installed high enough to form an effective back shutter for the grout. Therefore, a structural grade polyurethane expandable foam was used to seal this part of the void by injecting the foam through holes drilled through the concrete slabs at the rear of the spillway crest. The foam was also used locally to help retain the grout at locations where otherwise the grout would escape the scour hole area e.g. under the base of the damaged left side wall of the auxiliary spillway. The works to the scour hole are shown in Figure 6.
