LOCAL DEFECTS IN ASPHALT CONCRETE LININGS ON THE EMBANKMENTS OF PUMP STORAGE SCHEMES

V. CHMELARĚ AND M. RUDOLFOVÁ
CEZ group, a.s., Prague, Czech Republic

J. ŘÍHA AND M. ŠPANO
Brno University of Technology, Brno, Czech Republic

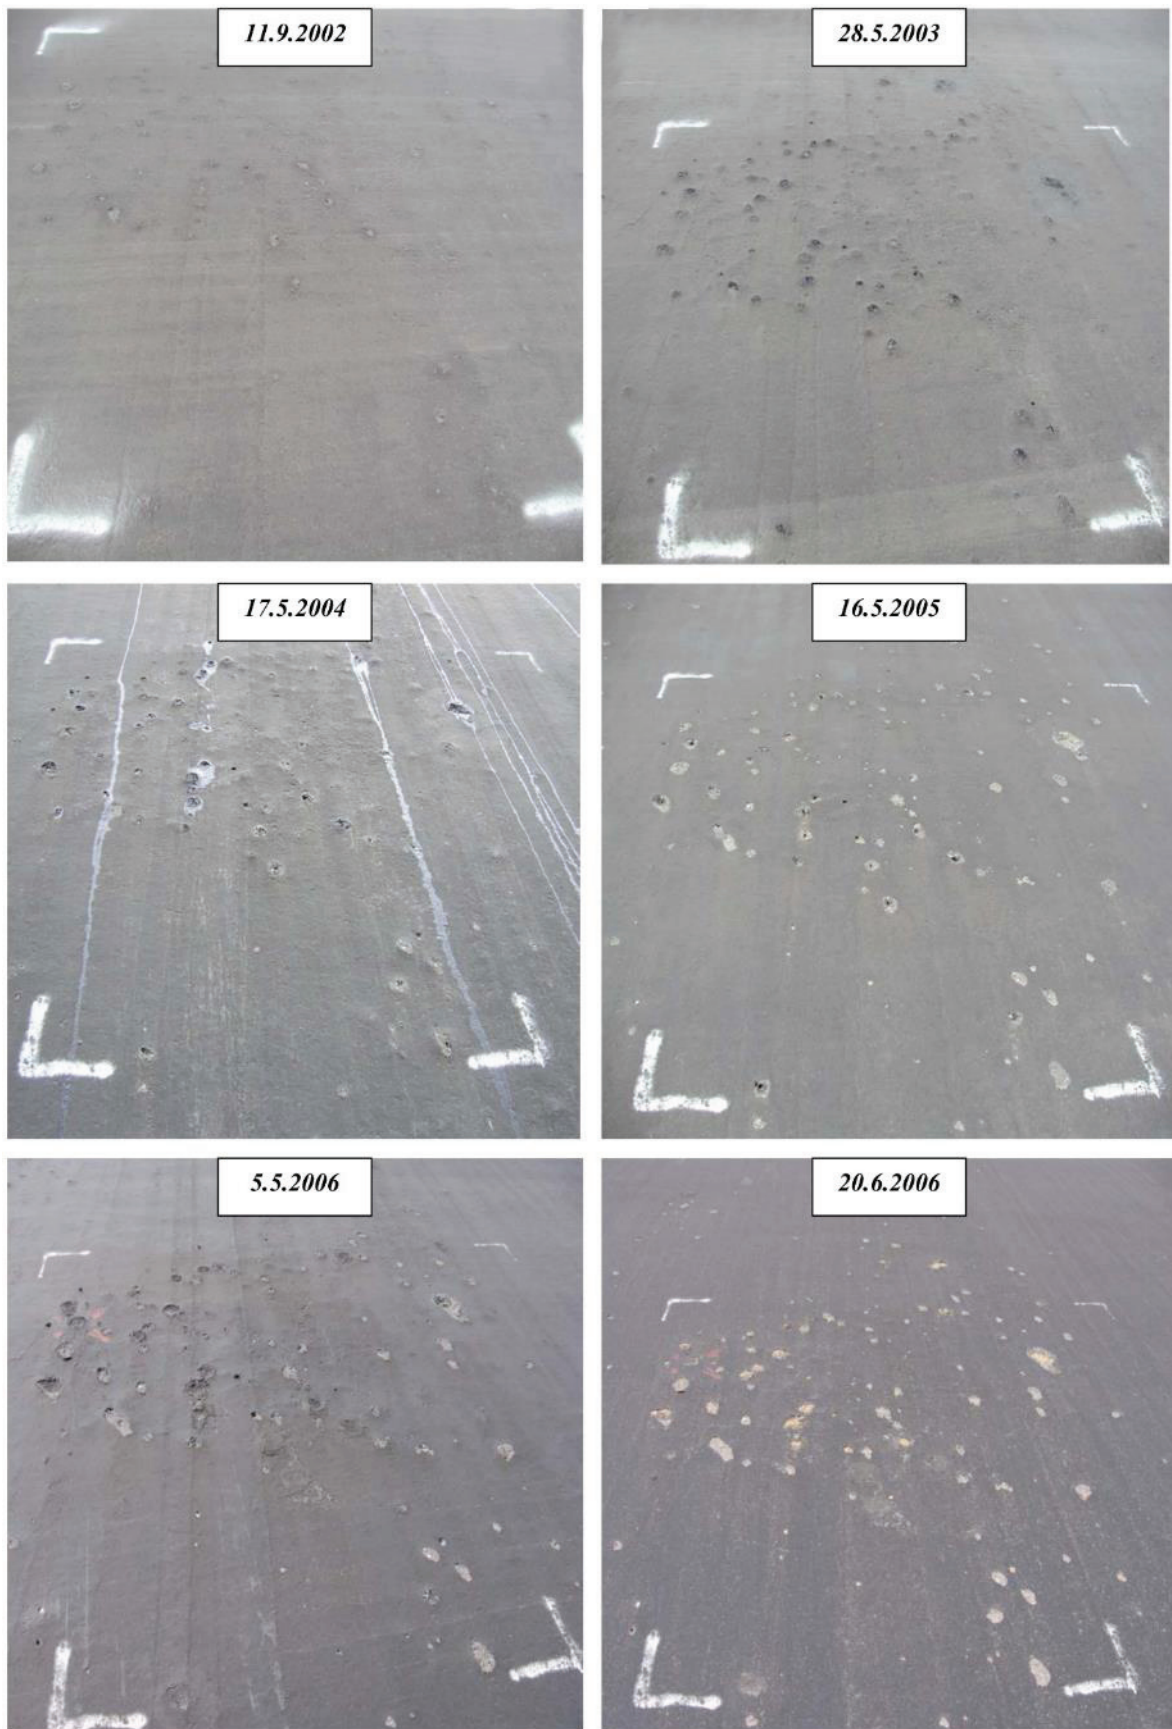
Figure 4 : Development of blisters.

The defects in the ACL manifested in the form of thousands of local blisters in 2002, which was just 8 years after the scheme commenced operation in 1995. The blisters occurred exclusively in the middle zone of the slopes, which is a region subject to reservoir water level fluctuation. Their development over time is shown in Figure 4.

The blisters were of different sizes and shapes, and were spread practically all around the peripheral dam, though their intensity varied locally. Openings which were originally closed inside the dense layer developed into open crater-shaped blisters. They looked like burst pustules with a diameter of around 150 mm and a height of between 30 and 50 mm. Inside the blisters there was an opening with a depth of 30 to 80 mm. It was filled with water and crumbled components of the asphalt concrete (aggregates, asphalt, asphalt with mastic remnants).

In 2006 it was decided that all of the asphaltic lining on the slopes, i.e. covering a surface area of about 90 000 m², would be repaired. In 2007 the damaged dense layer was scraped off together with the remaining mastic coating and replaced by a new one.

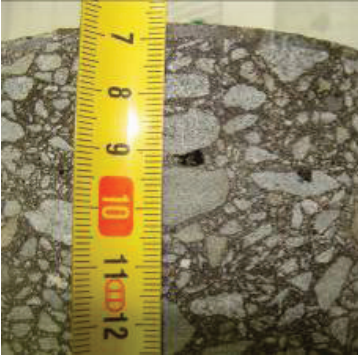
| Stage | Exhibition of the defect stage |
|---|--|
| Minor voids (1-2 mm) inside the dense layer | |

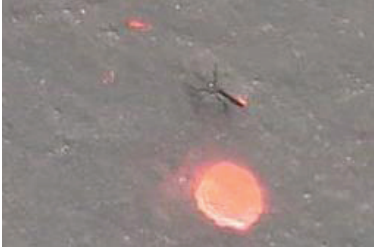
| Stage | Exhibition of the defect stage |
|---|--|
| Distorted surface of the lining | |

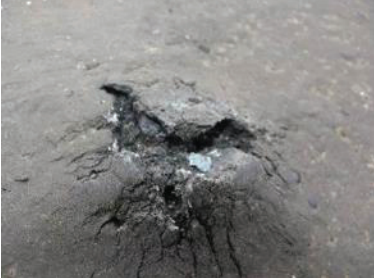
| Stage | Exhibition of the defect stage |
|---|--|
| Opened blister on the surface | |

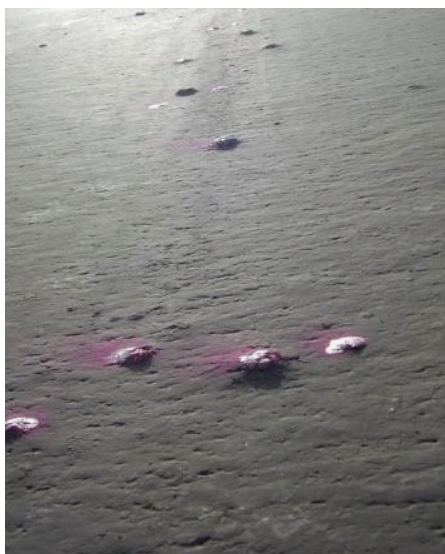
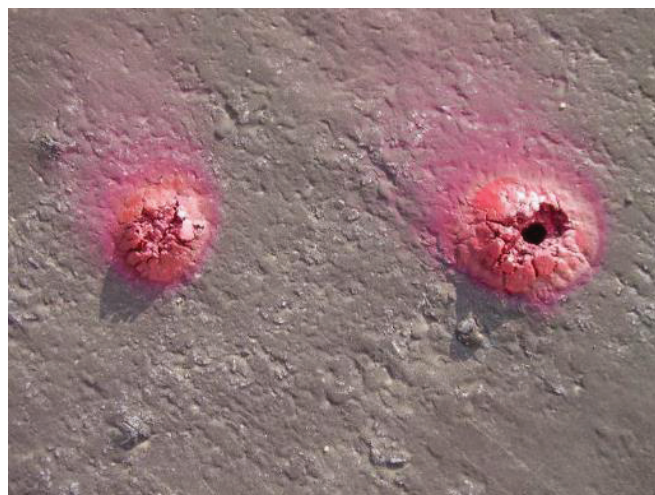
Figure 6 : Blisters developed 4 years after the repairs were carried out

Four years after the repairs were conducted, the first blisters appeared again (Fig. 6). In 2011 there were about 600 of them; these were locally repaired by a contractor.

The blisters in the asphalt concrete lining were spatially distributed in clusters that developed down the slope (Fig. 6). These clusters had a span of about 5 m, which corresponds to the width of the finisher used for the construction. The depth of the blisters varies from a few centimeters to nearly 80 mm (the whole thickness of the dense layer).

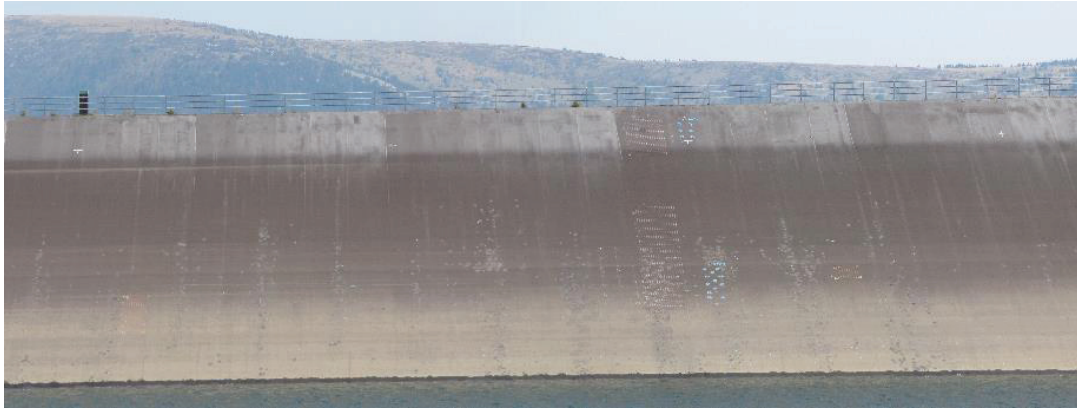
Figure 7 : Arrangement of blisters in clusters extending down the slope.

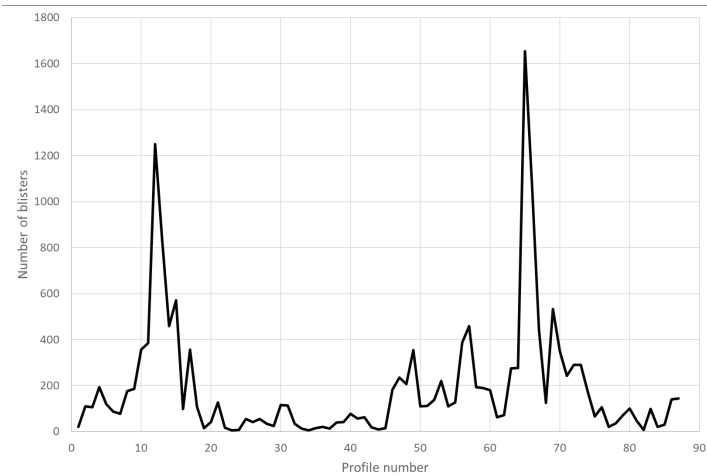
Regarding the arrangement of the blisters along the dam perimeter, it was found that some places are more prone to the blistering than others. The dam perimeter is divided into 87 cross-sections marked PF 1 to PF 87 (Fig. 1). The distance between two adjacent cross-sections is 20 m. The cross-sections and the most affected areas are marked in Fig. 7. Here, the eastern and western slopes are most affected by blistering. A minimal number of blisters were found in the arcs (northern and southern slopes).

Figure 8 : Arrangement of blisters in profiles along the dam perimeter

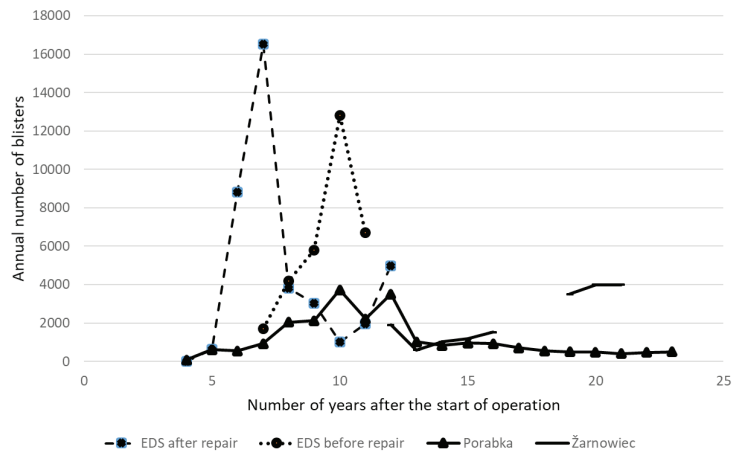
Similar defects have also been reported at the Porabka and Żarnowiec reservoirs in Poland, the Längental Dam in Austria and the upper reservoir of the Markersbach pump storage plant in Germany. The documentation of blister development shows that the extent of blistering is different at individual schemes. It was reported at the Längental and Markersbach schemes that hundreds of blisters occurred in the linings and were locally repaired. At the Polish dams thousands of blisters were counted, while at the Dlouhé Stráně (EDS) upper reservoir, the annual number of blisters reached about 12 to 16 thousand only a few years after the completion of the scheme, and the same occurred shortly after it was repaired (Fig. 9).

From the comparison of the blistering documented at EDS and the Polish schemes (Fig. 9), it can be seen that at EDS blistering started relatively early after the scheme commenced operation. The extent of the blistering grew during the first decade of operation, though after some years it decreased and stagnated. In case of EDS the initial development of blisters was extreme when compared with the mentioned Polish dams.

Figure 9 : Comparison of the blistering at different schemes.
