# UNDER WATER DIAGNOSIS IN REPAIR AND REHABILITATION OF DAMS – CASE STUDY : THE SHOLAYAR DAM, TAMIL NADU, INDIA

*Underwater investigations were carried out at Sholayar dam, Valparai, Tamil Nadu in 2018. It is a Composite dam. Maximum height of masonry and earthen dam are 345ft and 123ft respectively. Storage capacity at MWL is 5677.09Mcft and Dead storage capacity is 338.89Mcft. Dead storage height is 90ft. By sonic tomography, zones of low velocities were assessed which predicted low density materials and thus concluded seepage in those low density pockets. Visual inspection of submerged portion of U/s face of dam was performed using ROV Nondestructive tests were carried out and measures to reduce the seepage and to increase the stability were suggested.*

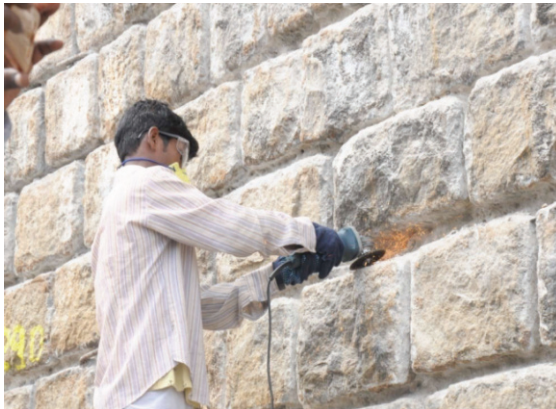
Figure 5 : Surface Preparation

Providing and filling the deeper cavities of the R R masonry which are beyond 5 cm and up to 30 cm using non-shrink, cementitious micro concrete mixed with water at a ratio of 0.16 to fill the gaps where, normal access is restricted and to achieve proper compatibility and placement without vibration. The micro concrete shall contain no chloride admixture and provides minimum compressive strength of 40 N/mm<sup>2</sup> in 7 days & 50 N/mm<sup>2</sup> in 28 days when tested in 70.7mm cube. The product had controlled expansion characteristics of 1 to 4% on 12 June 2019 for 20 cubes. (The product shall have controlled expansion characteristics of 1 to 4% when tested as per ASTM C 827– 1987).

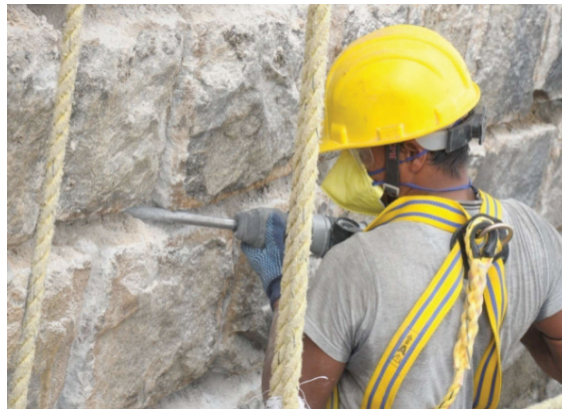
Figure 6 : Surface Preparation

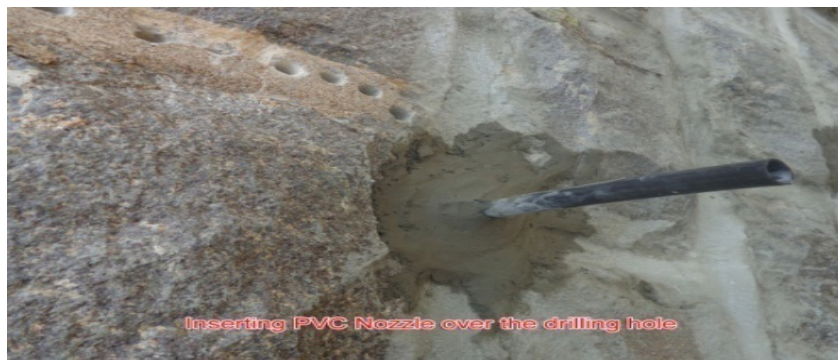
Figure 7 : Injection grouting

Treating the internal cavities up to 1 metre deep in the R R masonry using injection pressure grouting by drilling hole of 25mm dia and 300mm deep in triangular pattern at inclined position. Fix PVC nozzles of 12mm dia & 200mm deep using quick setting cement. Mix OPC 43 grade cement with water in ratio 0.35 - 0.4 as per the consistency required and by adding polymer rubber based latex @ 1 litre per bag of cement and plasticized expanding – non shrink grout admixture @ 225 gms per bag of cement and grouting the same by using 40 psi grouting pump. The grouting material shall give min compressive strength of 35 N/mm<sup>2</sup> in 28 days when tested in 10cm cube. On completion of grouting, the top portion of the PVC pipe shall be cut and seal with cement putty.

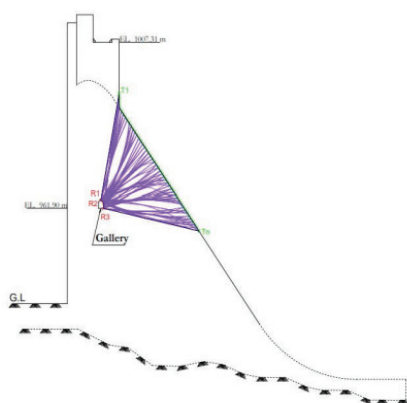
Figure 8 : Sonic Tomography

- (1) On an average, the velocity range in the investigated portions of the dam cross sections is between 3000 m/s and 5500 m/s. The values encountered from the tomographic investigations are representative ranges expected in random rubble stonemasonry with cement mortar, which is the structural material used in the construction of the dam.

- (2) The average P-wave velocity values are lower in the spillway segment than the non-spillway segment, indicating a relatively poorer quality of material in the spillway segment, which is on the expected line.

- (3) Zones of low velocity also have been identified in non-spillway sections TS-6, TS-7 and LS-1, and these are corroborated by the significant volume of seepage in these blocks, 17/29 Blocks 28 and 29, which are possibly most significant. Specific locations of these low velocity zones can be seen in the tomograms.

- (4) Pockets of low velocity are seen in sections TS-1 and TS-8, but these may not be significant to cause seepage. This is corroborated by the low seepage observed from the drain holes in these blocks, Blocks 21 and 31.

- (5) Significant zones of low velocity are seen in the spillway sections, TS-2, TS-3, TS-4 and TS-5 consist of large regions with low velocity ranges, possibly contributing to seepage. Except for TS-4, which shows a moderate level of seepage through the drainholes, the seepage observations at the other three locations corroborate these findings. In likelihood these identified areas are susceptible to seepage.

- (6) From the tomographic sections investigated and the diffused presence of zones of low velocities, it can be stated that there is likelihood of seepage within the blocks due to the presence of low density pockets. This seepage is in addition to that happening through the construction joints between the blocks as observed from the high volume of seepage from drain holes close to the construction joints.
