ICOLD Symposium on Sustainable Development of Dams and River Basins, 24th - 27th February, 2021, New Delhi

INDIAN EXPERIENCE IN FLEXIBLE GEOMEMBRANE FOR WATERTIGHTNESS OF AGEING DAMS

Carpi India, Chennai, India

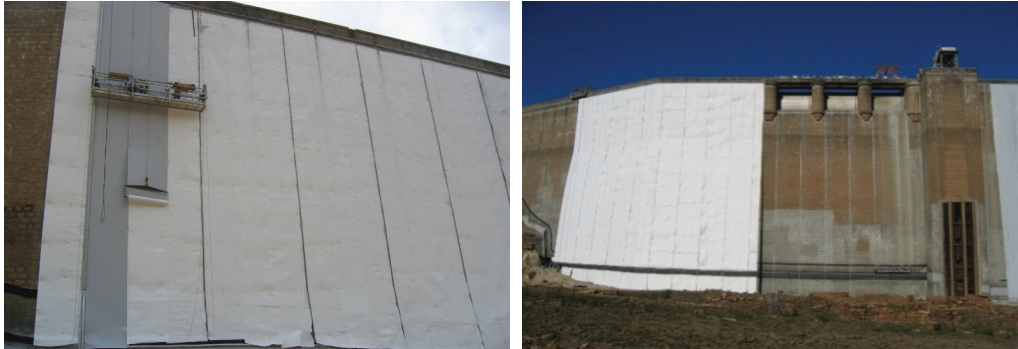
Figure 1 : Installation of anti-puncture geotextile and of waterproofing geocomposite.

The major elements included the anti-puncture geotextile layer of 2000 g/m², installed on the entire upstream face of the dam to reduce risk of puncture by the very aggressive surface of the stone masonry blocks. The nonwoven needle-punched geotextile made of pure polyester fibre was anchored to the face (Figure 1 at left).

The geocomposite sheets were lowered from the dam crest and positioned on the upstream face by crews working from suspended platforms (Figure 1 at right). On the masonry face large offsets were observed and at the bottom perimeter seal area a layer of shotcrete was done to allow even adhesion of the stainless-steel element to the dam body.

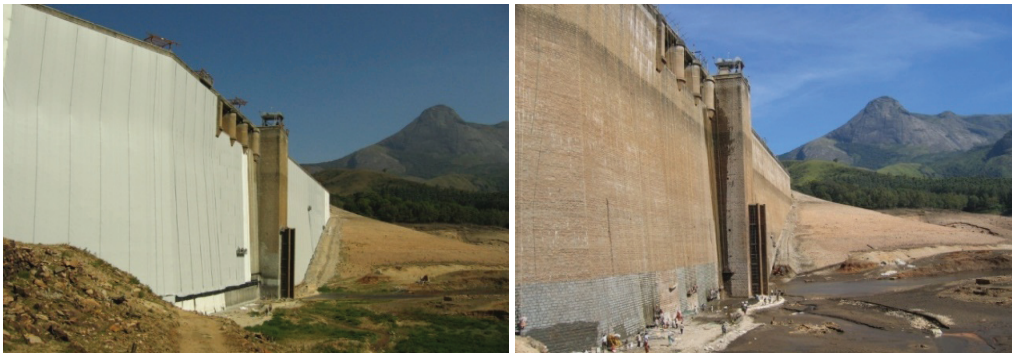
Figure 2 : Upstreamface of the dam before and after geomembrane installation.

The result of the geocomposite installation at Kadampara dam in 2018/2019 is still sound with the leakage still around the same levels. The first geomembrane project has more than satisfied the client in terms of the results, and since its installation the dam is now filled up to the FRL (Full Reservoir Level) thereby allowing full generation power of 400 MW, which was not possible before geomembrane works as the dam was operated at nearly 10 metre below FRL.

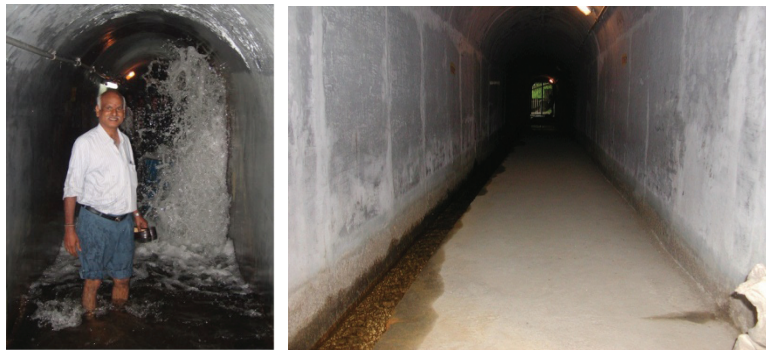
Figure 3 : Drainage gallery before and after geomembrane installation.

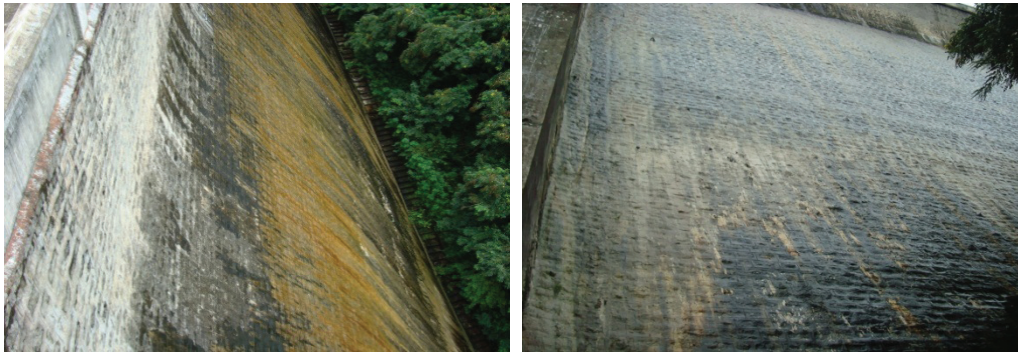
The major problem in Servalar dam is the high seepage collected inside the gallery through the vertical shafts and the extremely wet downstream side. The left flank of the dam experienced heavy seepage (Figure 5) when compared to that to the right flank, while a complete wet and oozing downstream side is visibly seen and goes unmeasured. The problem is attributed majorly to the poor quality of construction. The leakage which has been continuing for many years now has resulted in many of the drainage shafts getting choked, and heavy calcination was observed both inside the gallery as well on the downstream side of the dam.

seepage did not give a permanent solution and instead the leakage continued to rise every year. With the available data and observation, the water oozing out from the downstream side should be more than 5,000 l/minute (approximately) from the left and spillway blocks.

Figure 5 : Heavy seepage on left flank.

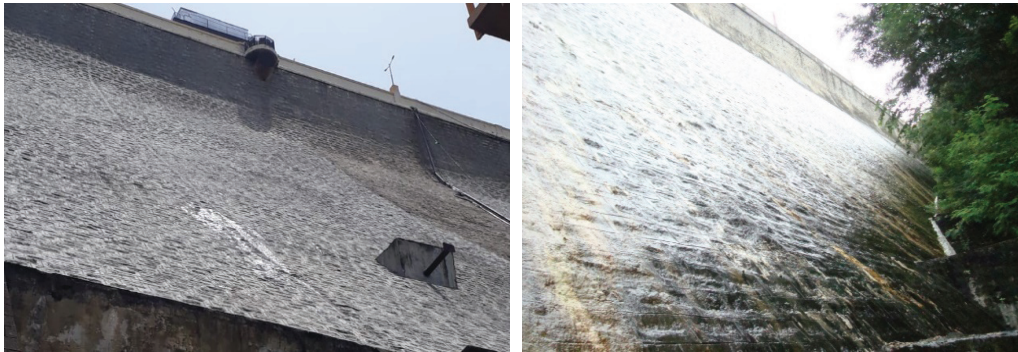
The entire work was completed on 14th of October 2018 and an inspection of the gallery was done on 15th of October jointly with the client and Carpi. Leakage from shaft reduced from 1,200 litres/minute to 1.31 litres/minute. The downstream face is now completely dry with water level almost close to FRL. The recorded leakage through the vertical shafts is 1.31 litres/minute on 09.11.2018 at water level 257.14 m.

Figure 6 : Downstream side before and after geomembrane installation.

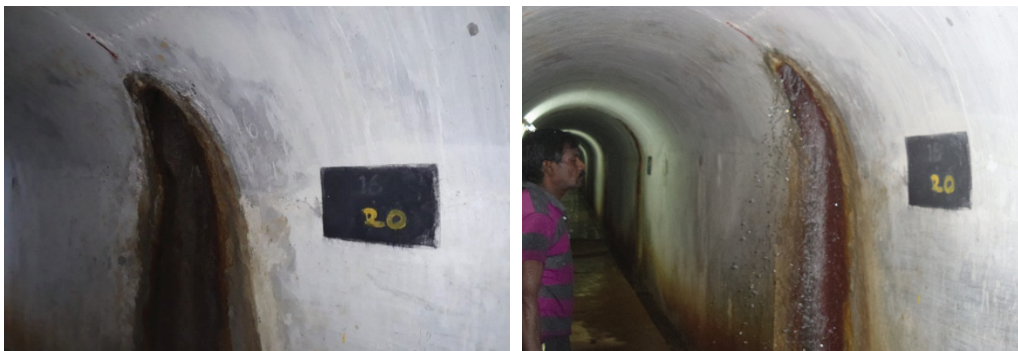
Figure 7 : Vertical shaft leakage before and after geomembrane installation.

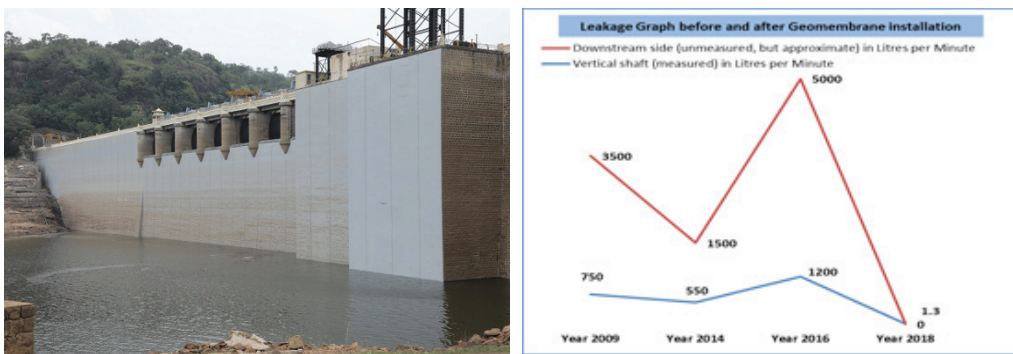
The results achieved is yet another proof of effective and professional design of geomembrane waterproofing system on large dams. A dam which was leaking at a rate of > 6,000 litres/minute is now reduced to just < 2 litres/minute on the left and spillway section.

Figure 8 : Leakage pattern before and after geomembrane installation. At right, Servarar dam after geomembrane installation.

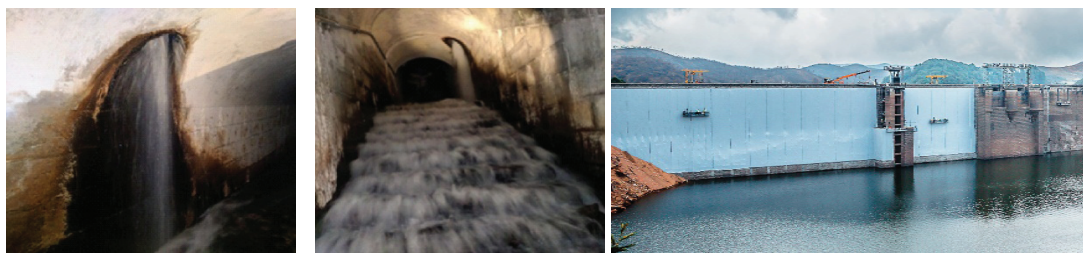
Upper Bhavani dam, a stone masonry dam of 80 m height, located in the Nilgiris District, Tamil Nadu (India) is the third project in India for Carpi and the second project in the DRIP program (Dam Rehabilitation and Improvement Project). The dam, constructed in the year 1965, started leaking badly since the early 2000ies. Leakage started increasing thereafter and especially the region surrounding the spillway started leaking very badly. Around 8,000 l/minute has been recorded as the leakage from the two shafts surrounding the spillway alone. Various repair attempts were made between 2003 and 2010 and the dam has been declared as the most distressed dam in spite of the conventional repair works carried out, which again did not provide good results. Ultimately it was decided to install a geomembrane waterproofing system citing the previous success stories of the Kadamparai and Servarar projects. The project is being executed in two phases out of which 20% of geomembrane installation has been completed in the first phase between April and June 2019. The next phase will commence by February 2020 once the monsoon ends by December 2019. Despite the challenges of extreme cold weather and location of the dam in a deep reserved forest, the balance work has been planned to get completed in second phase between Jan and June 2020. The water from the Upper Bhavani dam acts as the main source for a series of cascaded power houses with a total power generation capacity of >600 MW. Thus, saving water is of utmost importance for the client TANGEDCO.

Figure 9 : Leakage in vertical shaft of drainage gallery at left. At right, geomembrane lined on the upstream face of the dam as of June 2019.
