ICOLD Symposium on Sustainable Development of Dams and River Basins, 24th - 27th February, 2021, New Delhi

DAM BREAK ACCIDENT AND RESULTING SEDIMENT MANAGEMENT AT DOWNSTREAM DAMS IN LAO PDR - HIGHLY TURBID FLOOD-FLOW AND SEDIMENT FLUSHING AT NAN NGIEP 1 HYDROPOWER PROJECT –

T. TABUCHI

Nam Ngiep 1 Power Company Limited, Bolikhamxay, Lao PDR

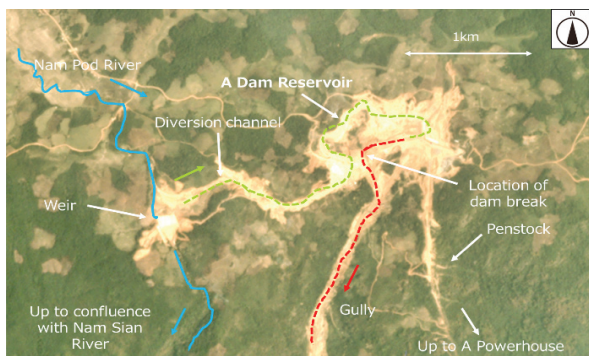
The A Project takes the water from the Nam Pod River to the reservoir through a diversion channel. The powerhouse is located downstream of the confluence of the Nam Pod River and the Nam Sian River. A part of the dam breached with 20 m high, 20 m wide, and 100 m long at 13:45 11th September 2017. Almost all the stored water around 500,000 m³ was released from the reservoir due to dam break (See Fig. 3) and the released water seemed to be flushed away along 3 km downstream gully in 100 m wide with the state of the bore (Muraoka 2012 in Japanese) by swallowing clay, silt, and rubble (See Fig. 2). By the way, the photos of the incident were uploaded on Facebook on 13th September (Himel 2017).

Figure 2 : Image of highly turbid water flush

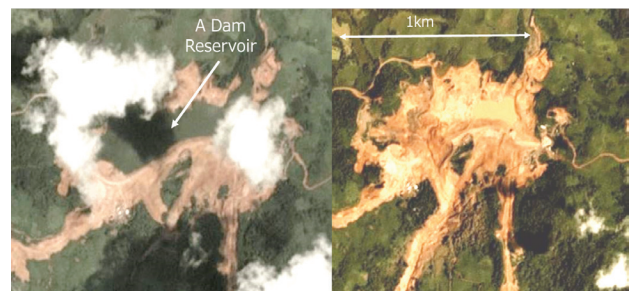
(a) Before dam break

(b) After dam break

Figure 3 : Image around the dam before after dam break

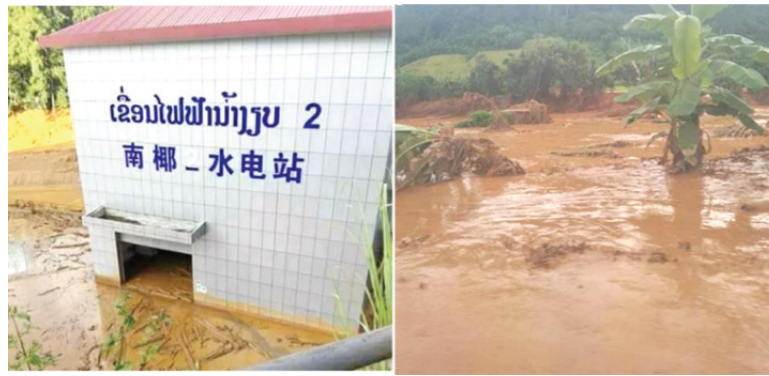
Though so far no injuries and human loss were not reported, damages on infrastructure, agricultural land cattle and so on were seen at eight villages of Thavieng district located downstream of the A dam. The powerhouse of the Nam Ngeip 2 hydropower project (NNP2), which is located 3.5 km downstream from the A dam, was damaged due to the intrusion of the highly turbid water (See Fig. 4 left). The residents along the Nam Nigep River started evacuation by themselves before the caution was announced by the public agency. The status of the damages was uploaded on Facebook and was noticed by people all around Lao PDR. It is still very hard to negotiate compensation with local investor of the A project due to their fewer funds.

Figure 4 : Damage on powerhouse of NNP2 and agricultural land

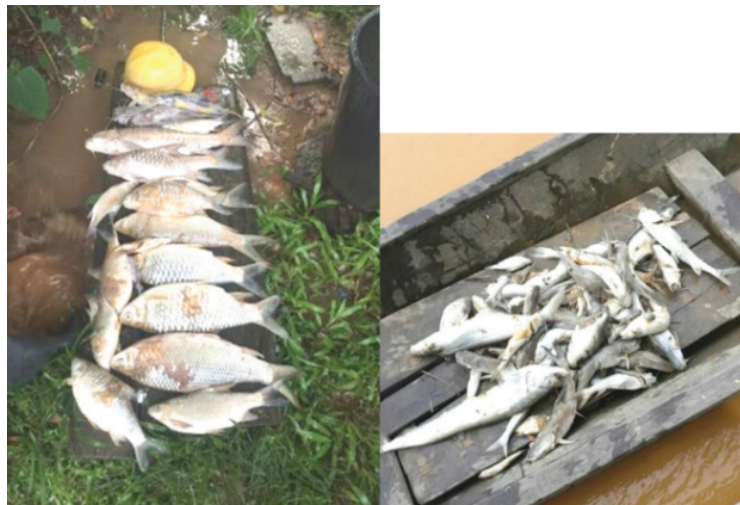
The amount of dead fish caught by the residents from 12th to 13th September 2017 and the photos of dead fish are shown in Table 1 and Figure 8 respectively, while small dead fish was not counted in the table since the residents didn't catch the small fish which does not deserve eating or selling. The amount of dead fish at Hat Gniun village, which is located downstream of the re-regulation dam, was the maximum of 6,410 kg, which was six times as much as the monthly maximum fish yield from 2015 to 2016. The kinds of dead fish and their ratio are shown in Table 2. The majority were carp and catfish and several kinds of the eel were contained. There is a clear difference in kinds of fish between the upstream area and at Ha Gniun village, however, it has not been analyzed whether there existed difference in habitat or resistance of fish between them. Among dead fish there existed Endangered Species and nearly Threatened Species in Red-List of IUCN. On the other hand, a huge difference in the amount of dead fish between the upstream area and Hat Gniun was observed. The amount of dead fish caught in Thavieng was just 5 kg/household and that at Hat Gniun was 100 kg/household. Though information on water quality in the upstream area during the incident was not obtained, it is assumed that the density of the turbid water was low in the upstream area where the rather wide river flows but quite high around the NNP1 main dam site. Then quite a lot of fish died at the narrow valley due to the highly turbid water concentration and were flowed to downstream Hat Gniun. The death of fish was informed to residents at Hat Gniun by those in the upstream area and then many residents at Hat Gniun rush into the river to catch dead fish without evacuation. Almost all large dead fish were picked up at Hat Gniun and only small dead fish were moved downstream.

Figure 8 : Photos of dead fish

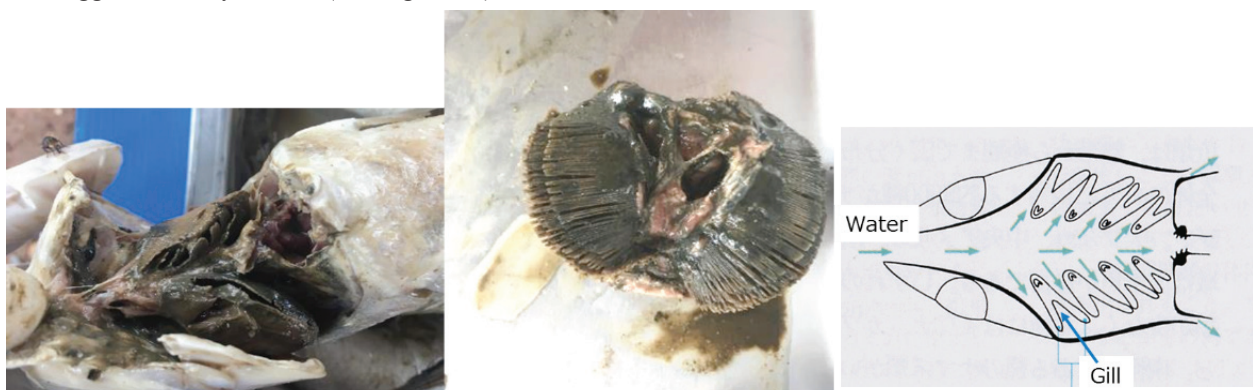
The dissection of dead fish was conducted by the NNP1 in 2018 to confirm the cause of death (NNP1PC 2018). The gill was clogged with clay and silt (See Fig. 9 left).

Figure 9 : Photos and figure of gill of dead fish (Syougakukan 1992 in Japanese)

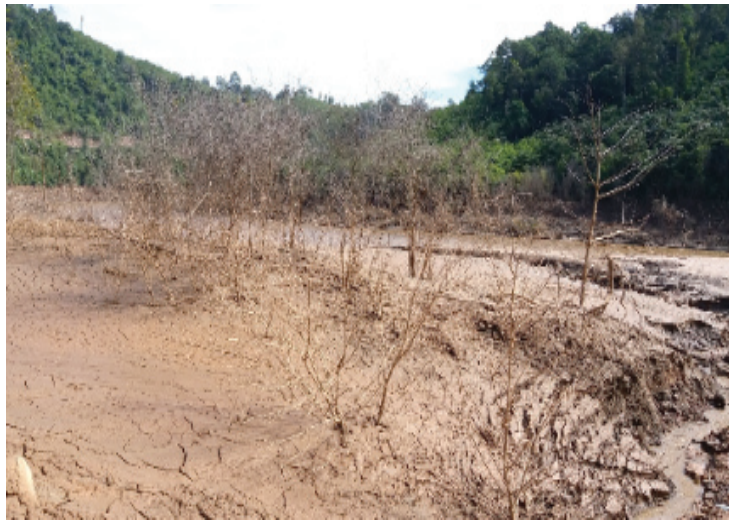
The average inflow in September 2019 was 260 m³/s and the maximum TSS was 100,000 mg/L, then sedimentation volume is estimated to be 100,000 m³/hour. The state might continue for hours and the total volume of sedimentation in the re-regulation dam reservoir is estimated to be at least 700,000 m³ by considering the above fact and survey results of riverbed survey in the re-regulation dam reservoir. The state of the sedimentation in the re-regulation dam reservoir is shown in Figure 10.

Figure 10 : Sedimentation in re-regulation dam reservoir in November 2017

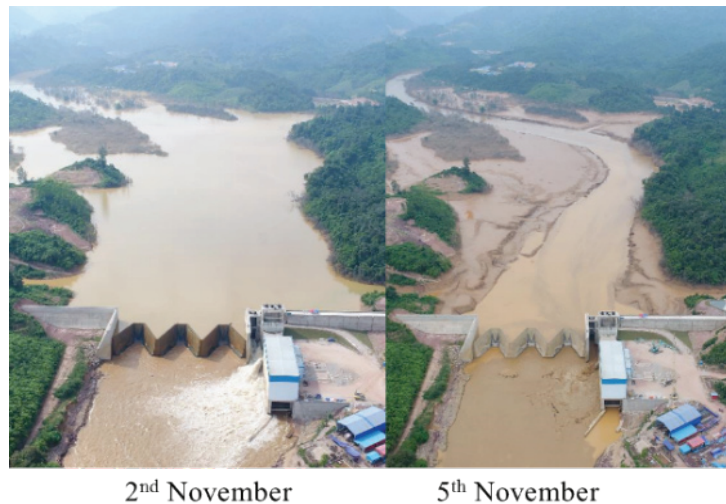
Time series of the reservoir water level of the re-regulation dam reservoir, turbidity (NTU), and TSS are shown in Figure 16, 17, and 18 respectively. The reservoir water level decreased to the minimum water level at midnight on 4th November 2017. The maximum TSS of 7,350 mg/L was observed at 7:00 of 5th November 2017 and the maximum turbidity of 12,370 NTU was observed at 11:00 of 5th November 2017. Though the exact time of the peak of them is not identified due to limitation of the water quality test during the night time, it is assumed that sediment flushing succeeded effectively when the reservoir water level got the minimum water level and the sediment flushing continued until the reservoir water level was raised to the full tank level on 7th November 2017. The turbidity downstream of the re-regulation dam decreased to the normal level on the same day. On the other hand, turbidity at the confluence of the Mekong River and the Nam Ngiep River (NNG08) continued high till 8th November 2019. The amount of dead fish during the sediment flushing along several kilometers downstream from the re-regulation dam was only 2 kg. Therefore the impact of the sediment flushing on the habitat was not significant. The photos of the reservoir before and after sediment flushing are shown in Figure 19. The riverbed appeared upstream right side of the reservoir, of which surface was covered with mainly the silt and the sand.

Figure 19. Photos of reservoir before and after sediment flushing

The NNP1 conducted the sediment flushing at the re-regulation dam, which is located downstream of the upstream project by using the gate for the environmental flow to avoid the subsequent environmental issue during the initial impounding. And the sediment flushing had an effect to mitigate the issue that the anaerobic clay and silt would be released during the initial impounding. On the other hand, the re-regulation dam reservoir might have a role to dilute the highly turbid water flowing downstream.
