Rehabilitation and Replacement of 136 no's of Sluice Gates and Their Hoisting Equipment's of 100 years old KRS Dam, Karnataka

By: Aditya Mishra, Dy. Director, Gates Design (E&NE), CWC Rahul Kumar Singh, Director, Gates Design(NW&S), CWC Vivek Tripathi, Chief Engineer, Design (E&NE), CWC

Condition Assessment of Sluice Gates at EL +106, +106 and +114 Level

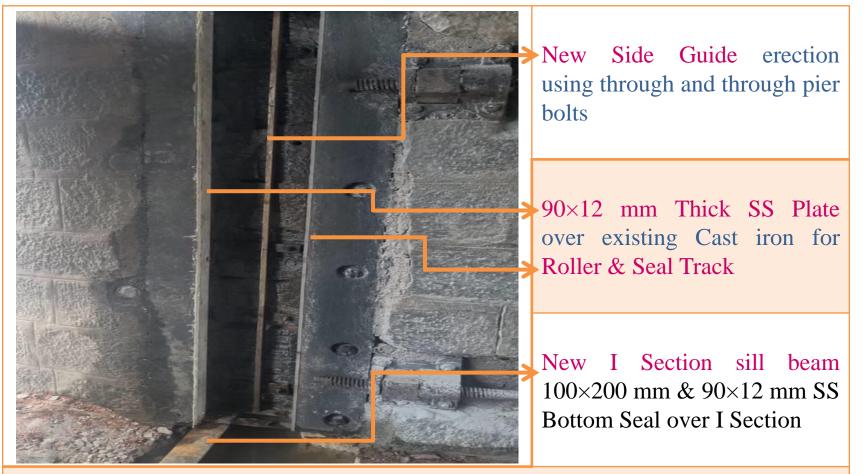
(Approved Drg No. HTMPL/KRS/106'/GATE/04)

Details of +103 & +106 Embedded Parts after rehabilitation (*from KRS Dam site erection*)

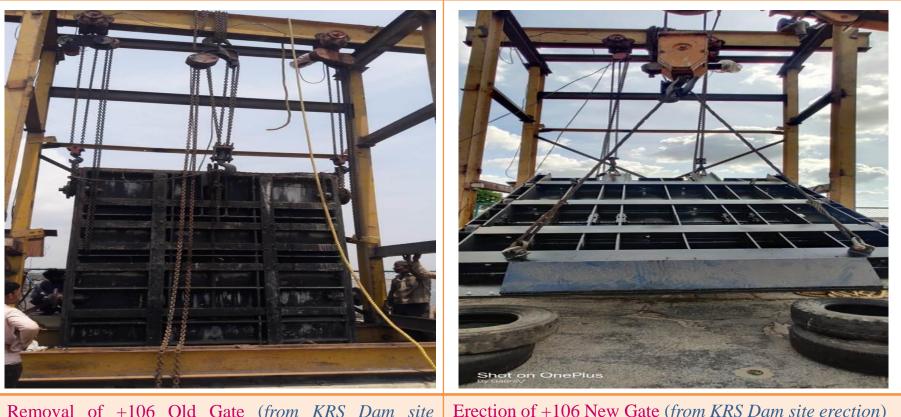
Removal of +106 Old Gate (from KRS Dam site Erection of +106 New Gate (from KRS Dam site erection) erection)

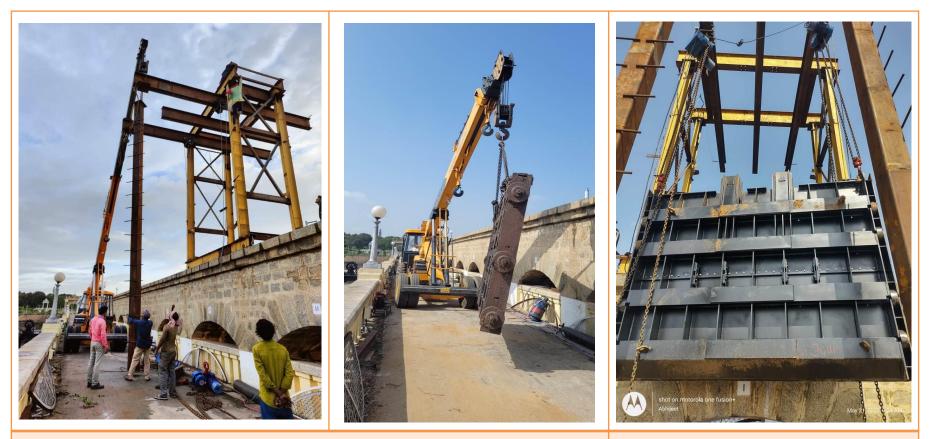
Removal of +103 Level old Gate (from KRS Dam site erection)

Erection of +103 Level New Gate (*from KRS Dam site erection*)

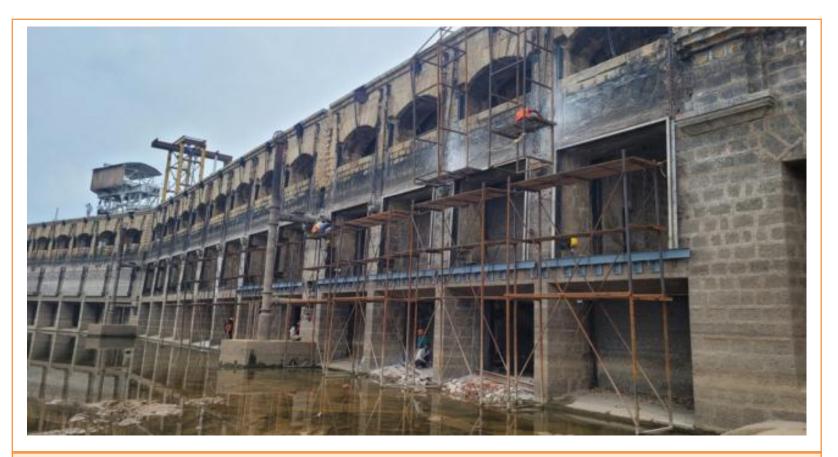
Embedded parts of +114' Level Sluice Gates after Rehabilitation (from KRS Dam site erection)

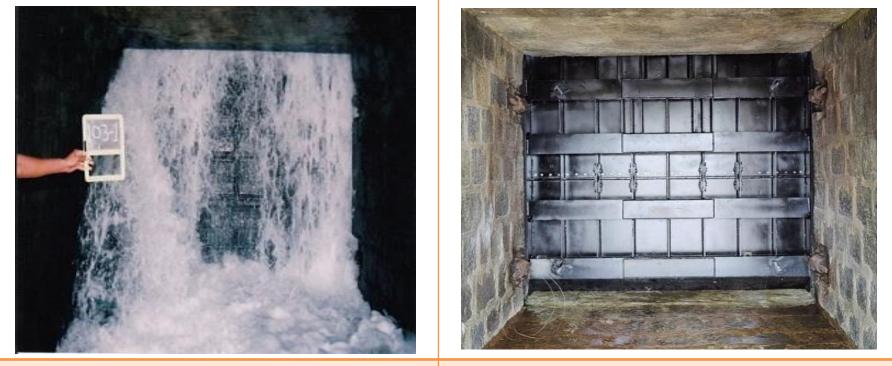
Leakages in +103' Level Sluice Gates before Leakage arrested +103' Level Gates after **Rehabilitation** (from KRS Dam site erection) *rehabilitation* (from KRS Dam site erection)

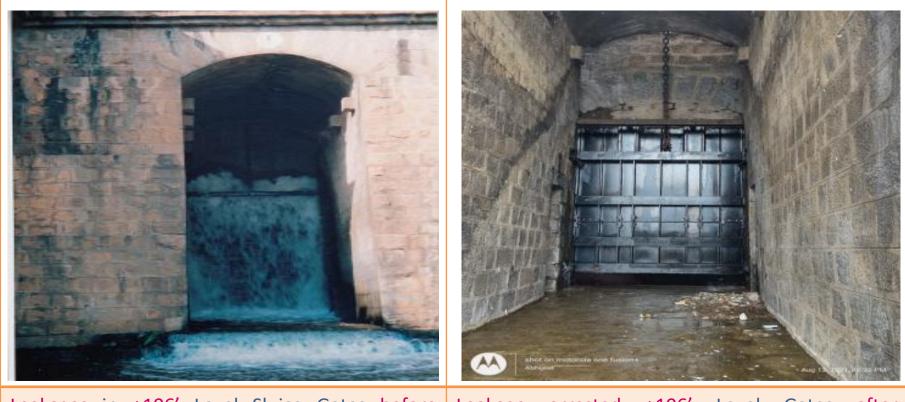
Leakages in +106' Level Sluice Gates before Rehabilitation (from KRS Dam site erection) Leakage arrested +106' Level Gates after rehabilitation (from KRS Dam site erection)

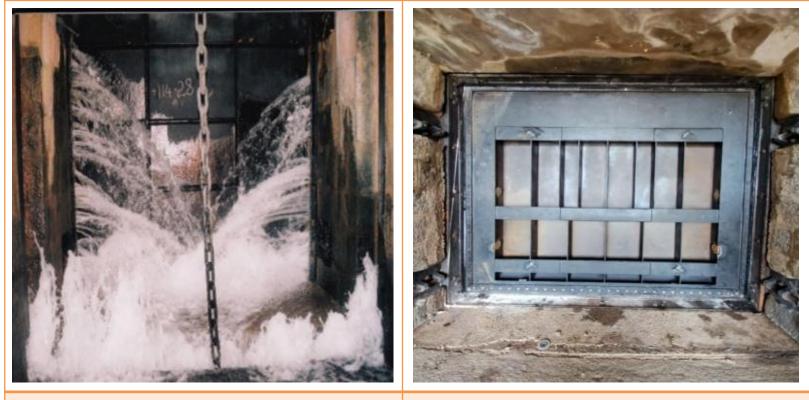
Leakages in +114' Level Sluice Gates before Rehabilitation (from KRS Dam site erection)

Leakage arrested +114' Level Gates after rehabilitation (from KRS Dam site erection)
