INTERNATIONAL DAM SAFETY CONFERENCE

REHABILITATION OF *GARARDA* EARTHEN DAM

Authors: Randhir Kumar Choudhary, *Deputy Director*
Ashwani Kumar Verma, *Deputy Director*

Central Water Commission, New Delhi (India)

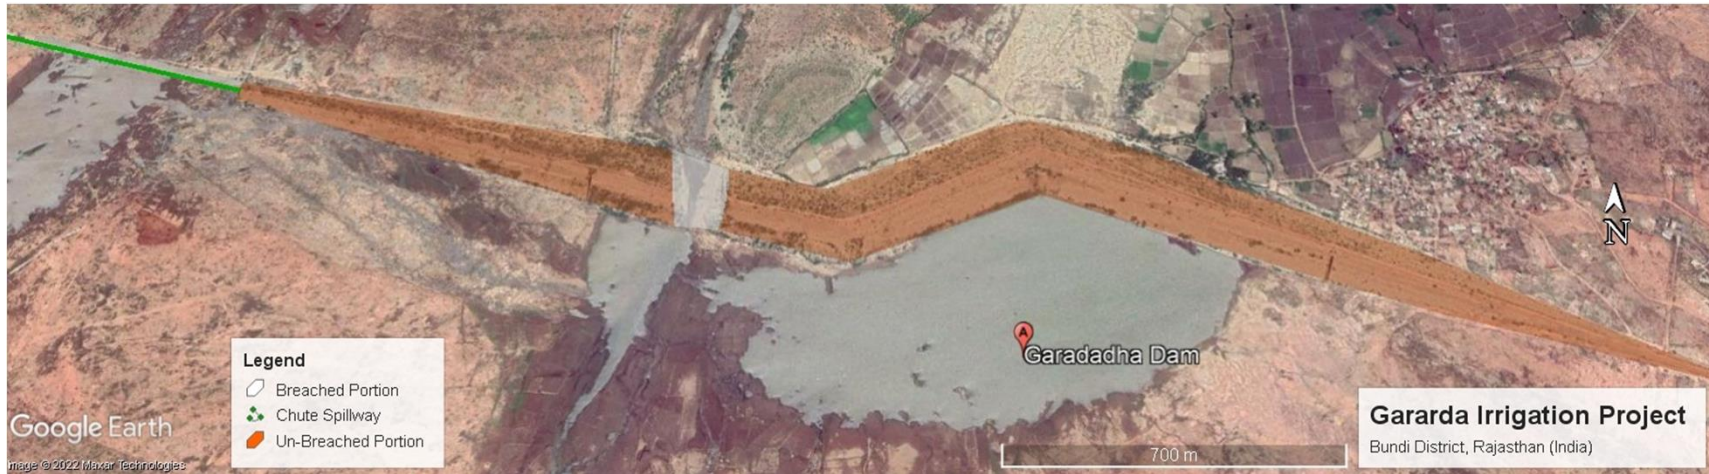
On August 15, 2010 at 4:30 am, the central portion of the dam across the Dungari River washed away from the closure section

- Flooding at least a dozen villages on the D/S and**
- Causing major damages to crops.**
- However, no casualties were reported.**

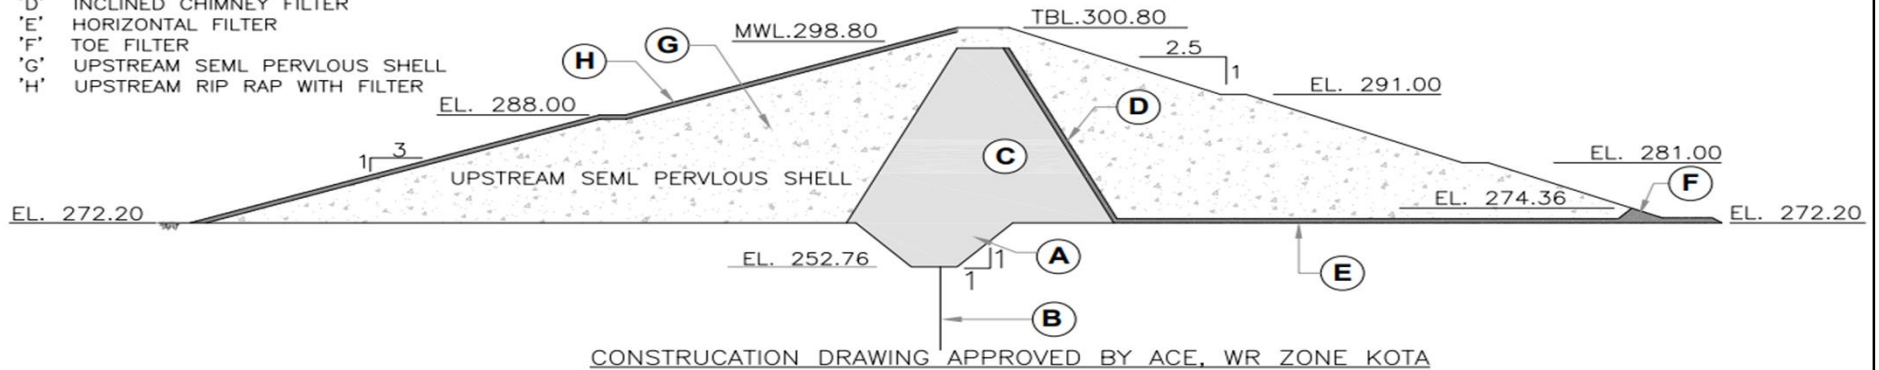
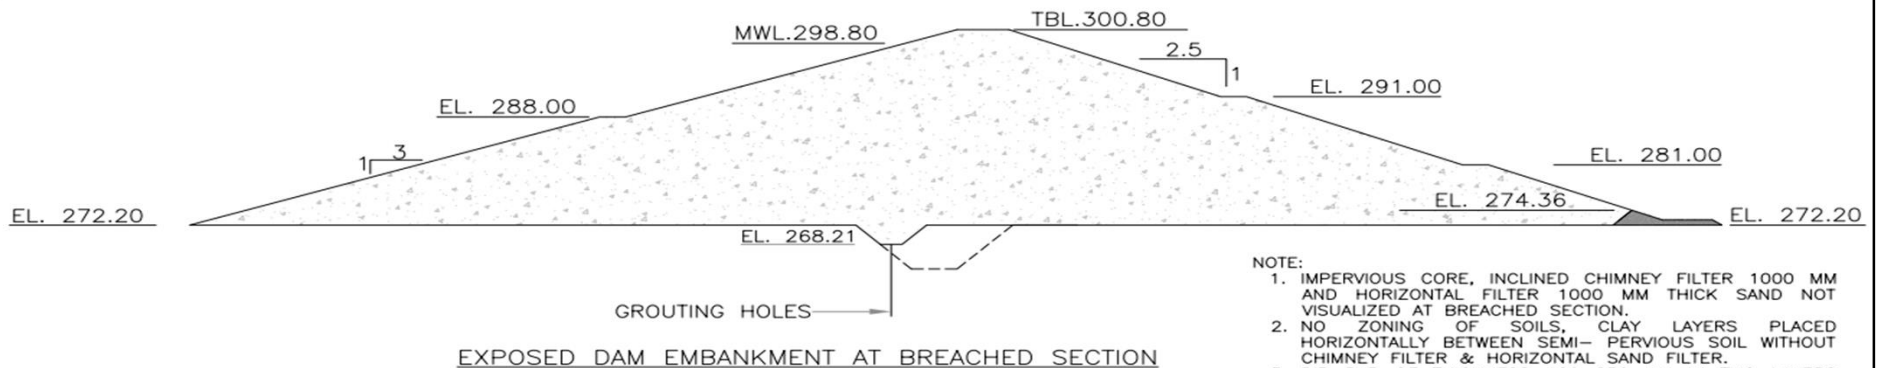
DESIGNED AND EXECUTED CROSS SECTION

1. IMPERVIOUS CORE, INCLINED CHIMNEY FILTER 1000 MM AND HORIZONTAL FILTER 1000 MM THICK SAND NOT VISUALIZED AT BREACHED SECTION.
2. NO ZONING OF SOILS. CLAY LAYERS PLACED HORIZONTALLY BETWEEN SEMI-PERVIOUS SOIL WITHOUT CHIMNEY FILTER & HORIZONTAL SAND FILTER.
3. RIP RAP OF THICKNESS 120-230 MM IN TWO LAYERS IN PLACE OF TWO LAYERS OF 230 MM LAID OVER QUARRY SPALL IN PLACE OF 150 MM THICK COARSE FILTER OVER 150 MM THICK FINE FILTER.
4. TOE FILTER WAS NOT AS PER DRAWING & SPECIFICATION.

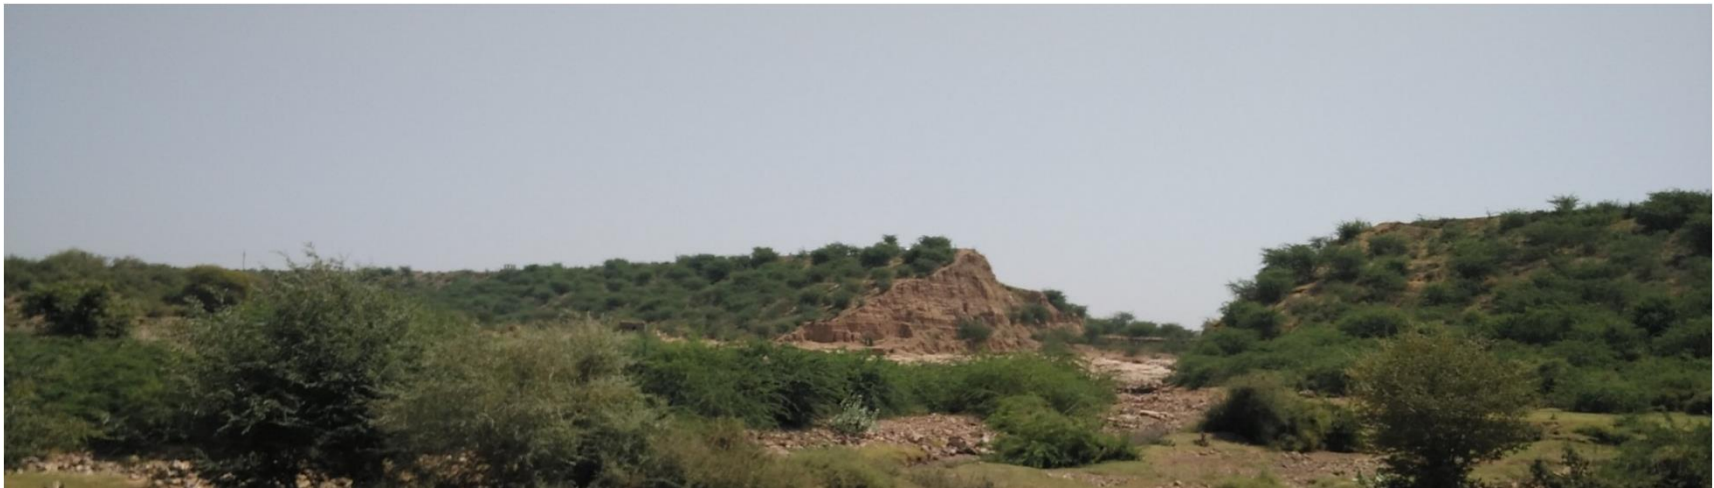
Excessive weeds and shrubs growth with deep roots in the upstream and downstream slope were seen.

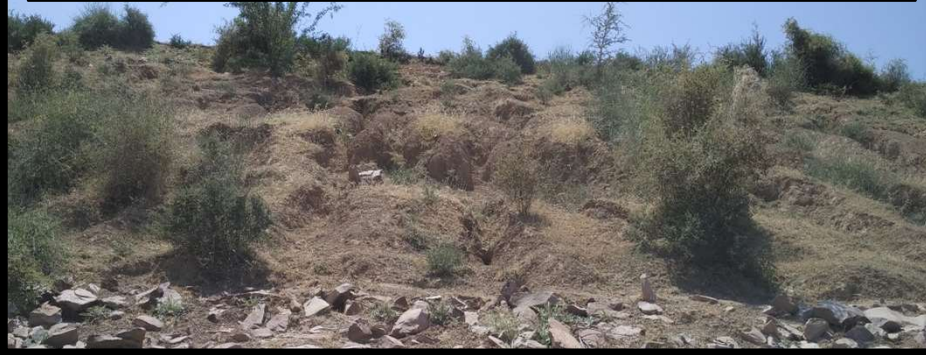
Deep rain cuts and gullies were observed on the D/S slope on entire dam body.

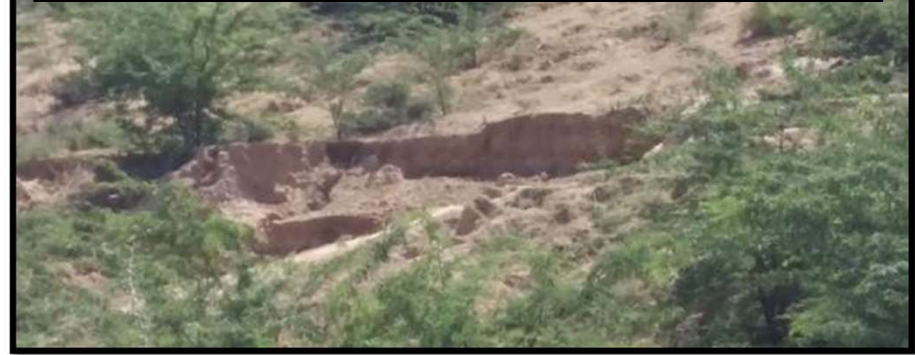
Localized slope failures were also found at some location on D/S slope.

- ✓ Further, during breach even existing dam section was subjected to sudden drawdown condition which has resulted in local slope failure in upstream face and settlements at the discrete location. The FEM analysis also depicts local slope failure near toe and first berm on the upstream slope.

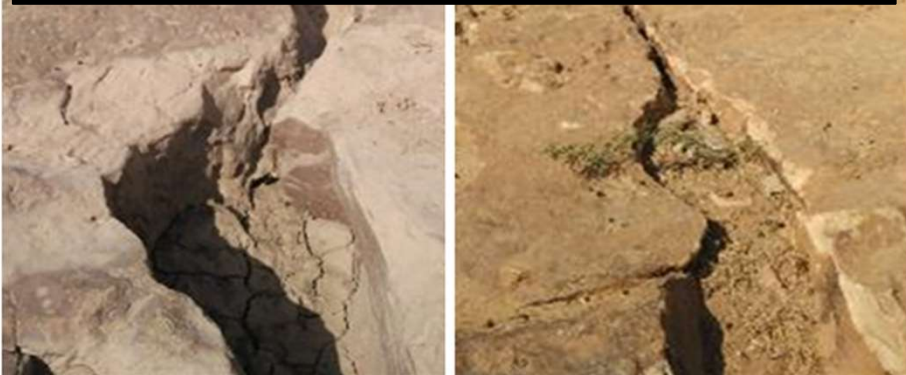
Two wide vertical open joint parallel to flow of river at expose portion

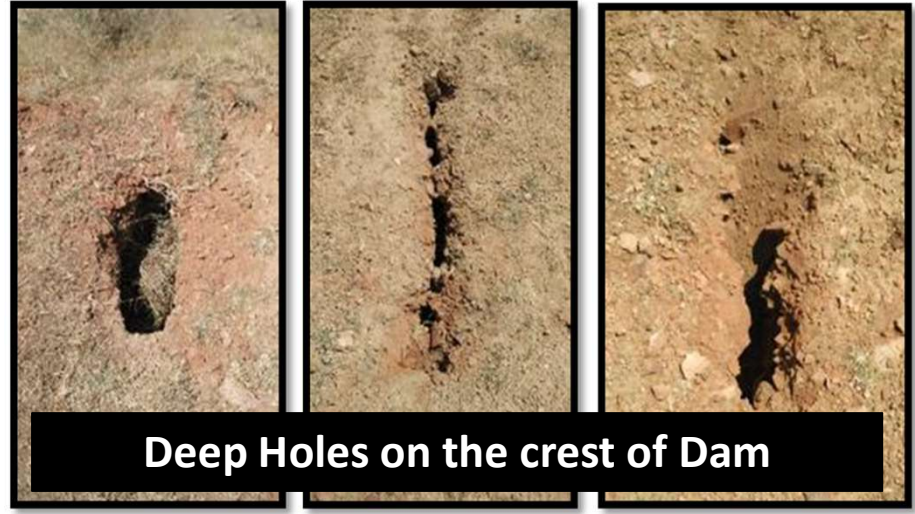
Deep Holes on the crest of Dam

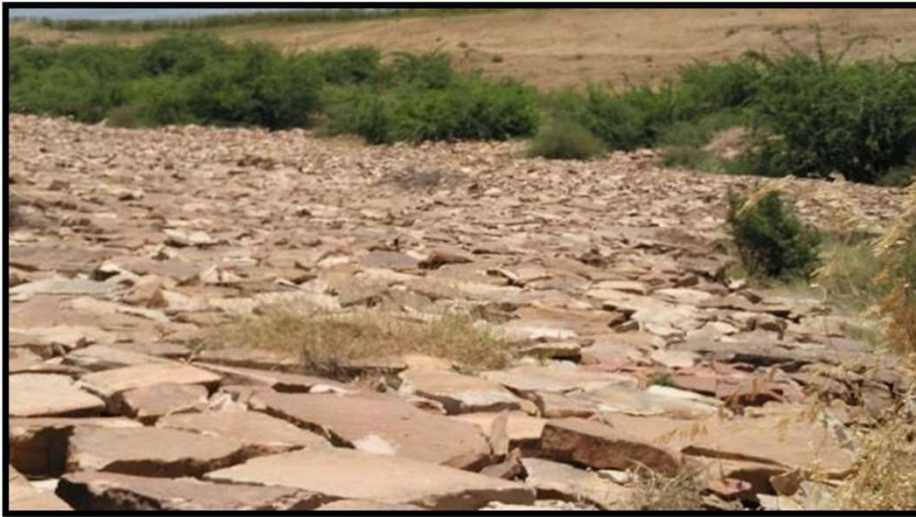
Settlement/Bulging of rip-rap in U/S side of dam was observed in entire length of earth dam

- × The U/S slope was observed with very thin single layer stone pitching **without any filter**.

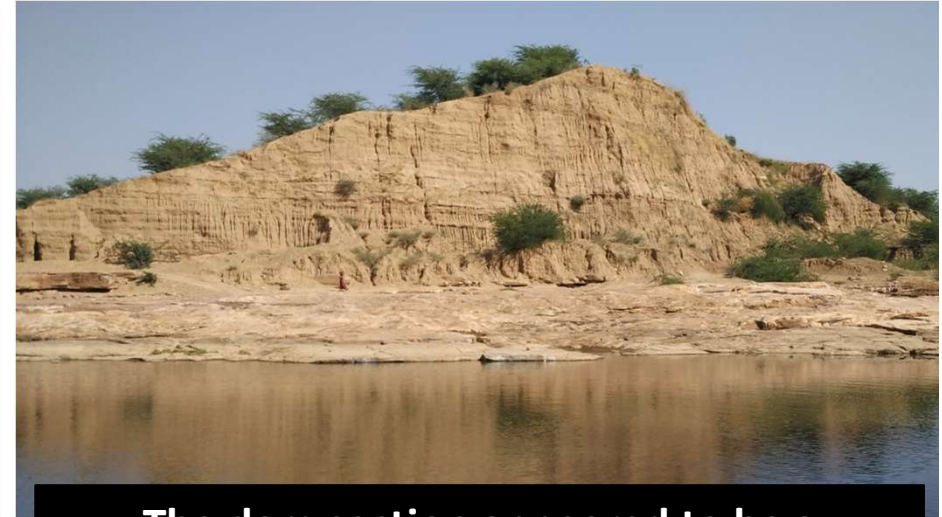
The dam section appeared to be a homogeneous one.

- × There was no clear evidence for existence of any **filter** material, clay **core** and **cut-off** trench in the dam body as evident from exposed portion of breached section of dam.

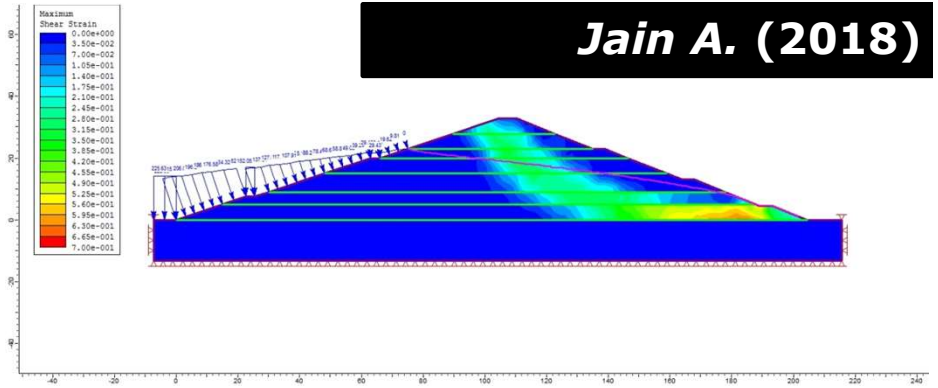
FE Analysis Results of Steady State Seepage Conditions.

- ✓ The filter on the downstream slope of COT is highly desirable especially for those COTs which are formed by excavating very permeable strata and can trigger particle migration and piping. This study shows that in the absence of downstream drainage filter, downstream slope of the existing dam is becoming seeping face.

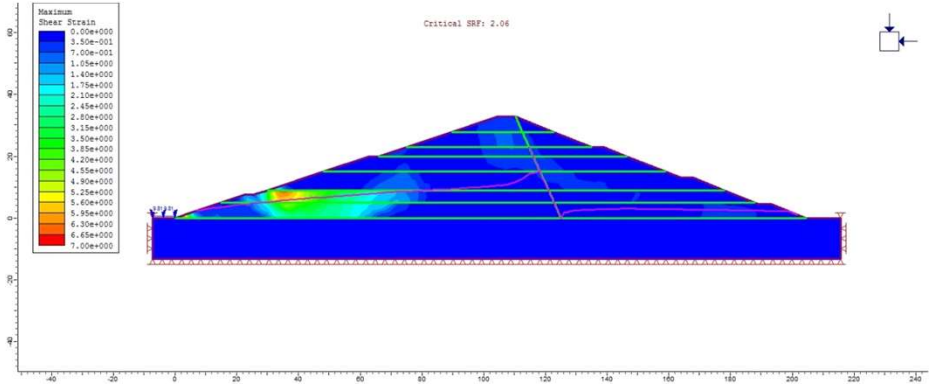
FE Analysis Results for Drawdown Conditions

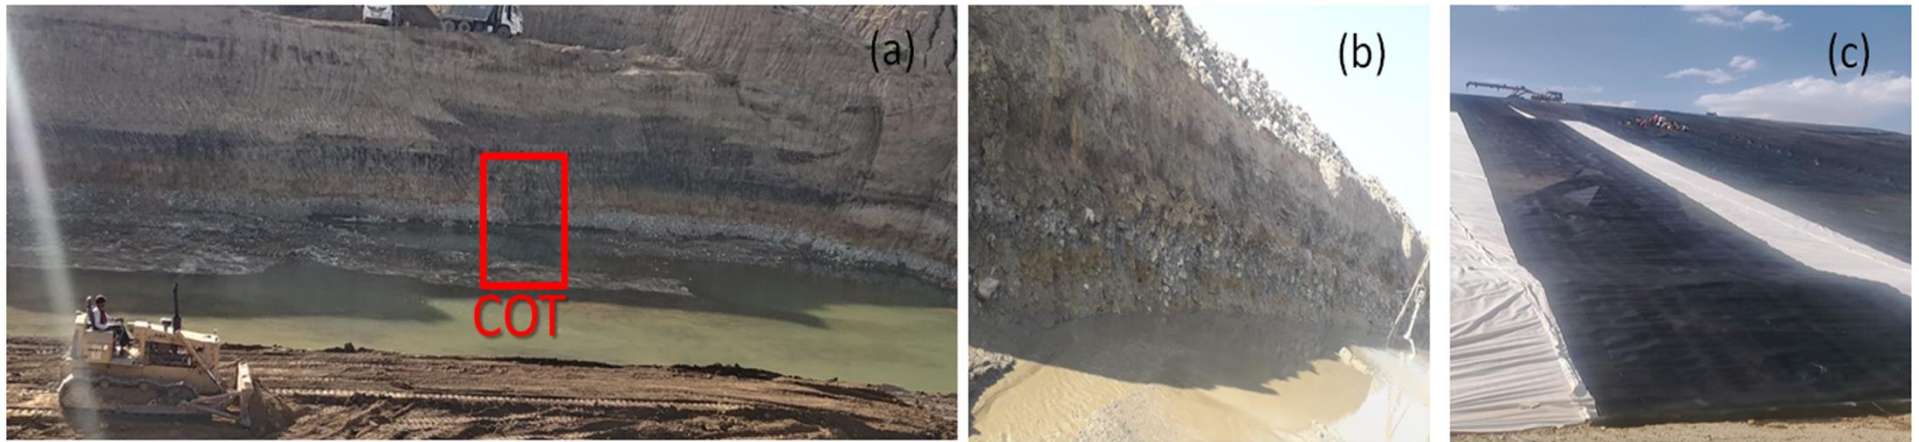
a) The Cut-off Trench in the unbreached portion can be seen to be laid against the highly permeable cobble layer without filter protection

b) The cobble layer over which the unbreached section was founded

The portion of unbreached portion, founded over cobble layer, completely removed and laid as fresh dam section.

c) Laying of Geocomposite (Geotextile+Geomembrane+Geotextile) on u/s slope.
