REINTEGRATION OF THE SPILLWAY SHUTTERS OF KRISHNAGIRI DAM TAMIL NADU, INDIA - A CASE STUDY

KRISHNAGIRI DAM, TAMIL NADU, INDIA

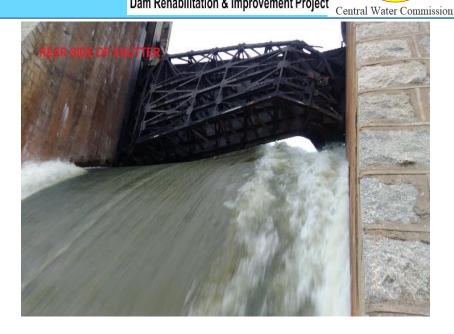
- To worsen the situation, the Krishnagiri dam catchment received heavy rain due to the cyclonic Ockhi storm.
- In the afternoon of 29th November, 2017, spillway shutter No. 1 got buckled.
- The Field Engineer heard a loud band and noticed leakage in spillway shutter no.1, with damages occurring on the lower left bottom edge of the shutter.
- Due to hydro-static pressure, gate no.1 shutter heaved in towards the downstream direction and lifted approximately 1m off from the sill beam.
- Fortunately the Stakeholders meeting was conducted in month of August 2017.

Failure of Gate no 1 in Krishnagiri Dam

- Hence it was easy to invoke the EAP to ensure necessary downstream protection. No other damages were observed.
- Temporary stoplog gate was fixed to the height of 3.6m above crest to store the water temporarily.
- As the spillway gates served for more than 60 years, the State Government decided to replace the damaged shutter
- The Gate was replaced successfully and the structural integrity of the dam also restored.

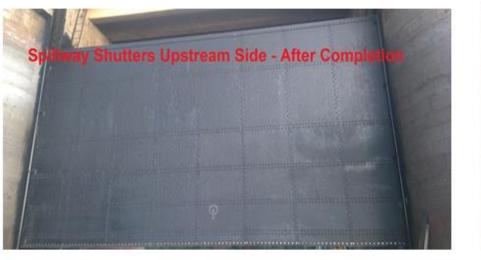
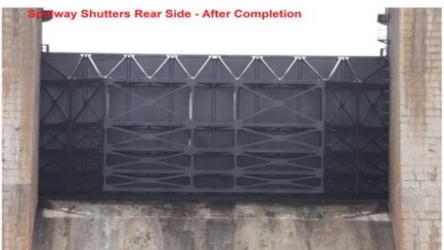
U/S & D/S VIEW OF THE REPLACED SPILLWAY GATE NO-1 OF KRISHNAGIRI DAM

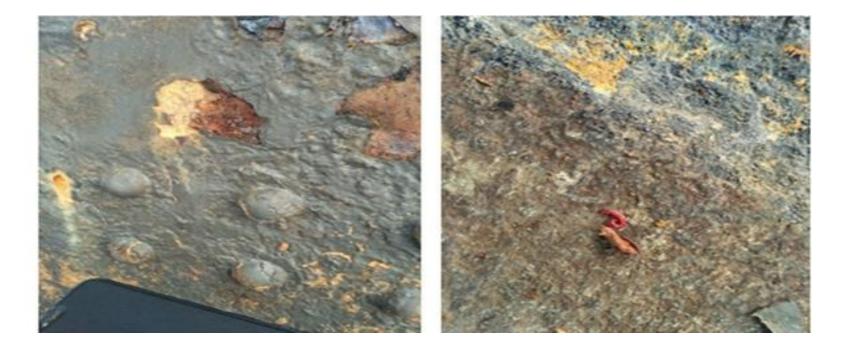
- The preliminary steel analysis including corrosion rates are analysed and reported that the corrosion rate of the shutter near the replaced shutter is nearly 2.5 times more than that in middle of the reservoir
- Bacterial growth was observed.
- Hence recommended to identify appropriate steel coating.

• The pH value of Krishnagiri dam is of 8.5 and high alkaline of 250mg/l resulting in scale forming water. The high chlorides and sulphate will increase the rate of corrosion.

Corroded portion of the Gate no 1 in Krishnagiri Dam

- The structural adequacy of the gate no. 01 was ascertained by the Structural Department IIT Madras.
- Following this, the professors of IIT Madras has suggested to use Zinc-Aluminium Alloy metal coating (metalizing) followed by polyurethane.
- The scientists of IGCAR Kalpakkam. identified the key findings on microbiological corrosion of Krishnagiri dam spillway shutter based on the analysis of dam water, biofilms and corrosion products of shutter specimen.
- The very high density of microbes in the reservoir appears to have accelerated the corrosion rate of spillway shutter material.
- Considering the alarming thickness reduction of shutters, due to micro-biologically influenced corrosion, it is suggested to replace all the existing shutters with new ones having suitable antifouling coatings.

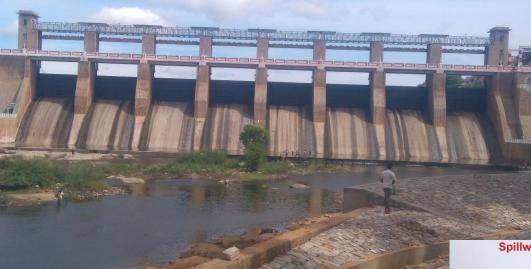
Spillway Shutters Rear Side - After Completion

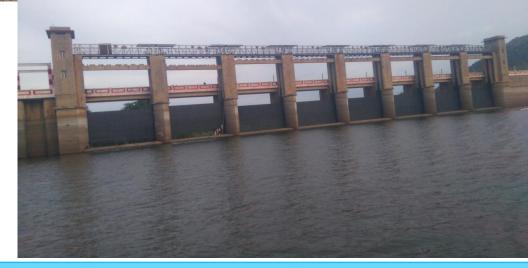
Spillway Shutters UpStream Side - After Completion
