## REPAIR & REHABILITATION OF SPILLWAY GLACIS USING STEEL LINER - CASE STUDIES OF DHAULIGANGA & TEESTA STAGE-V DAM

Rao Musharraf Ali Khan, Rajesh Kumar & Shankar Kumar  
NHPC Limited, Haryana, India

10-12 October 2022 at Jaipur, Rajasthan (India)

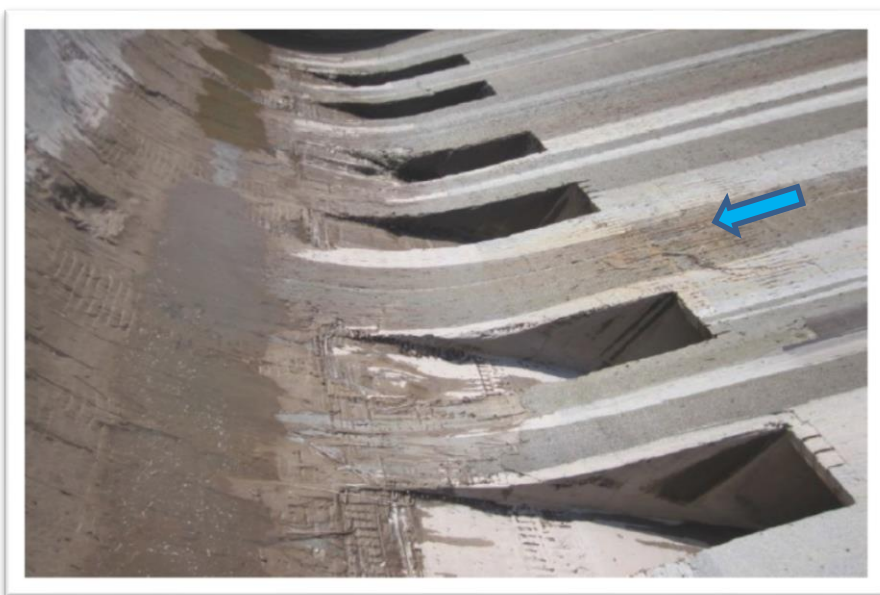
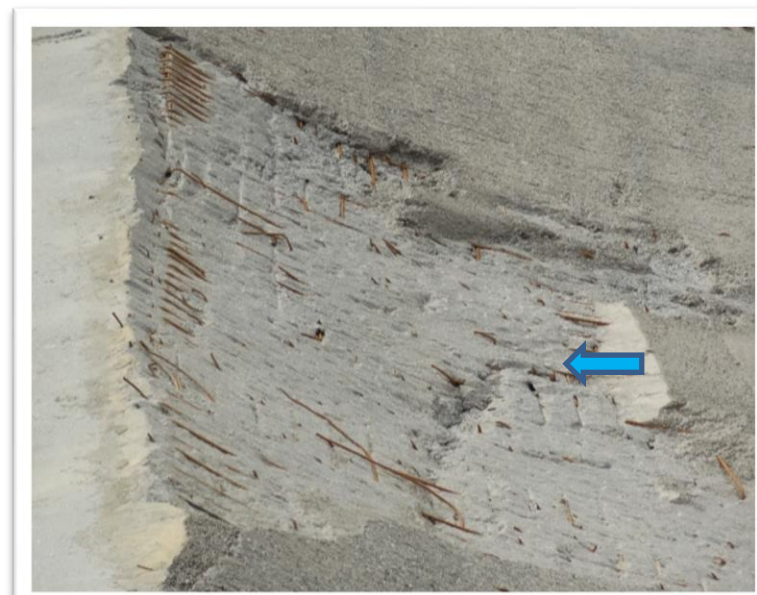
**ABRASION**: It is gradual wearing away of concrete surface due to sediment flushing. The damage is relatively **Uniform** over large surface. The rate of abrasion depends on **Sediments load, Flow Velocity & Concrete Grade**.

**Erosion in the bucket area of Crest Spillway - Salal Dam**

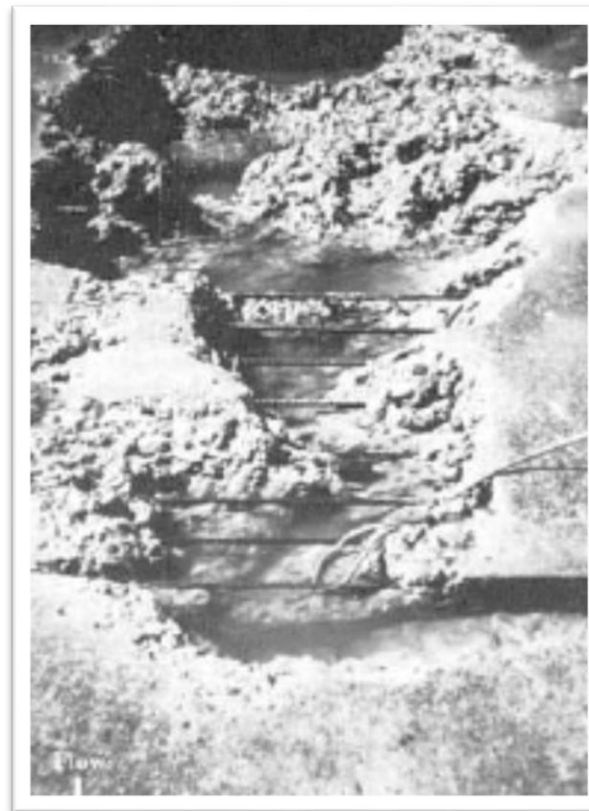
**CAVITATION**: Formation & Bursting of water bubble causes tensile stresses at concrete surface. The **high stress in small area causing Pitting** on the surface.

**Cavitation damage**

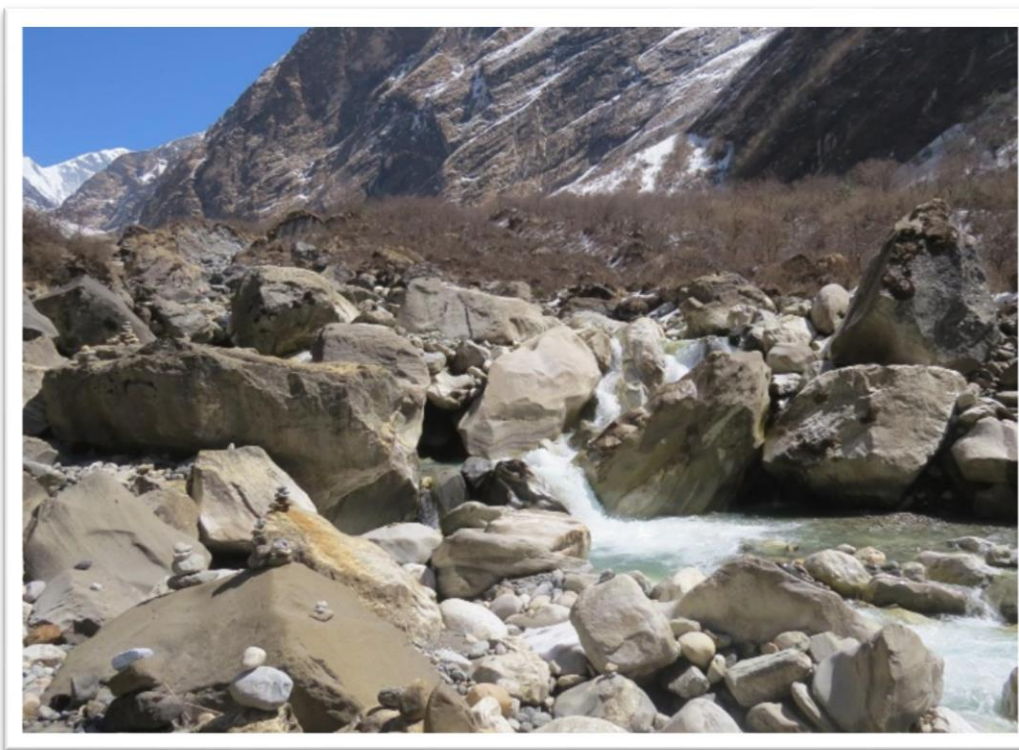
**IMPACT:** Impact forces are caused by **Stones & rolling Boulders** during flood disposal. **Severe damages due to impact forces** are observed in the low-level Orifice Spillways.

**Passing of boulders upto  $\pm 2.5\text{m}$  size are observed in the orifice spillways**

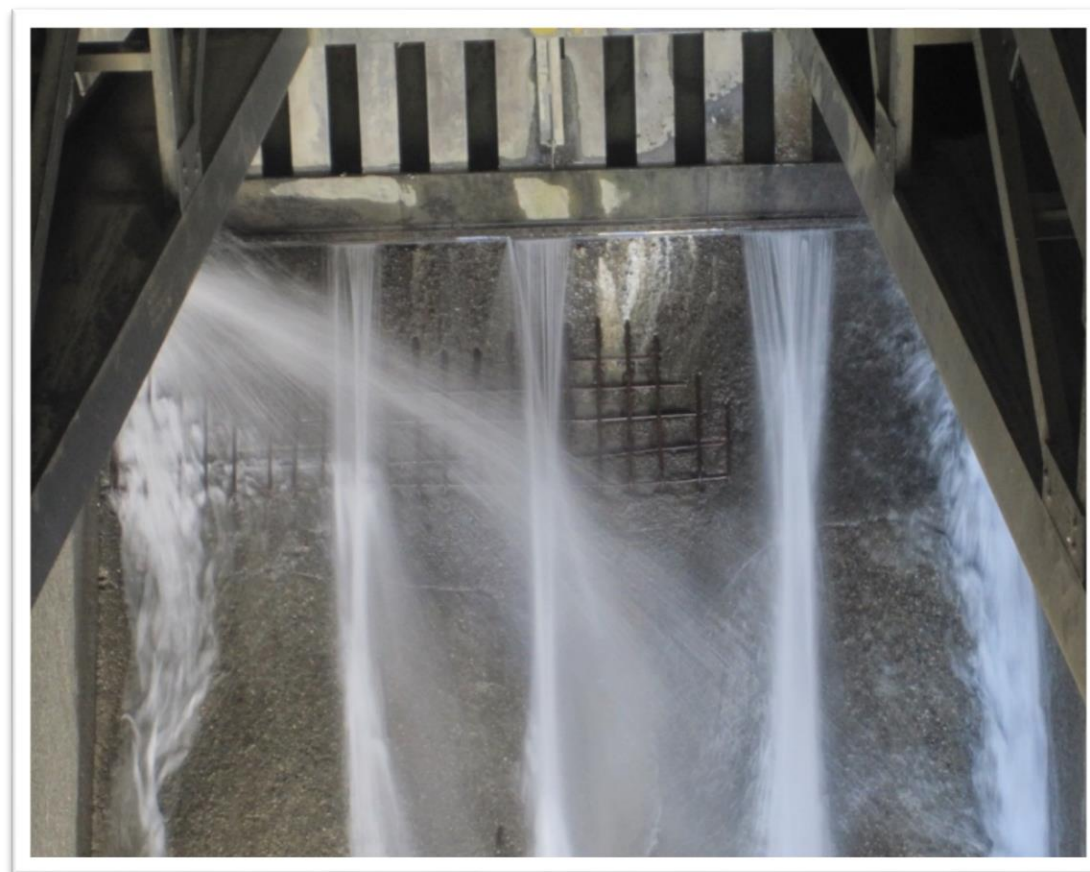
**WATER JET CUTTING:**  
**Impinging water jets**  
from small opening  
of gates or leakage  
through gate seal  
causes **Concrete**  
**cutting.**

**Water jet cutting near radial gate**

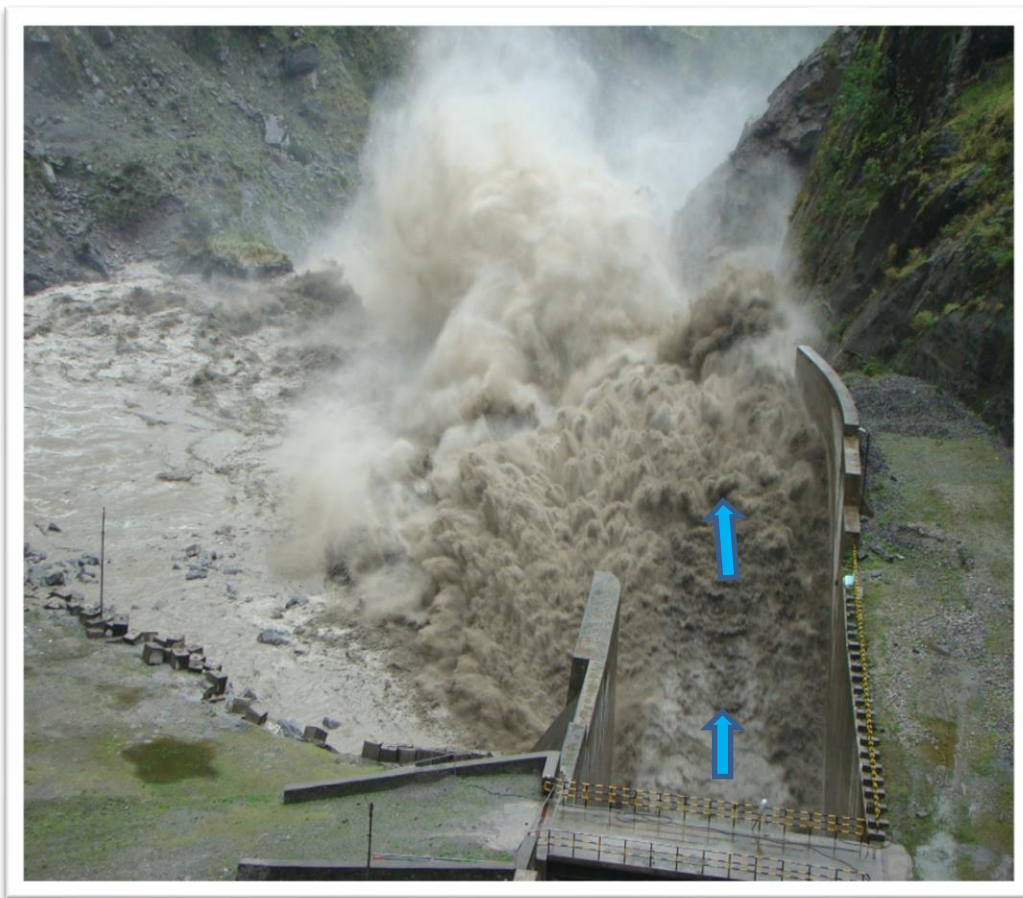
Once Abrasion, Cavitation, Impact force & Water jet have **substantially altered Spillway surface Profile**, the high velocity of water during flood strikes irregular surfaces and it further accelerates the damage.

**Spillway discharge: view from Dhauliganga Dam top**

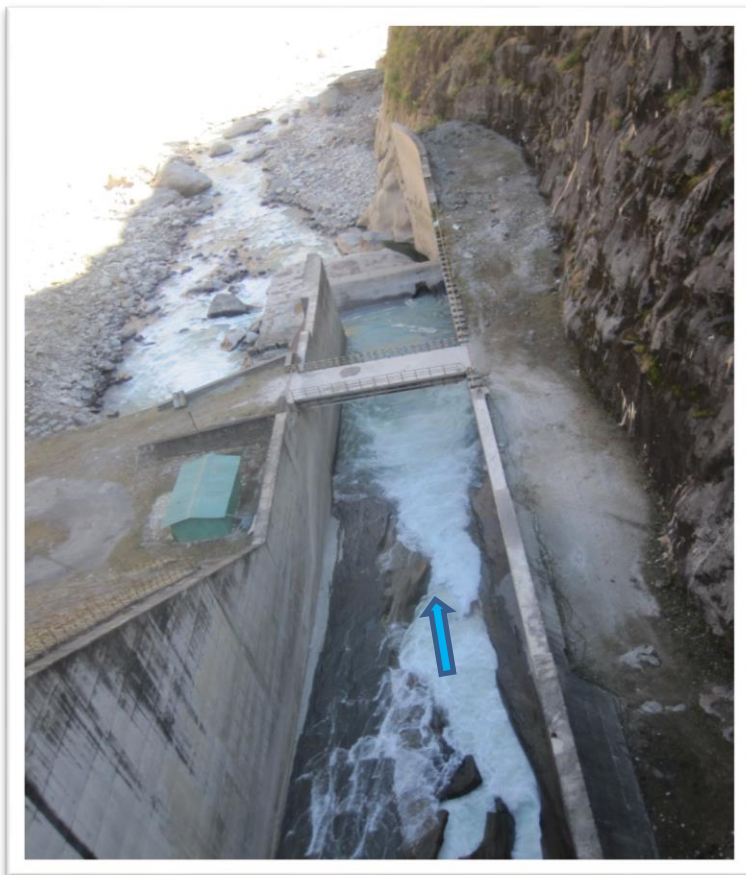
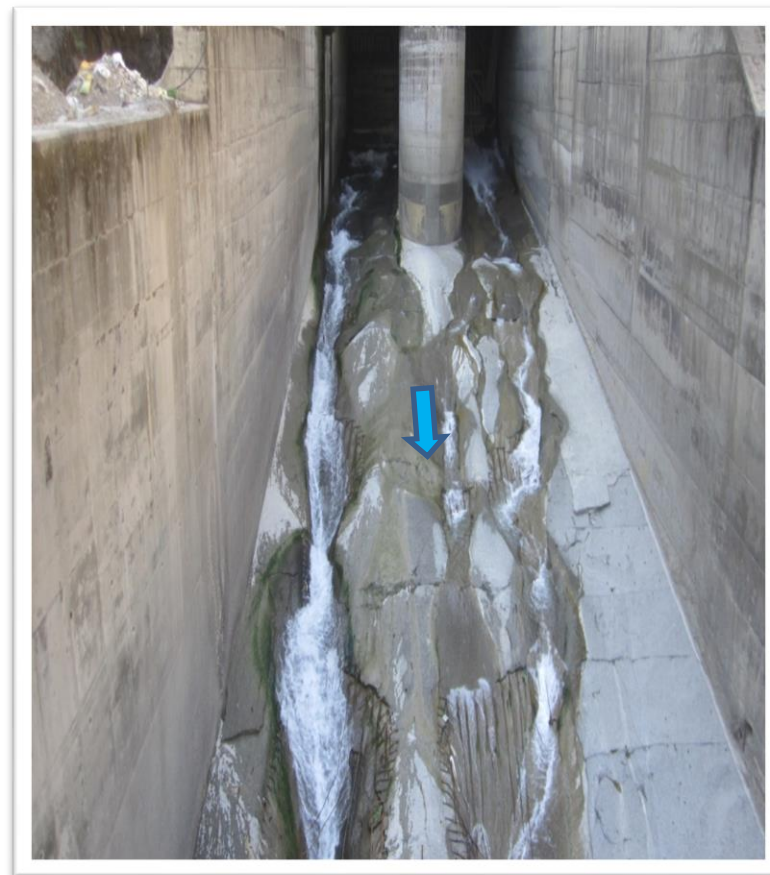
**Damages on Spillway Glacis**

- ❖ The damage profile of spillway has been assessed and eroded portion of glacis has been restored to its original profile using HPC (M60) or Epoxy mortar based on extent of damage.
- ❖ The old concrete and HPC have been bonded by the provision of 25 $\Phi$  Fe500 grade, L-shaped grouted anchors @ 1m c/c.
- ❖ The damaged reinforcement has been repaired with new reinforcement by providing requisite overlapping or welding as per the site suitability.
- ❖ The substrate surface has been prepared to the desired level and Steel liner plate of 32mm thick, E 410 grade has been placed in position.

- ❖ The Steel plate has been fixed by Torque controlled counter sunk anchor (Mechanical anchor).
- ❖ Epoxy Mortar conforming to ASTM C-881 Type-IV, Class B & C was used to fill the space between Steel liner and Pier.
- ❖ Epoxy Grout conforming to ASTM C-881 of Type-IV, Grade 1, Class B & C of bond strength  $>10\text{MPa}$  at 14 days was used for contact grouting between steel plate and HPC.
- ❖ The pressure for contact grouting was of order of  $1-2 \text{ kg/ cm}^2$

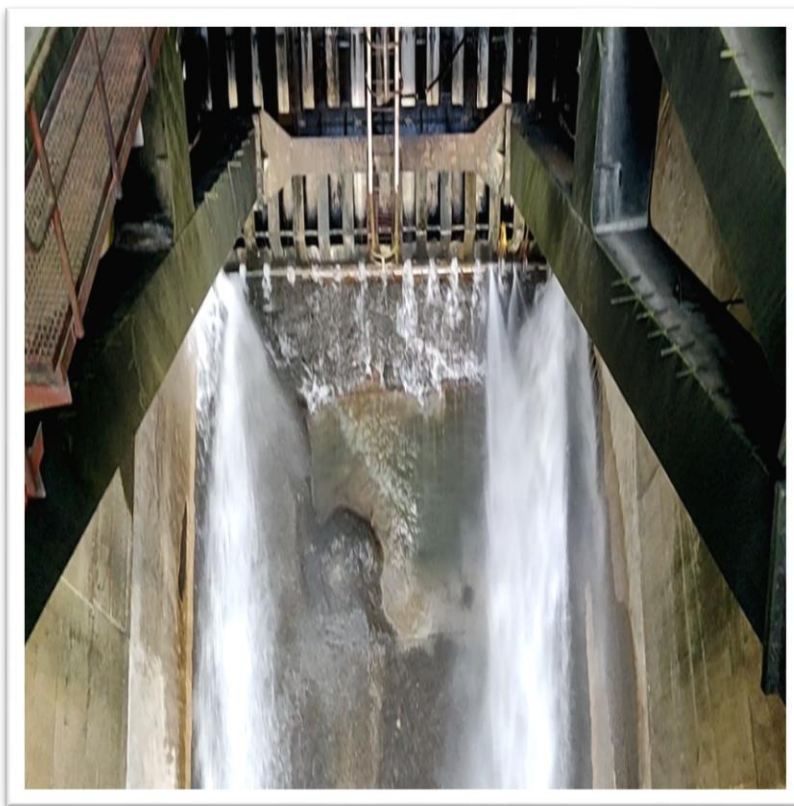
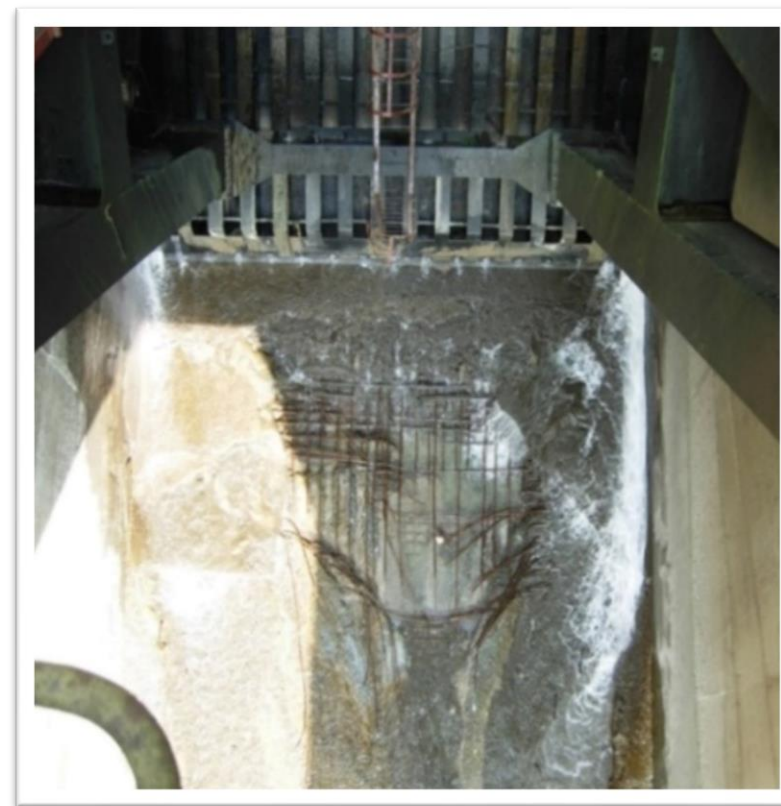
**Damages on Spillway Glacis**

The Steel liner on Spillway # 1, 4 & 5 has been installed by combination of **Mechanical anchors & Chemical anchors** (Similar to Dhauliganga Dam).

In Spillway # 2 & 3, due to high damages near radial gate the Steel liner has been installed by **Conventional method** (using stiffener).

- ❖ 32mm thick Steel liner of E-410 grade has been used. The structural steel for stiffener was of grade E-250.
- ❖ The non-shrinkable self-compacting concrete of grade M35A20 was filled below the steel liner in damaged area.
- ❖ Non-shrinkable Cement grout was used for filling the gap between Steel liner and Concrete surface.
- ❖ Epoxy mortar conforming to ASTM C881 of Type-IV, Class C have been used to fill the recess between Steel liner and Pier.
- ❖ The lower portion of the spillway glacis has been repaired by HPC of grade M70A20.

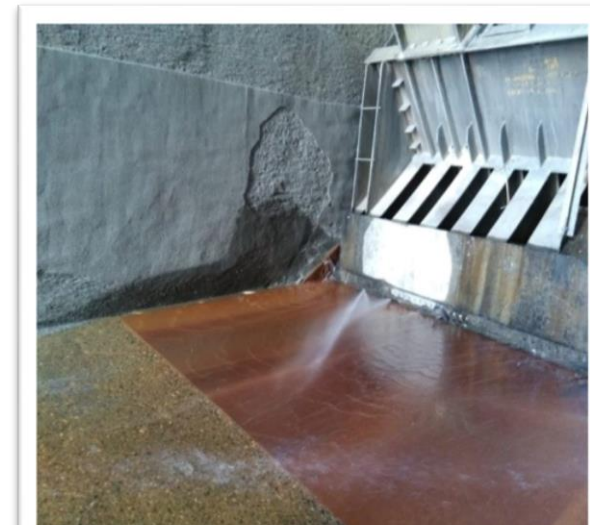
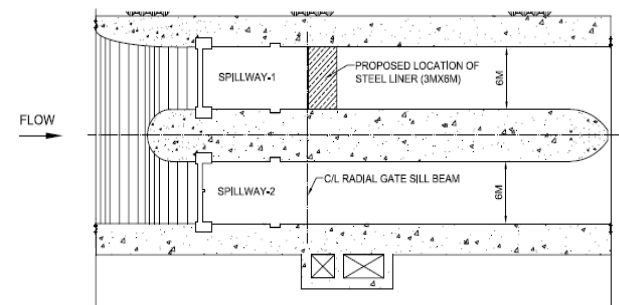
**Steel Liner (3mx6m) at  
Spillway no 1 (Feb 2017)**

- ❖ In order to reduce frequent repair of glacis, Steel Liner plate has been installed in few reaches near radial gate sill beam area of two dams namely Dhauliganga (280 MW) & Teesta Stage-V (510MW) on **Experimental basis**.
- ❖ Abrasion resistant **Steel Liner Plate (E410 grade or above)** has been found effective in resisting impact load generated & water jet concrete cutting.

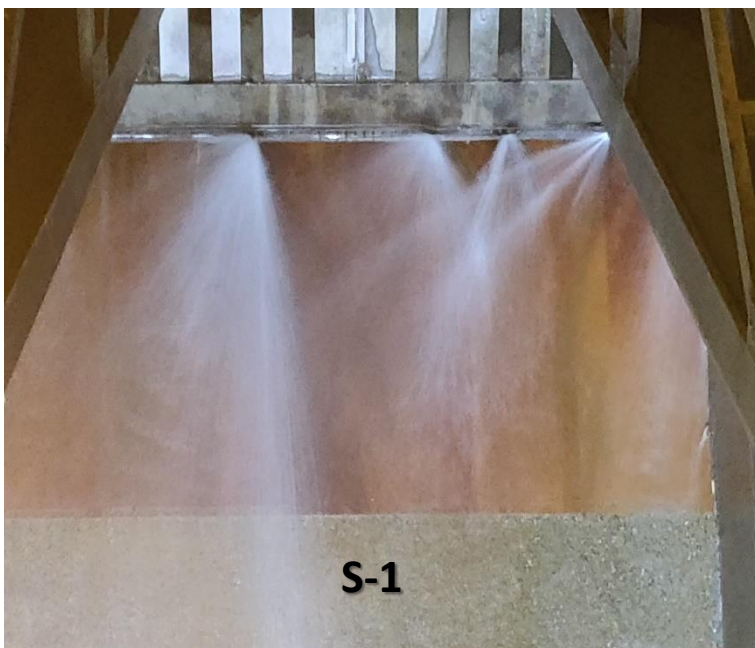
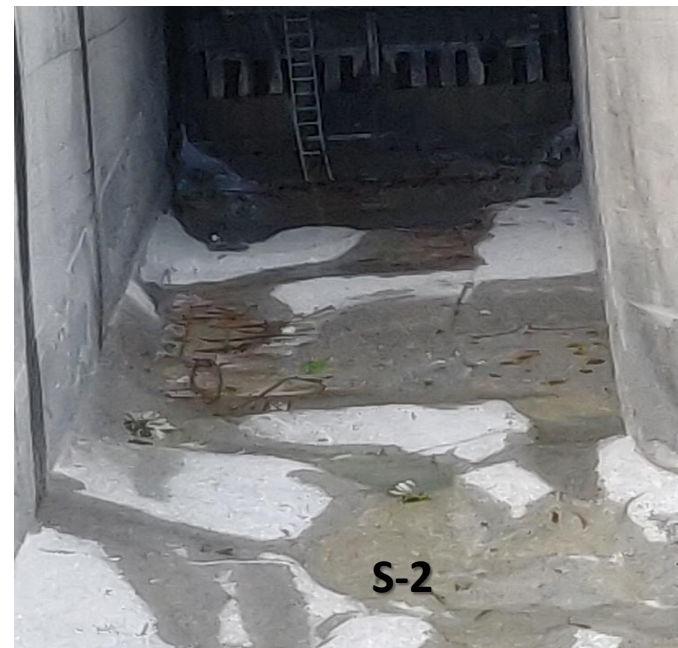
### Condition of Spillway # 1 & 2 in October 2018

The Dam Safety Inspection committee (Oct. 2018) reported that  
**Performance of Steel Liner is Satisfactory.**

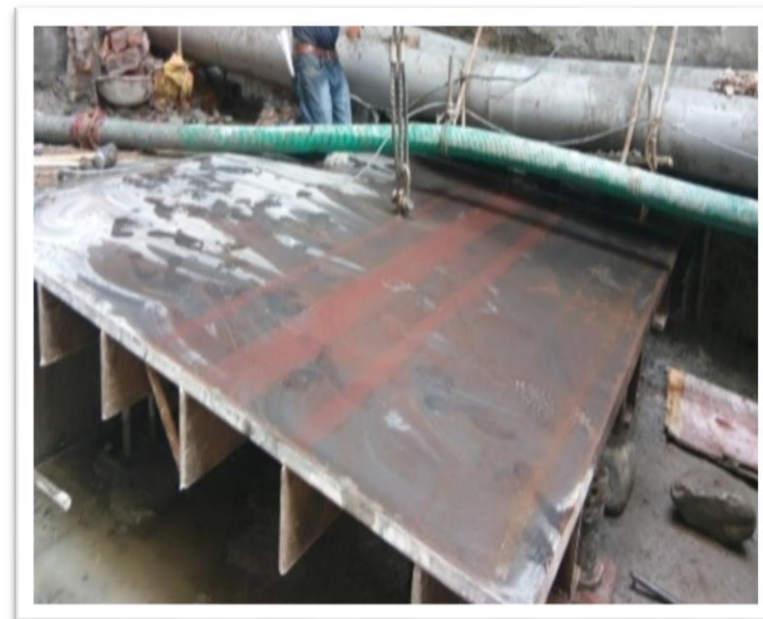
**Stiffener under Steel liner**
