**CHALLENGES IN HYDRO PROJECTS:
PLANNING THE RESTORATION OF RCC STRUCTURES
- CASE STUDY OF TAPOVAN VISHNUGAD HYDRO POWER PROJECT**

Vivek Gupta, Dy. General Manager, NTPC Ltd. (INDIA)

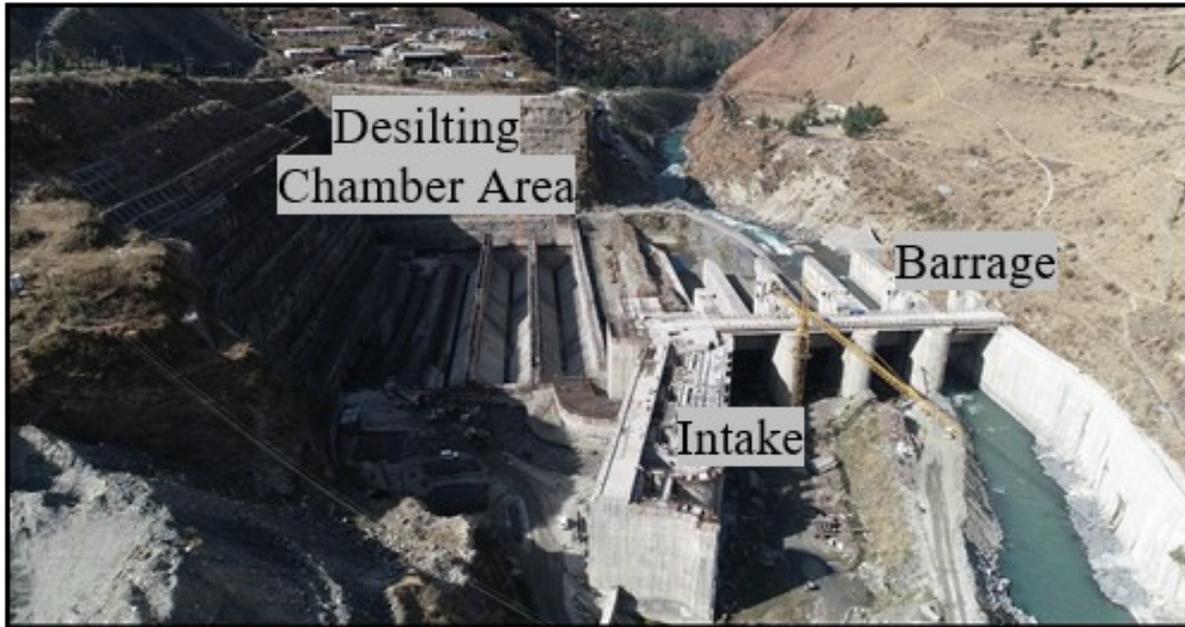
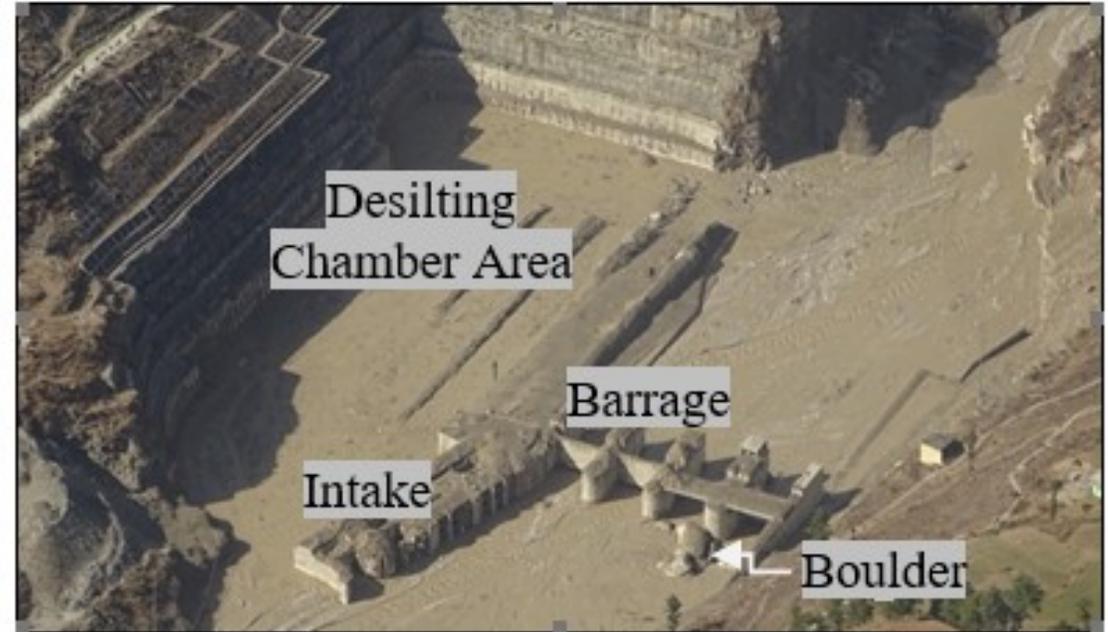
Barrage Complex Before & After Incident

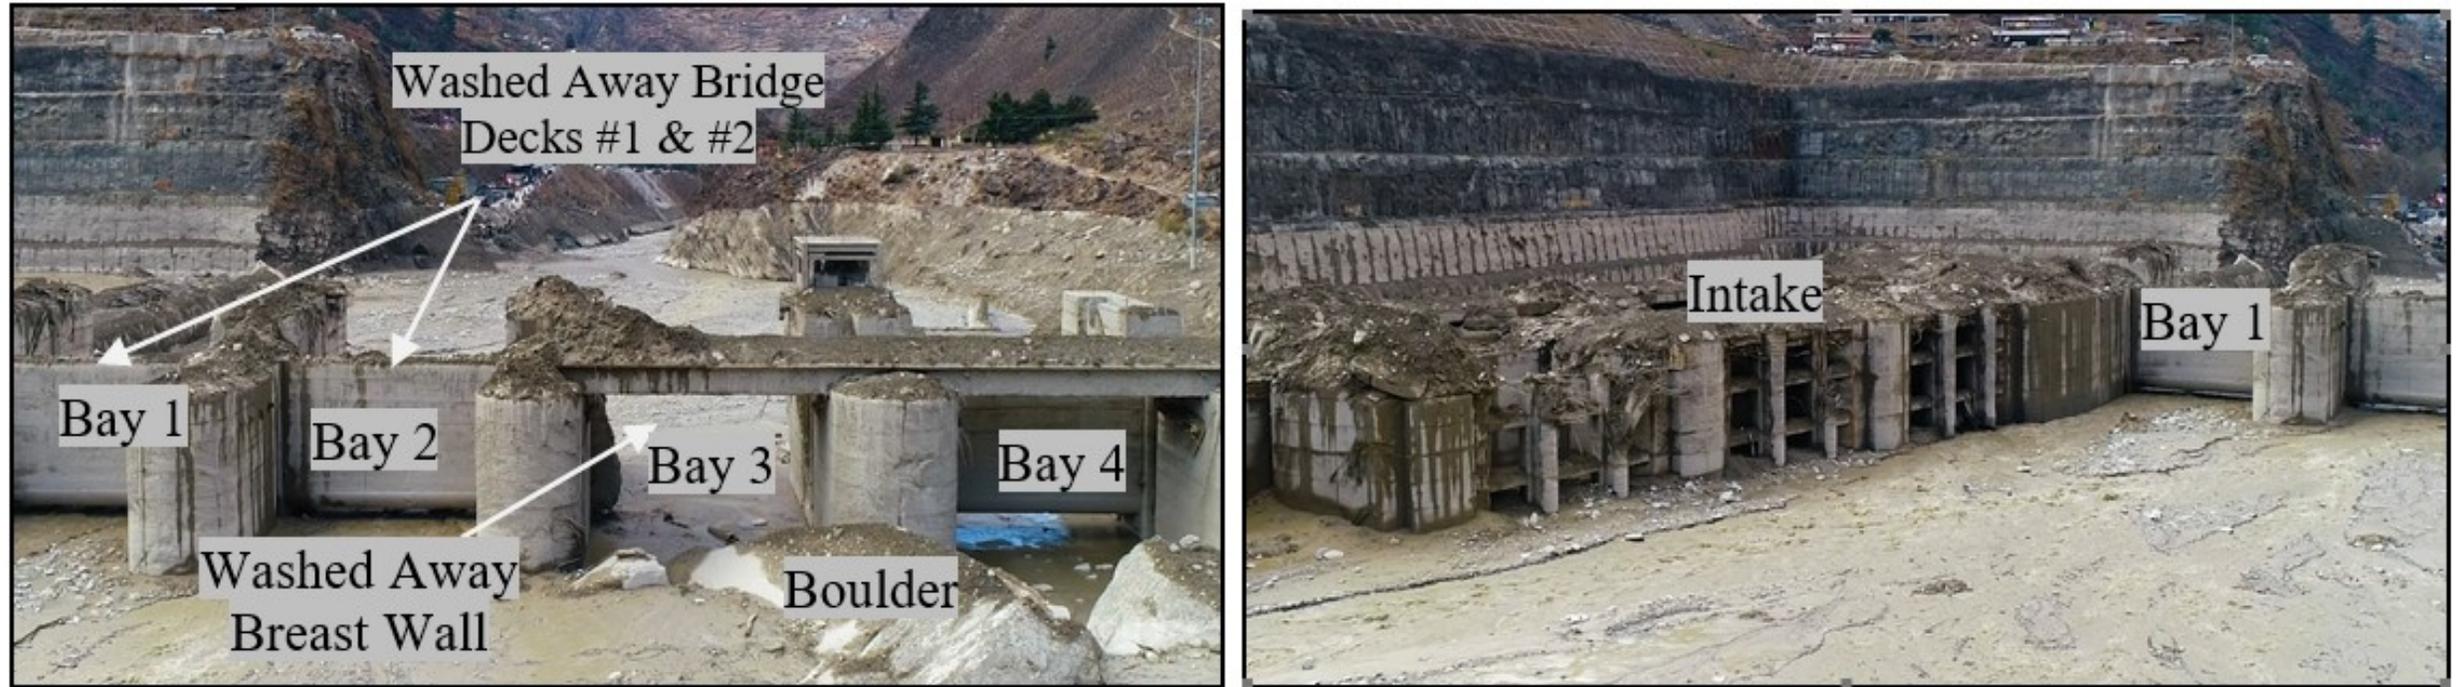
Fig. 2. Barrage & Intake after Incident

- Glacial debris flow overtopped the Barrage at El. 1807.5 m, about 4 m above FRL (1803.5 m).
- Post-event, upstream riverbed level near the Barrage aggraded by about 11 m.
- Around 18 m of debris was deposited downstream above the stilling basin.
- The Barrage structure suffered extensive damage.
- Breast wall at Bay 3 was washed away.
- Bridge deck at Bay 1 and Bay 2 washed away.
- Pier control room between Bay 1 and Bay 2 was severely damaged.
- Large boulders (5–15 m size) accumulated in front of Bay 3 and Bay 4.
- Heavy silt and debris accumulated over the intake structure.
- Trash rack columns of intake Bays 2 and 3 were severely damaged.
- Partially erected radial gates (Bays 1 to 3), hydraulic cylinders, tie flats, and trunnion bolts were washed away.

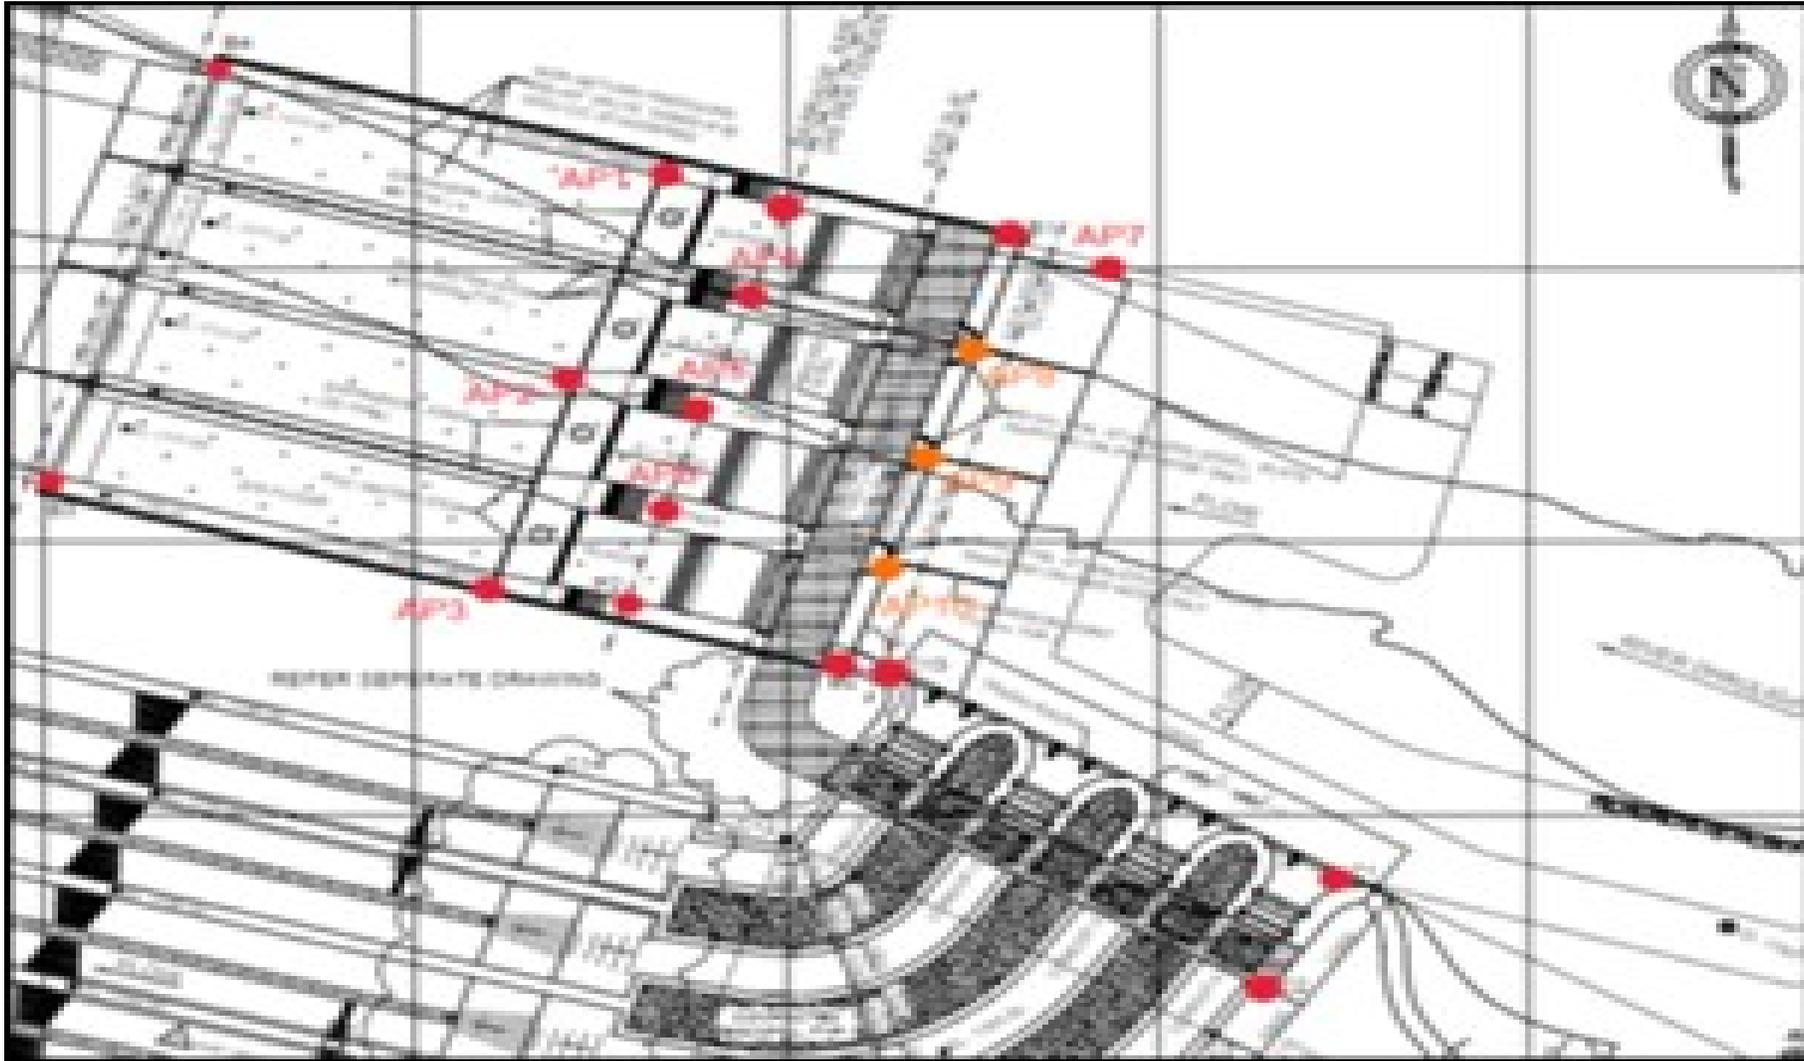
- Barrage alignment was checked against pre-incident position by surveying predefined layout points.
- Nineteen (19) points were surveyed and compared with construction drawing coordinates.
- Most points showed no deviation; only minor deviations of a few millimeters were observed at some locations.
- At eroded locations with exposed reinforcement, readings were taken using fixed steel plates.
- Survey results confirmed that the RCC barrage alignment remains undisturbed.

Details of Verified Survey Points at Barrage and Intake

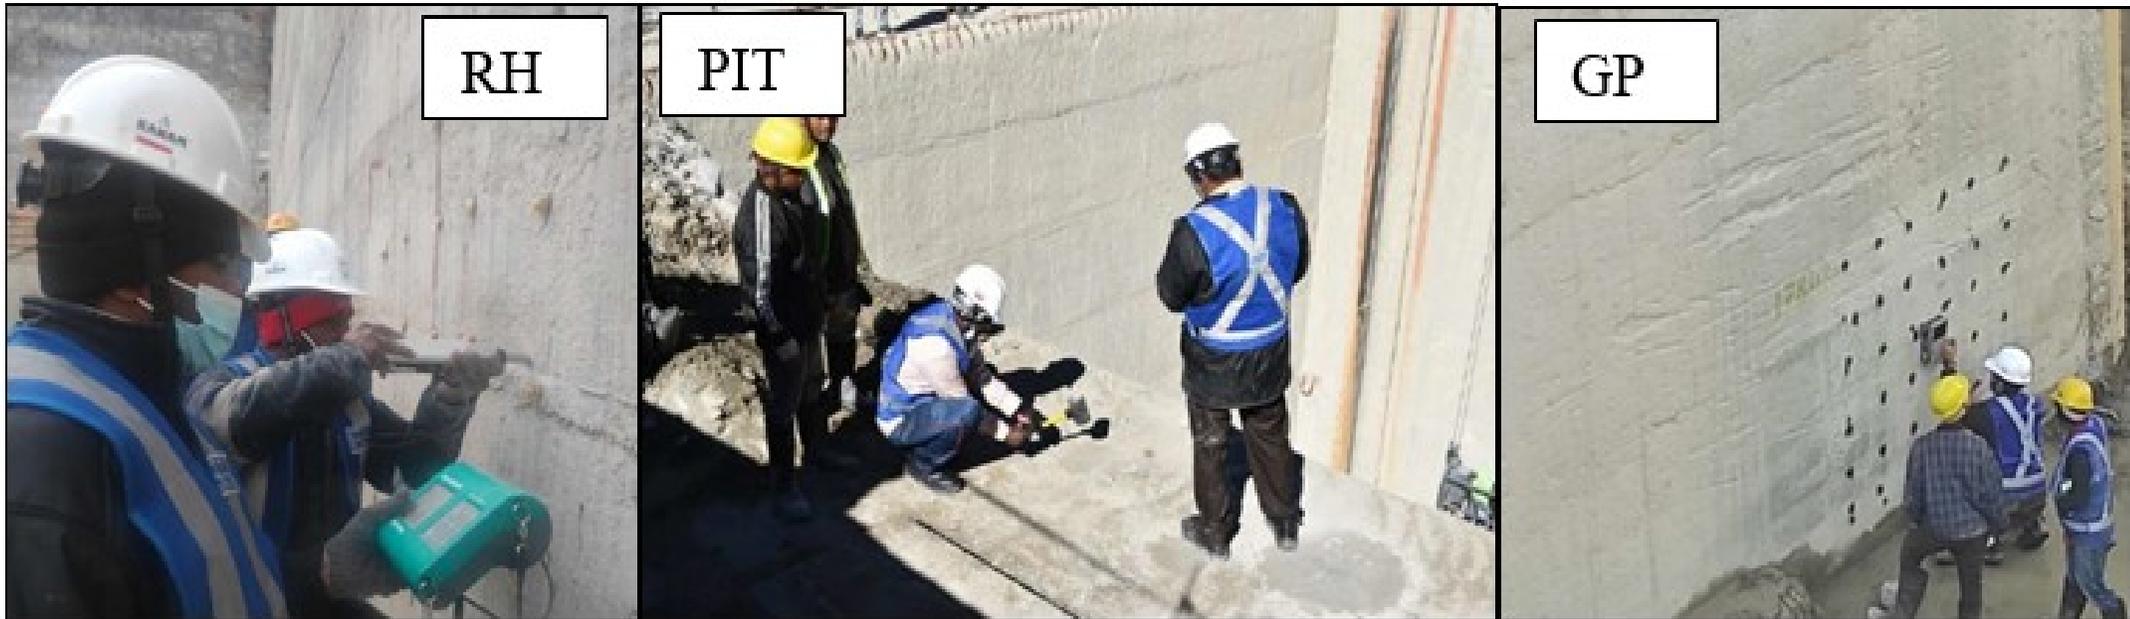
- Low Strain Pile Integrity Test (PIT) was used to assess continuity and integrity of pile-like structures
- PIT provides indication of defects such as cracks, necking, and section changes
- Test is quick, simple, and suitable for multiple locations
- Tests conducted at several locations in piers and breast walls.
- PIT results indicated satisfactory concrete integrity in Barrage piers.
- Concrete integrity suspected in breast walls where multiple cracks were present

Fig. 5. Typical Measurement of RHT, PIT & Rebar Profile using GPR

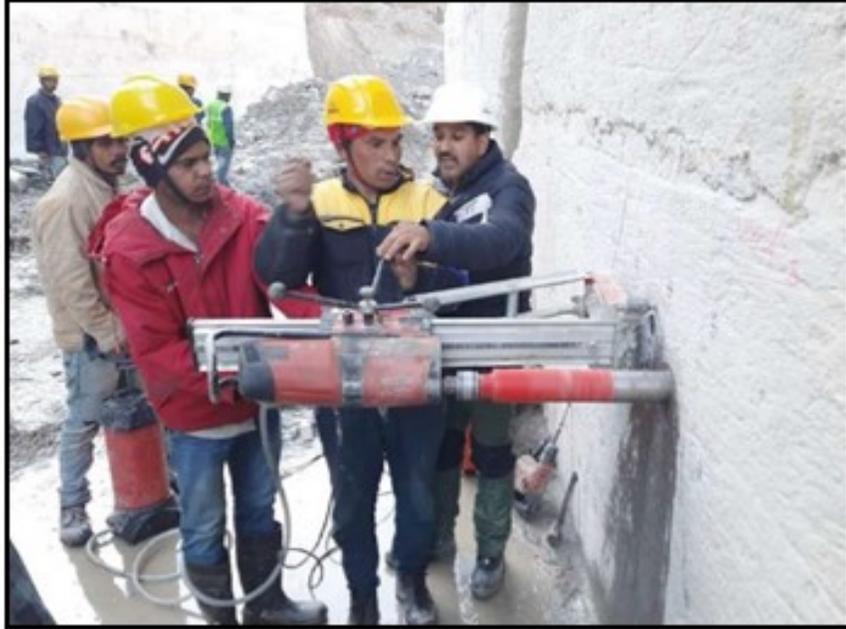
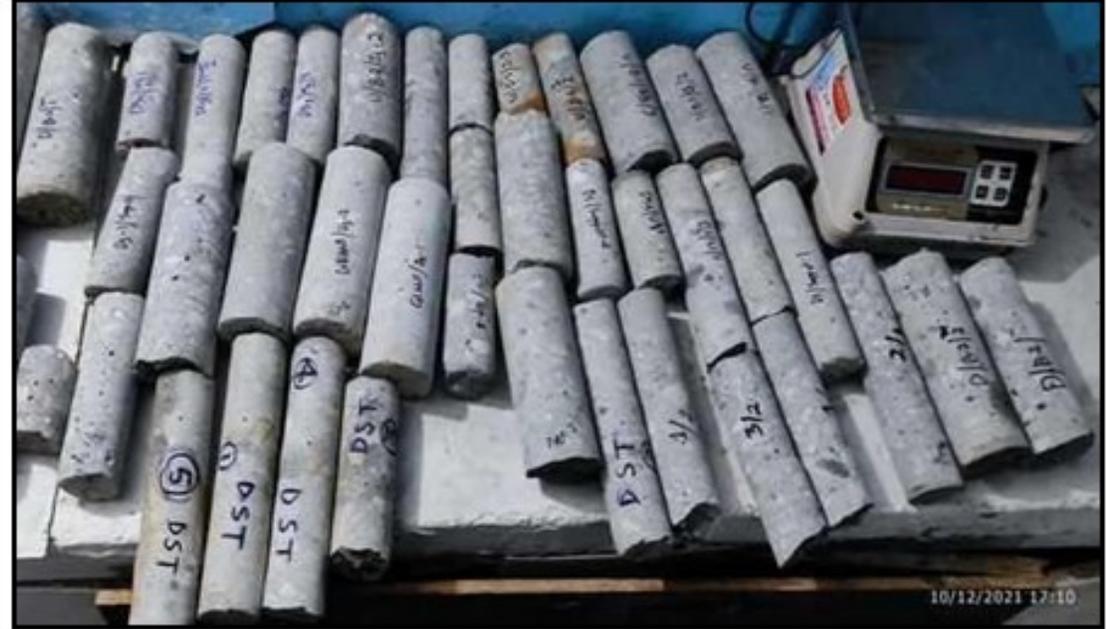
- Core samples collected randomly from various structures to assess concrete strength.
- GPR used to locate rebars and avoid cutting during coring.
- Results corrected for h/d ratio and converted to equivalent cube strength.
- Acceptance checked as per IS 456:2000 criteria.
- Core test results confirmed concrete strength meets design requirements.

Fig. 6. Typical Extraction of Concrete Core Samples from Barrage Pier
