**HEAVY WATER INGRESS IN DEEP SEATED FOUNDATION GALLERIES OF OPERATIONAL DAMS  
ISSUES, CHALLENGES & REMEDIAL MEASURES- A CASE STUDY OF NTPC KOLDAM**

Vishal Kaushik, Jagat Singh Yadav & Dr. Anubhav  
NTPC KOLDAM, INDIA

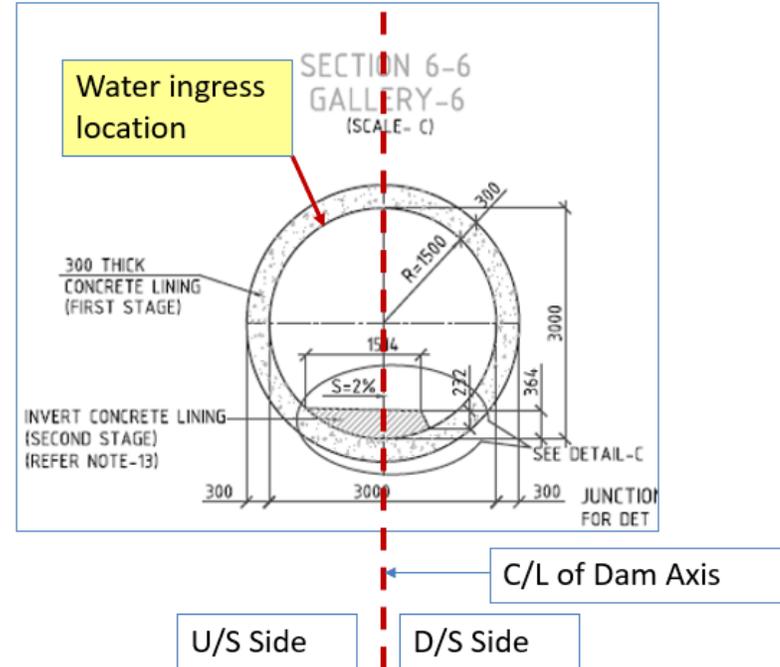
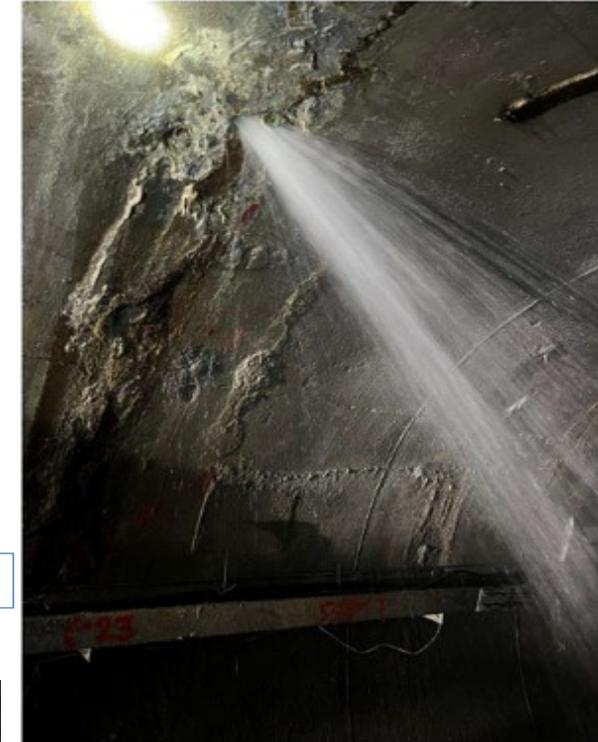
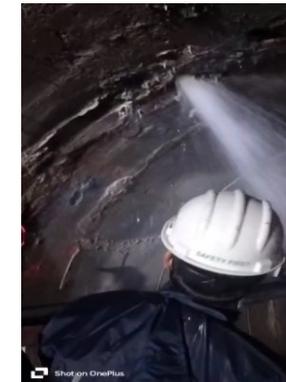
- ✓ Heavy water ingress in Dam foundation gallery was observed on 18.01.2025.
- ✓ This Gallery is concrete lined (Plain concrete), 3m finished diameter & 160m long .
- ✓ Water ingress was observed at RD 55M & 11 O'clock position, D/s side.
- ✓ Discharge measured was of the order of 330 to 350 lpm

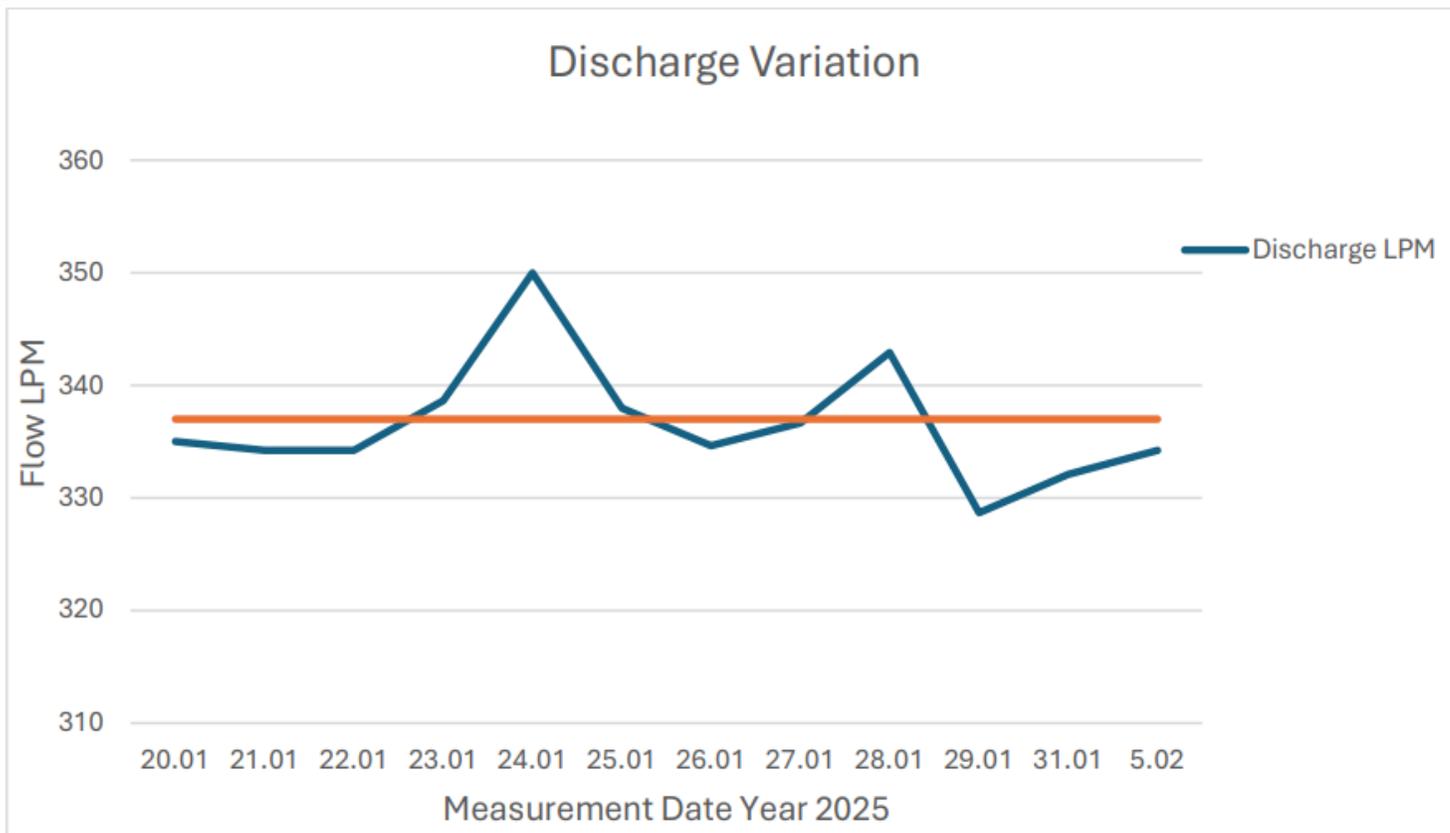
Fig: 2 Chronological discharge variation pattern

- ✓ Immediately after the occurrence of the leakage, as the solution to the problem was being discussed/ finalization by Engineering, leakage monitoring campaign for monitoring quantum and quality of water was started.
- ✓ No large variation in leakage rate and properties could be observed till the solution of problem- a great sigh of relief, as this leakage has very high hazard potential.
- ✓ Average discharge of about 300 to 350 lpm

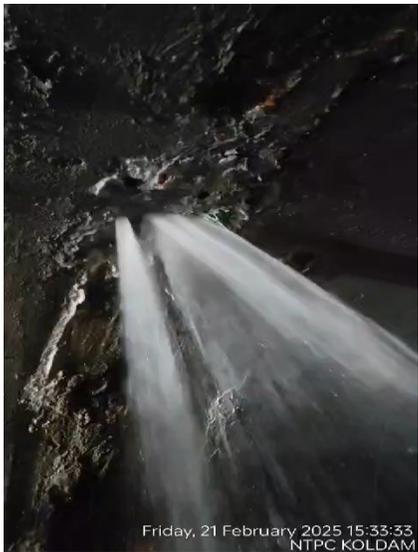
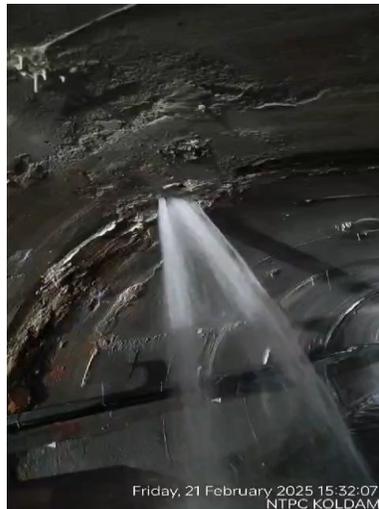
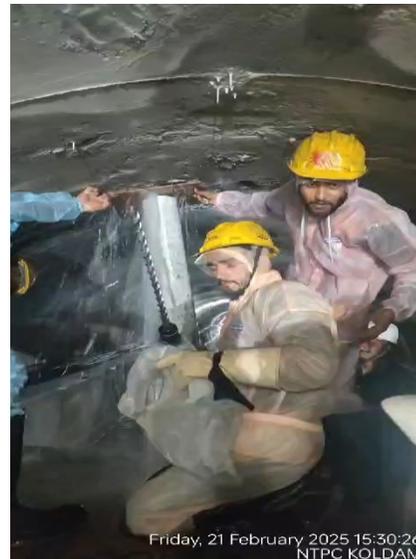
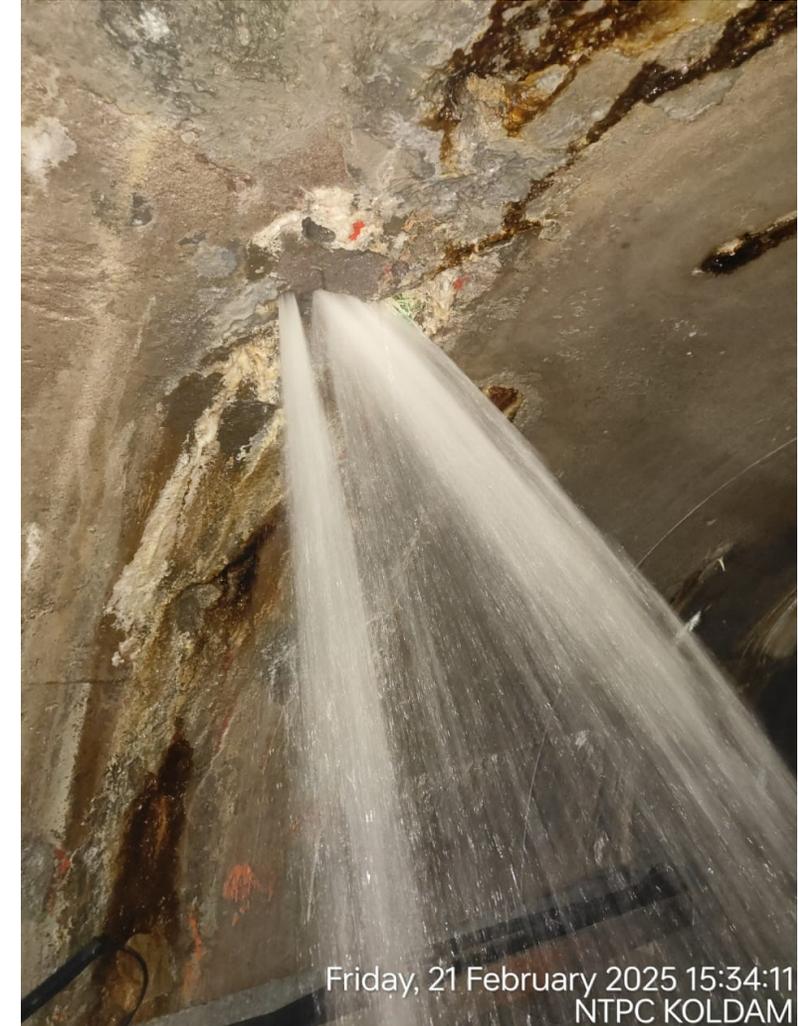
- ✓ Due to area fully surcharged & wet, lots of safety issue in execution. Considering this suitable execution plan like pneumatic drilling etc. were used.
- ✓ The work of fixing of leakage channelization arrangement by drilling of M20 bolts as per the sketch was attempted on 22.02.2025
- ❖ 1<sup>st</sup> hole was drilled up to 200 mm in the concrete, and no water was observed.
- ❖ 2<sup>nd</sup> hole was drilled and water started coming out of that drilled hole. (Photographs and videos attached), then further hole drilling was stopped at site.
- ❖ During drilling, not much of difficulty was felt and penetration rate was high, shows that concrete is weaken at that location.

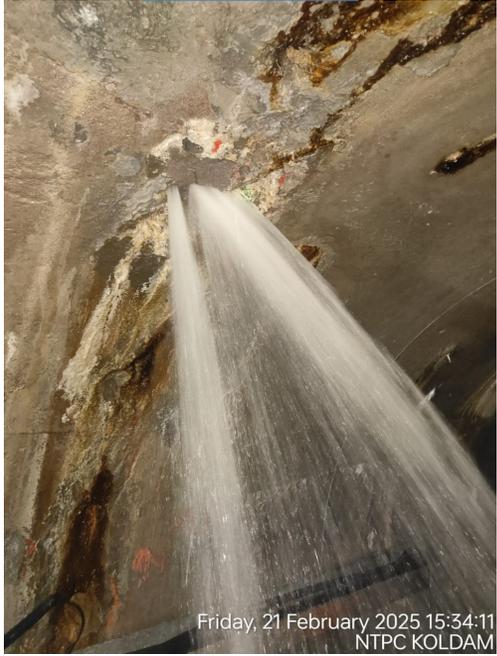
Before

Keeping in view the durability aspect of grouting and the structural health of tunnel overt at the affected location, following was also implemented as strengthening measures:

- ✓ Jacketing of overt portion of tunnel lining with the help of micro concrete and ribs.
- ✓ After completion of work, there is no further distress/deformation has been observed in the area.
