GEOTECHNICAL APPRAISAL OF FOUNDATION CONDITIONS OF DIBANG DAM, ARUNACHAL PRADESH, INDIA

Y K CHAUBEY, IMRAN SAYEED, SANKHADIP CHOWDHURY AND RAHUL KHANNA

NHPC Ltd, Faridabad, Haryana, India

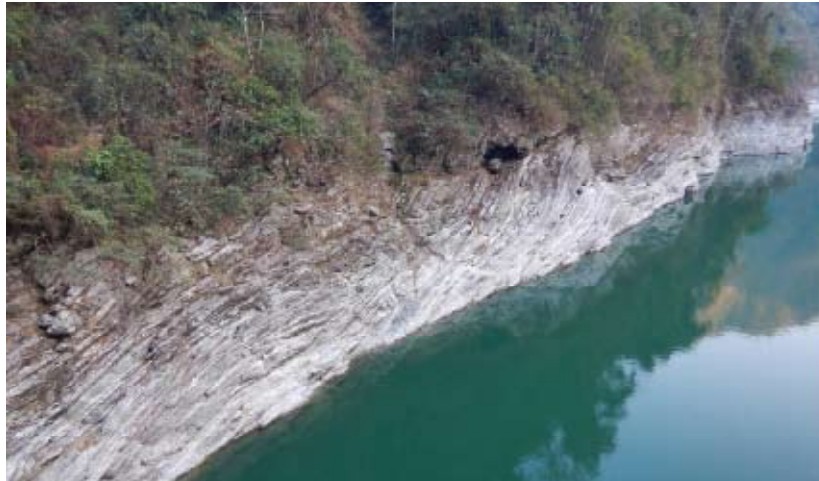
Fig 2 : Foliation joints with highly varying dip directions exposed towards left bank upstream of dam axis.

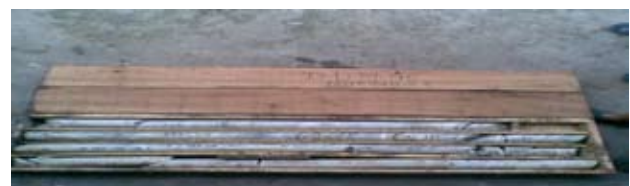
Fig 10 : Good quality core pieces recovered from drill hole DDH-40 having depth of 200m

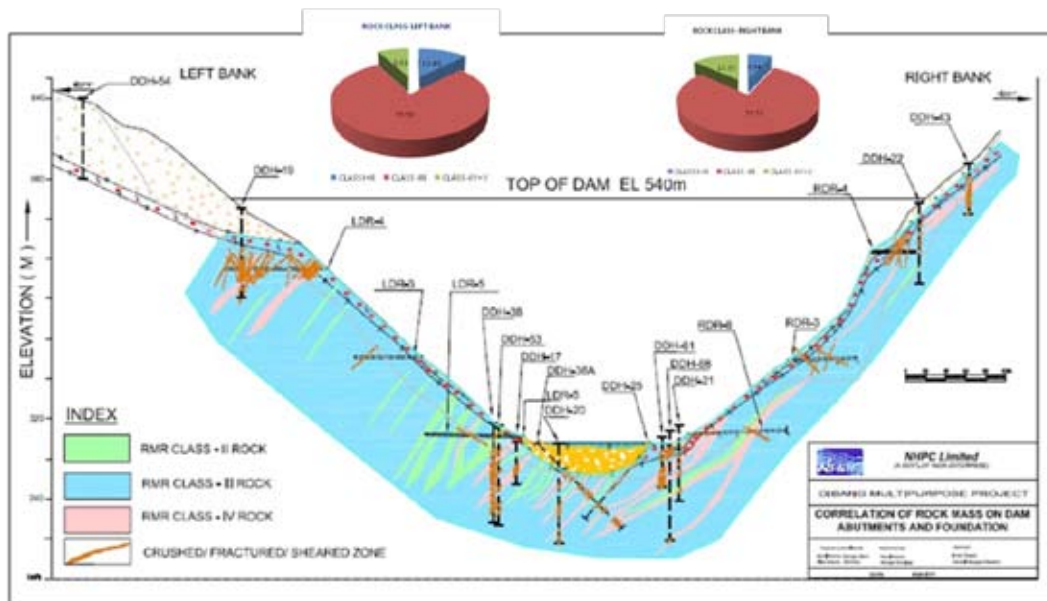
Fig 13 : Geological model based on geotechnical investigations in form of cross section at dam axis.

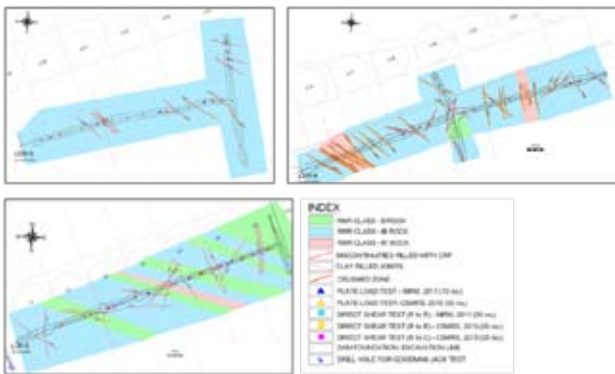
Left bank: A perusal of rock classification data from all the three drifts on the left bank indicates that majority of rock mass is of Class-III (80%), whereas Class-II (12%) and Class-IV (8%) contribute small portion only. Test locations along with the respective rock classes as encountered in left bank drifts is shown in Figure 14. Average values of all deformability tests conducted at various level drifts on the left bank are plotted against stress levels (Fig. 15). Accordingly at Stress levels 6, 8 and 10 MPa, deformation modulus of 3.72, 5.54 and 6.75 GPa has been worked out. After stripping of weathered portions, it is estimated that approx. 6% of Class-IV rock will still remain in foundation. The values given above represent Class II/III conditions which are anticipated in about 92% of the rock mass. For values pertaining to Class IV rock mass condition separate evaluation has been carried out for both the banks.

Fig 14 : Locations of insitu rock mechanics test shown along with estimated rock classes in the exploratory drifts towards left bank.

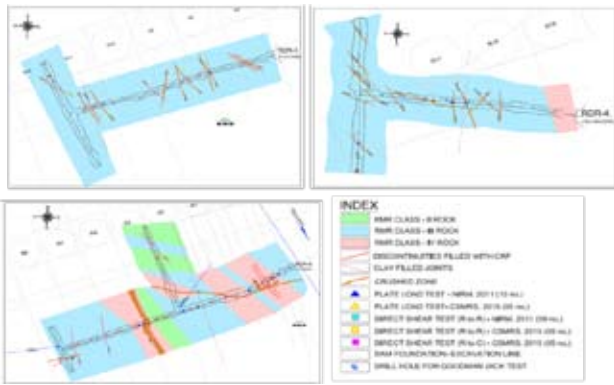
Right Bank: Rock mass data from all the three drifts on right bank also indicates that a majority of rock mass fall in Class-III (80%) category. However in case of right bank Class IV constitute 13% while Class-II is 7%. Test locations along with respective rock classes as encountered in right bank drifts is shown in Figure 16. Average values of all deformability tests conducted at various level drifts on right bank for Class-II/III rock mass (87%) are plotted against stress levels (Fig. 17). The deformation modulus values obtained from Goodman Jack tests undertaken in the two horizontal drill holes DDH-62 and 63 inside lower most drift on the right bank are also considered while averaging. It is however, difficult to ascertain rock classes from the drill-hole data.

The lower drift (RDR-8) has encountered 26% of Class-IV media which is mainly occupying initial 70m of the drift portion. Incidentally, the testing carried out by NIRM covers Class-IV rock at four locations. However, it is also seen from dam excavation section that about 45m of the right bank portion will be excavated. As the remaining 25m also encompasses majority of Class IV rock with a number of shear zones/seams has been recommended to increase the stripping corresponding to 70m in RDR-8 drift. If this portion is stripped then the percentage of Class-IV is expected to come down. However, it may be appreciated that inherent Class-IV bands (other than outer periphery owing to weathering) will continue to remain in foundation which are overall expected to be approximately 10% of the media on right bank.

Fig 16 : Locations of insitu rock mechanics test shown along with estimated rock classes in the exploratory drifts towards right bank.

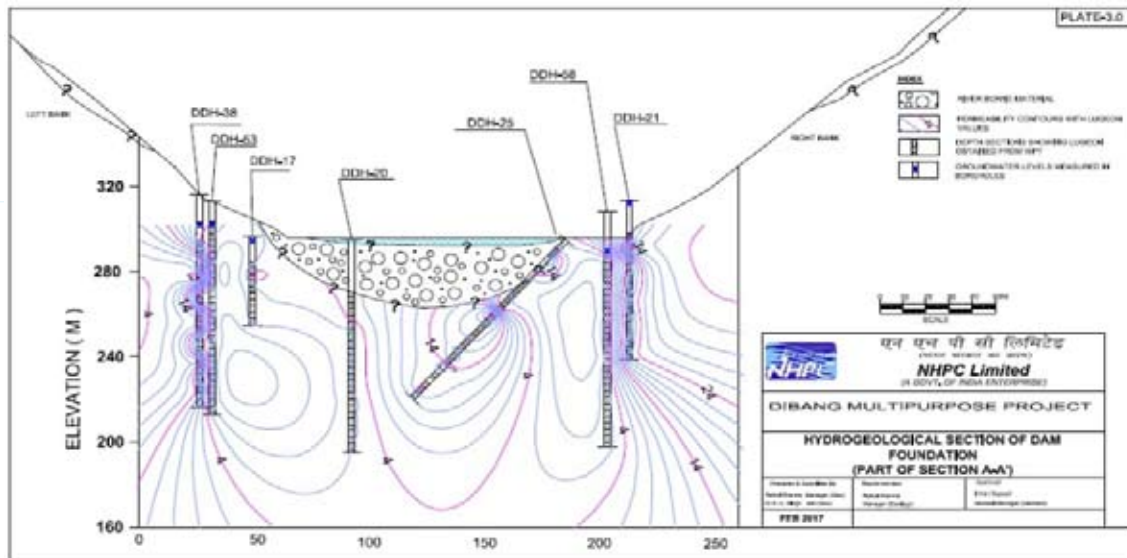
At the instance of International geotechnical expert, a hydro-geological section has also been prepared by NHPC at the dam axis (Fig. 19). This section depicts the measured permeability test results from various boreholes along with contour lines of permeability values. The section also included the groundwater levels measured in the various boreholes.

Fig 19 : Hydrological Section depicting permeability contours along dam axis.
