### REHABILITATION OF KONAR DAM UNDER DRIP – A CASE STUDY

Dipankar Chaudhuri, Chief Engineer (Civil) and Saroj kumar sah, ExecutiveEngineer (Civil)

### DAMODAR VALLEY CORPORATION

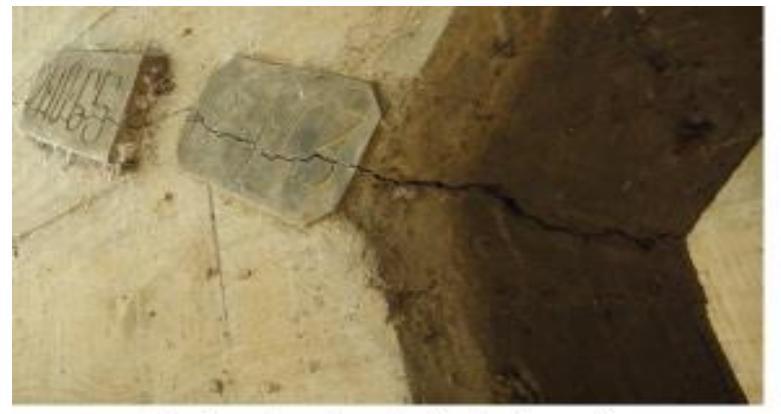
Outer dam body at abutment
