SONIC WAVE VELOCITY MEASUREMENT FOR EVALUATION OF IN-SITU QUALITY OF DAM

Central Water and Power Research Station, Pune, Maharashtra

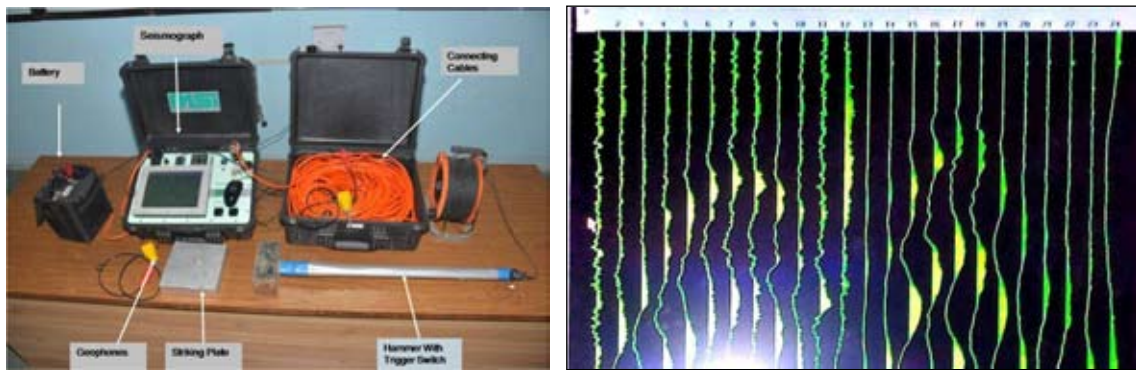
Figure 1 : 24-channel signal enhancement seismograph with accessories and a typical record showing the onset of P-waves at 24 locations

The arrival time of seismic waves generated at the upstream face were detected at the downstream face of the dam at different locations by deploying a 1) 24-channel signal enhancement seismograph and 2) 12-channel signal enhancement seismograph. The equipment has very high resolution and can automatically store the recorded signals in the digital form and the equipment. It has the facility to take onsite print of the record and the same can be analyzed later. The time of arrival of compressional waves on each geophone with very high precision, can also be read directly on display screen of the equipment. Figs.1 and 2 show a photographs of 24-channel and 12-channel signal enhancement seismographs with accessories and typical records obtained during field study respectively.

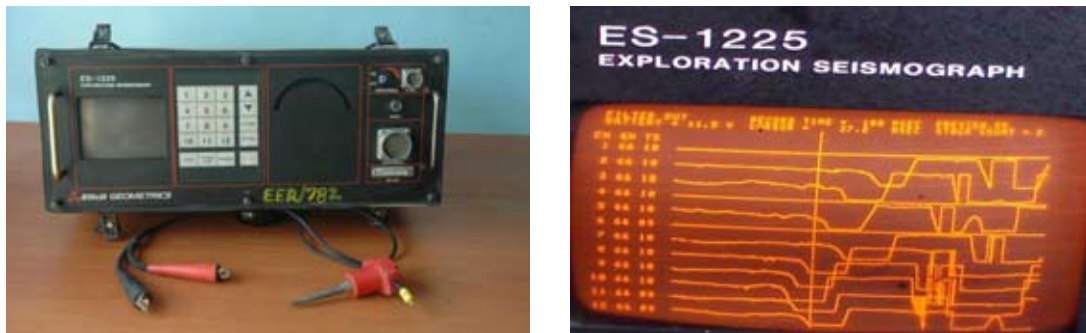
Figure 2 : 12-channel signal enhancement seismograph with accessories and a typical record showing the onset of P-waves at 12 locations

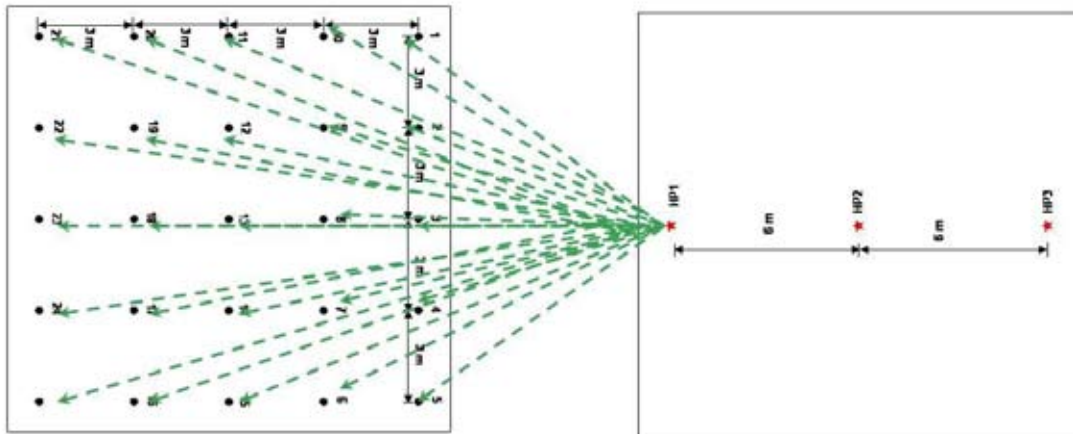
Pattern - A (5 points x 5 lines) : To cover selected portion, 24 geophones are fixed in a square type pattern on downstream side as shown in Fig. 3. First line taken at 1m from top of the dam and five points are marked horizontally at an interval of 3 m. Similarly four lines are marked below first line at an interval of 3 m and five points are marked horizontally at an interval of 3 m on each line. In this manner, 5 points in 5 horizontal lines are marked and named as Pattern - A. The Locations of geophones are marked as 1 to 24 (Fig. 3). Pattern - A is used for testing of earthen dams.

Three hammer points for generating seismic waves are marked in vertical line of 6 m spacing on the upstream face of the dam; Hammer Point 1 (HP1) opposite to geophone location 3, HP2 opposite to geophone location 13 and HP3 opposite to geophone location 23. Fig. 3 shows the location of three hammer points HP1, HP2 and HP3 located on the upstream face.

Figure 3 : Marking of geophones and location of Hammer points in Pattern - A for Earthen Dams

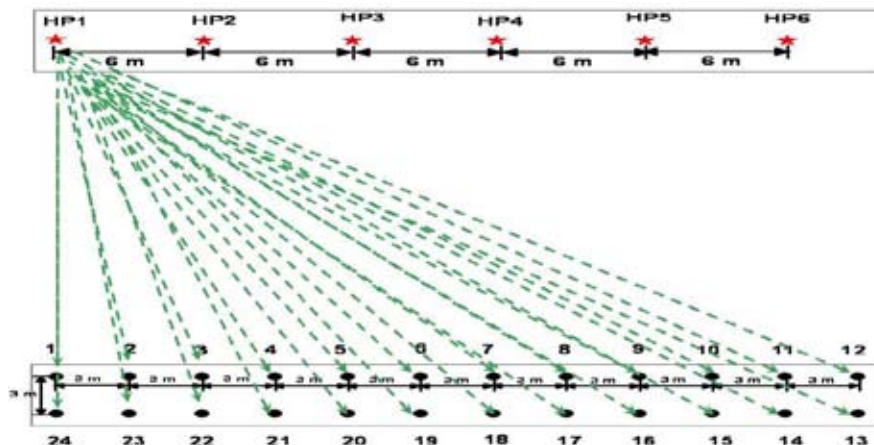
Pattern - B (12 points x 2 lines) : To cover selected portion 24 geophones are fixed in a linear type pattern on downstream side as shown in Fig. 4. First line twelve points are marked horizontally at an interval of 3 m. In second line (3 m below first line), twelve points are marked horizontally at an interval of 3 m. In this way, 12 points in 2 horizontal lines are marked and named as Pattern - B. The Locations of geophones have been marked as 1 to 24 (Fig. 4). Pattern - B is used for testing of masonry dams.

Six hammer points of 6 m spacing for generating seismic waves are marked in horizontal line on the upstream face of the dam; Hammer Point 1 (HP1) - opposite to geophone location 1, HP2 - opposite to geophone location 3, like that HP3 to HP6, opposite to geophone location 5, 7 and 11. Fig. 4 shows the photograph of six hammer points HP1 to HP6 located on the upstream face.

Figure 4 : Marking of geophones and location of Hammer points in Pattern – B for Masonry Dams

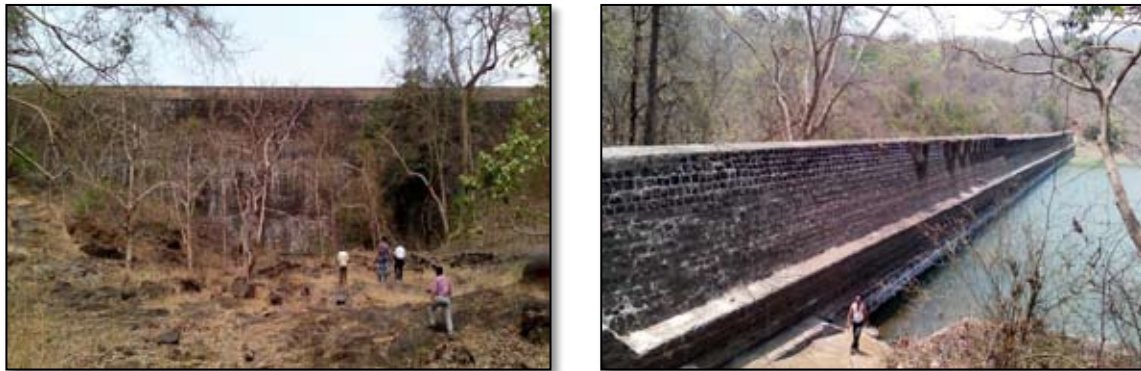
For conducting non destructive testing of masonry portion, two profiles have been made as per Pattern B shown in Fig.4. Selected locations of Tulsi dam have been marked at about 31.5 m and 51.5 m bottom and top of downstream side respectively. Fig. 5 shows its upstream and downstream side of the dam.

Figure 5 : Locations of Geophones at the downstream face and upstream face of the Tulsi dam No.1

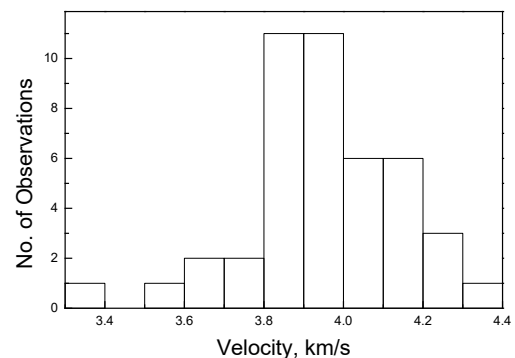
The distribution of P-wave velocities of Tulsi dam is shown in Fig. 6. It has been observed that the velocities of elastic compressional waves in the masonry dam lie in the range of 3.32 km/s to 4.31 km/s and the average P-wave velocity was 3.95 km/s which indicates the in-situ quality of material in this masonry portion to be good to very good.

Figure 6 : P-wave velocities at Tulsi dam (Masonry)

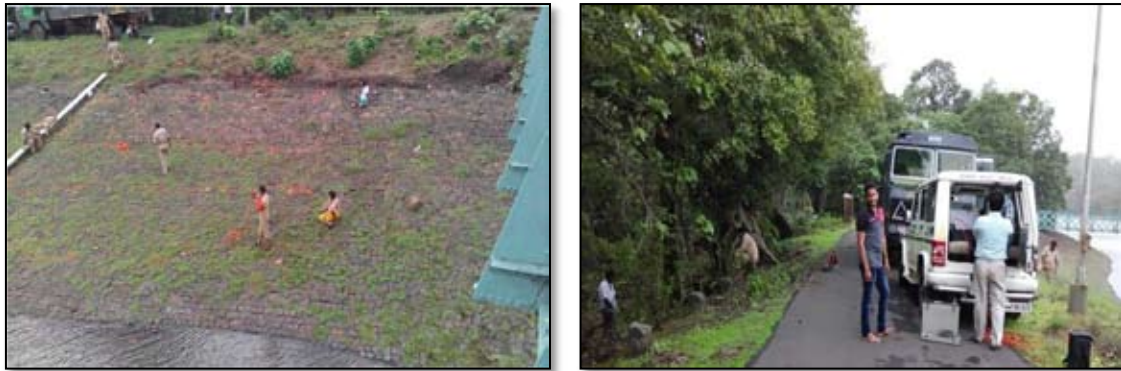
For conducting non-destructive testing of earthen portion of the dam, two profiles have been made as per Pattern A and are shown in Fig.3. Selected locations of Tulsi dam have been marked at about 23 m from left side on downstream side from intake well bridge. Fig. 7 shows its upstream and downstream side.

Figure 7 : Locations of Geophones at the downstream face and upstream face of the Tulsi dam No.2

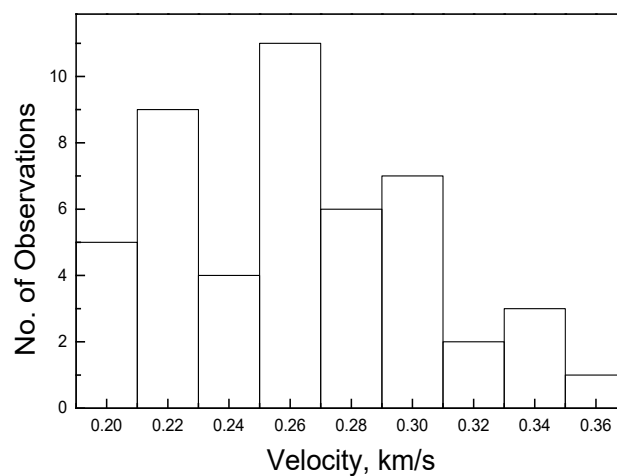
The distribution of P-wave velocities of Tulsi dam is shown in Fig. 8. It has been observed that the velocities of elastic compressional waves in the earthen dam lie in the range of 0.2 km/s to 0.36 km/s and the average P-wave velocity was 0.27 km/s which indicates in-situ quality of material in this earthen portion to be good to very good.

Figure 8 : P-wave velocities at earthen portion of Tulsi dam

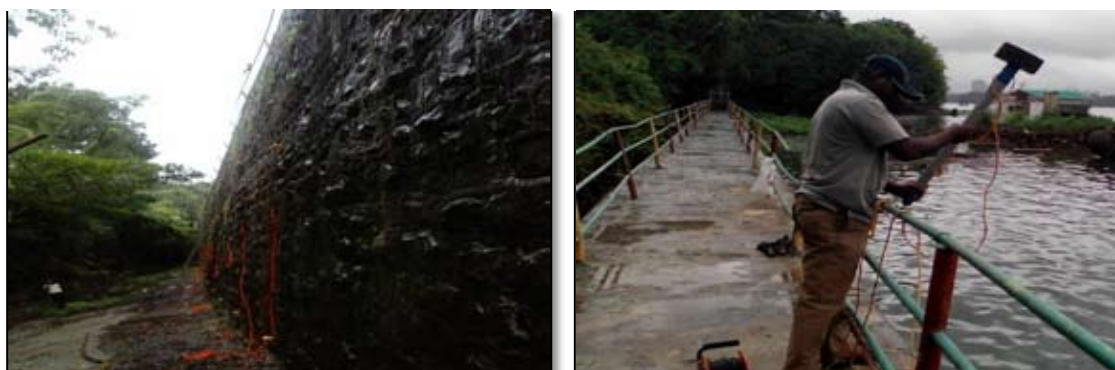
Powai Dam is the one of the oldest masonry Dam in Maharashtra, India, commissioned in 1890 located at Latitude of 19° 5' N – 19° 10' N and Longitude of 72° 50'E – 72° 55'E. It's catchment area is about 6.61 sq.km. with total length of 191.80 m, top width of 1.98 m and maximum height of 9.14 m. Powai dam is mainly used for irrigation and water supply of Mumbai city. Due to ageing, distresses have been observed in the dam body in the form of seepage and leaching of material from masonry portion necessitating repair and rehabilitation measures. Accordingly, Project Authority decided to carry out the NDT tests in order to assess the in-situ quality the dam masonry. Non-destructive testing for the masonry sections of the dam has been carried out by CWPRS, Pune to assess the in-situ quality of the dam masonry. For conducting studies, one profile has been made as per Pattern B shown in Fig.4. Selected locations of Powai dam Profile 1 (12 Geophones in 2 lines) have been marked at about 7 m from intake well at bottom of downstream side. Fig.9 shows its upstream & downstream side of the dam.

Figure 9 : Locations of Geophones at the downstream face and upstream face of the Powai dam

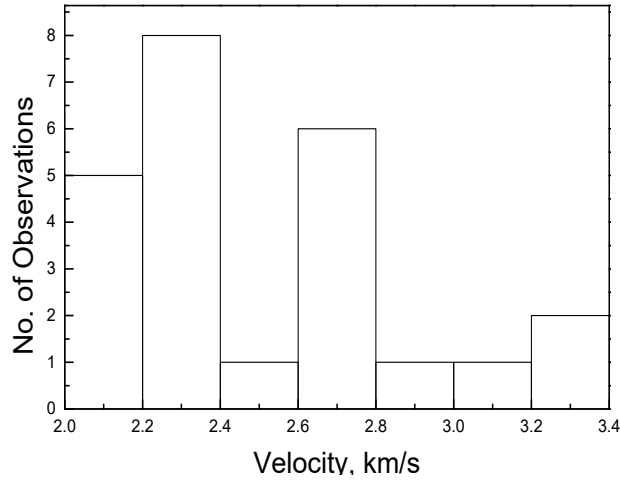
The distribution of P-wave velocities of Tulsi dam is shown in Fig. 10. It has been observed that the velocities of elastic compressional waves in the masonry dam lie in the range of 2 km/s to 3.4 km/s and the average P-wave velocity was 2.5 km/s which indicates the in-situ quality of material in this masonry portion to be good to very good.

Figure 10 : Distribution of P-wave velocities at Powai dam

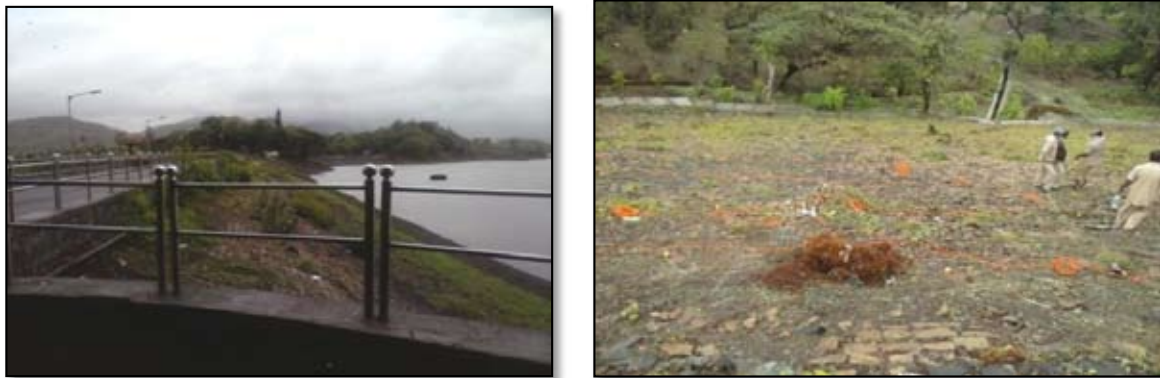
Vihar Dam is the one of the oldest earthen Dam in Maharashtra, India commissioned in 1859 and located at Latitude of 19° 5’N – 19° 10’N and Longitude of 72° 50’E – 73° E. It’s catchment area is about 18.96 sq.km. with total length of 711.20 m, top width of a)7.31 m, b)6.09 m, c) 6.09 m and maximum height of a)25.60 m, b)12.80 m, c)14.90 m. Fig.11 shows its upstream & downstream side of the dam.

Figure 11 : Locations of Geophones at the downstream face, upstream face of the Vihar dam (Central Portion)

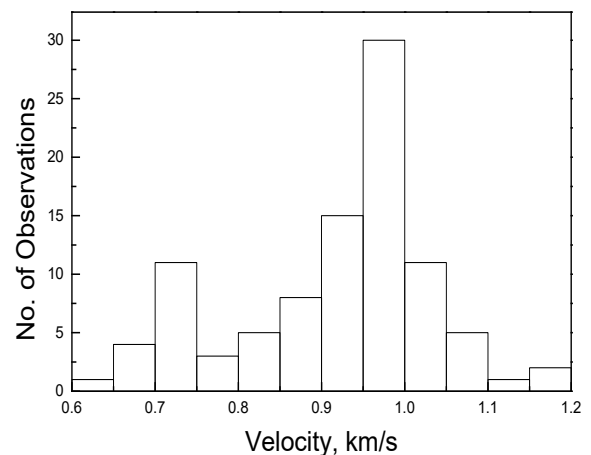
For conducting non destructive testing of main portion of the dam, four profiles have been made as per Pattern - A as shown in Fig.3. Selected locations of Vihar dam have been marked on downstream side, at 85 m from left side of the dam, profile 2 marked to the right side of profile 1, profile 3 marked below profile 1 and profile 4 marked below profile 2. The distribution of P-wave velocities in Vihar dam (Main Dam) is shown in Fig. 12. It has been observed that the velocities of elastic compressional waves in the earthen portion of the dam is in the range of 0.64 km/s to 1.17 km/s and the average P-wave velocity has been observed to be 0.92 km/s which indicates the in-situ quality of material in the earthen portion to be good to very good.

Figure 12 : P-wave velocities at Vihar dam Central Portion

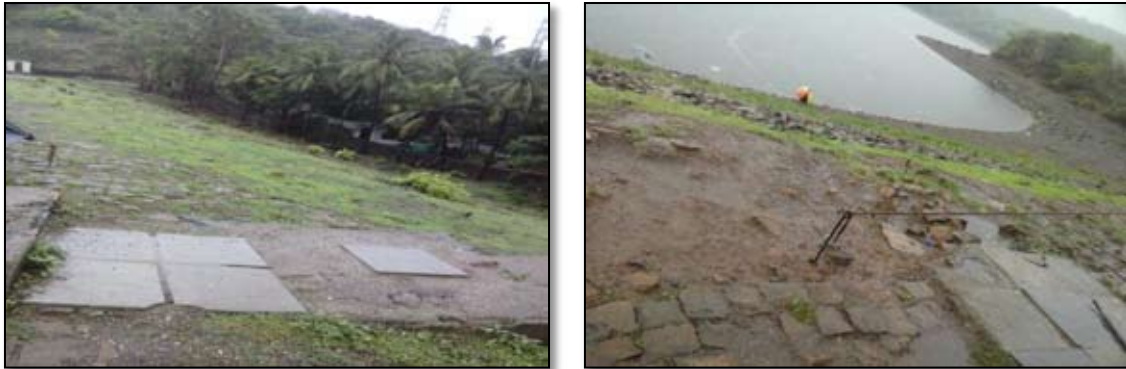
For conducting non-destructive testing of earthen portion near to Durgah, two profiles have been made as per Pattern A shown in Fig.3 at selected locations of Vihar dam No. 2. Profile 1 and 2 (12 m x 12 m) have been marked about 78 m from left side on downstream side. Fig.13 shows its upstream & downstream side of the dam.

Figure 13 : Locations of Geophones at the downstream and upstream faces of the Vihar dam near Durgah

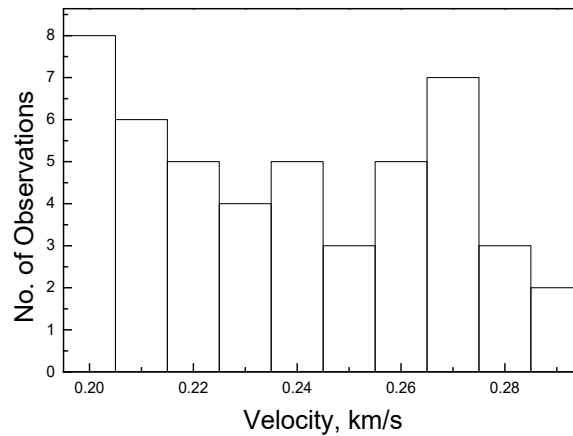
The distribution of P-wave velocities of Vihar dam is shown in Fig. 14. It has been observed that the velocities of elastic compressional waves in the earthen dam, lie in the range of 0.2 km/s to 0.29 km/s and the average P-wave velocity has been observed to be 0.24 km/s which indicates in-situ quality of material in earthen dam to be good to very good.

Figure 14 : P-wave velocities at Vihar dam near Durgah

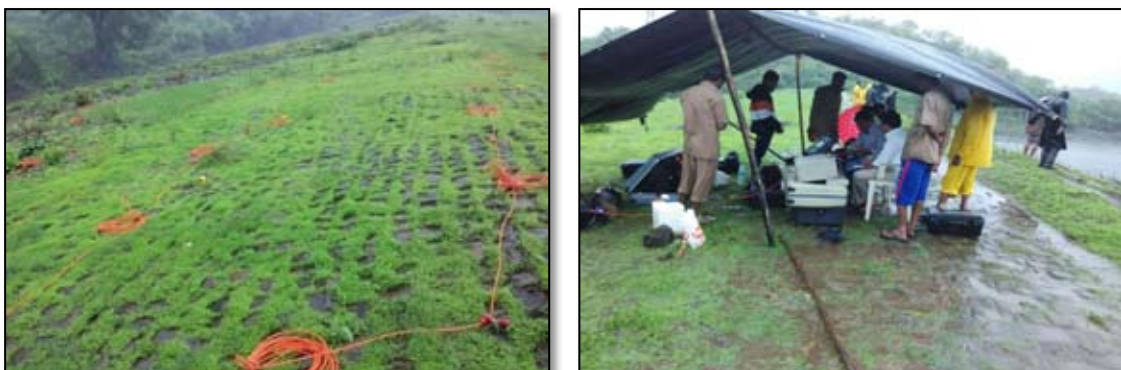
For conducting non-destructive testing of earthen portion near to pumping station, two profiles have been made as per Pattern A as shown in Fig.3. Selected locations of Vihar dam profile 1 and 2 (12 m x 12 m) have been marked at about 66 m from board side located at left and right side of steps on downstream side respectively. Fig.15 shows its upstream & downstream side of the dam.

Figure 15 : Locations of Geophones at the downstream face, upstream face of the Vihar dam near Durgah

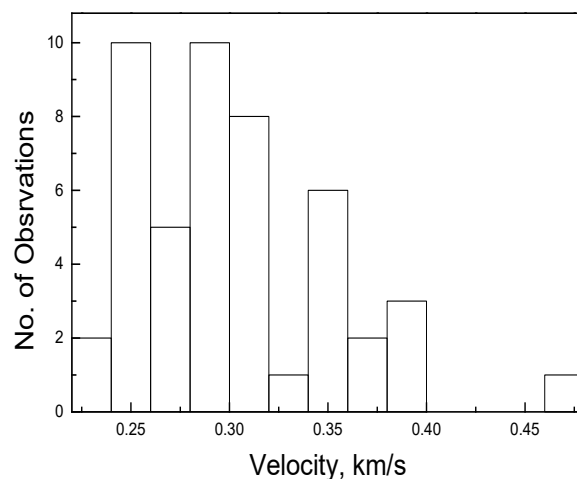
The distribution of P-wave velocities of Vihar dam is shown in Fig. 16. It has been observed that the velocities of elastic compressional waves in the earthen dam near Durgah lie in the range of 0.23 km/s to 0.47 km/s and the average P-wave velocity has been observed to be 0.31 km/s which indicates in-situ quality of material in this earthen portion to be good to very good.

Figure 16 : P-wave velocities at Vihar dam near Durgah
