SAFETY ASPECTS OF ROCKFILL DAM IN NARROW VALLEY WITH SEISMIC FAULTS IN THE FOUNDATION

M. WIELAND

Poyry Switzerland Ltd., Zurich, Switzerland

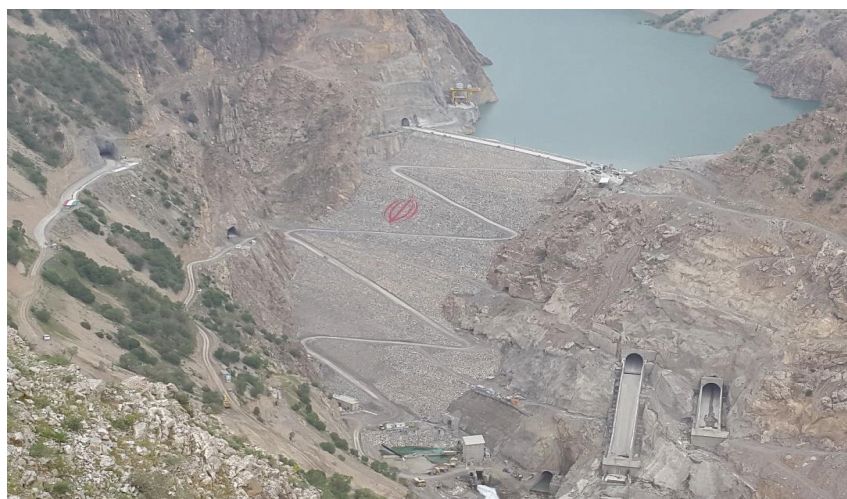
Figure 1 : Downstream view of Rudbar Lorestan ECRD and the two tunnel spillways on the left abutment.

The hydropower project has an installed capacity of 450 MW and provides peaking power to the Iranian National Power System. The powerhouse comprises two 225 MW Francis turbines with vertical axes. The ungated spillway consists of two tunnels each with 11 m diameter, length of 631 m and a total discharge capacity of 3342 m³/s. The dam has two bottom outlets which were used for river diversion during construction and for controlling the rate of reservoir filling during impoundment. The power intake structure is situated at the right bank close to dam body. The head of the plant is 430 m. The pressure system consists of two parallel steel penstocks and two penstock tunnels. The dam with the two tunnel spillways on the left bank is shown in Fig. 1.

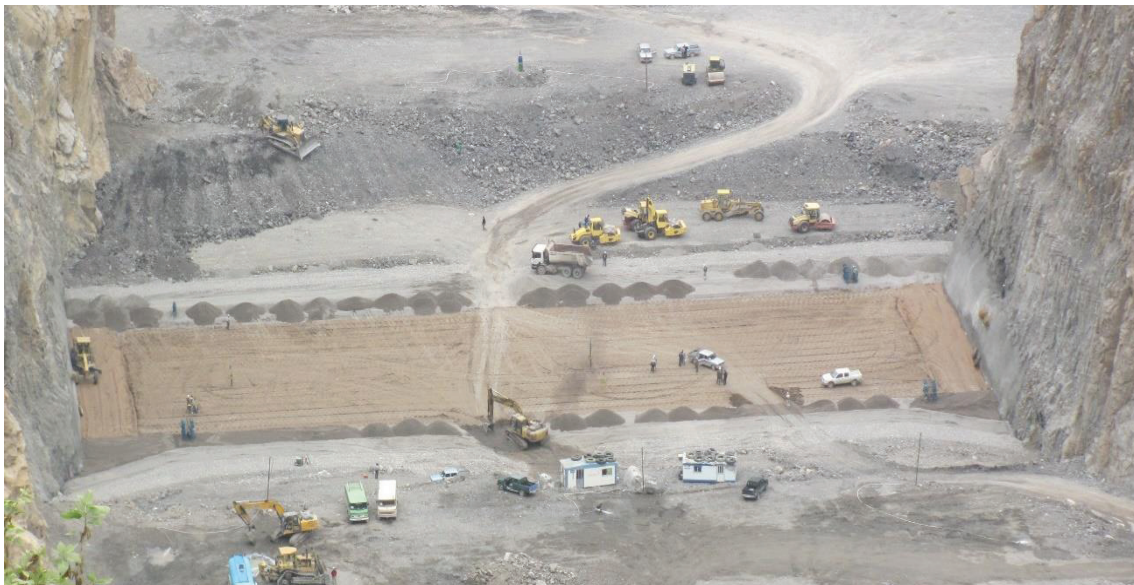
Figure 2 : View of core, 5 m wide plastic contact clay zone at the abutments, 5 m thick fine sand filter widened to 10 m at the downstream contact with the abutment, 5m thick coarse sand filter, 5 m thick transition zone, and rockfill (view from downstream).

In the dam body design, besides the clay core, a fine sand and coarse sand filter and transition zone, all of them 5 m thick, were provided to eliminate the risk of internal erosion, and to cope with possible foundation movements and seismic slope movements. In order to reduce the risk of seepage erosion along the steep core-abutment contact the width of the downstream fine sand filters in contact with the abutments was increased to 10 m (Fig. 2).

Because large differential settlement near the abutments may result in transversal cracking within the embankment, a 5 m wide plastic clay zone at the interface with the rock abutment is provided. This would minimize the seepage and erosion hazard along the abutments, minimize arching effects in the core, and increase compressive stresses in the core. The contact clay, which was compacted with special equipment, had a water content of 1-2 percent above the optimum water content.

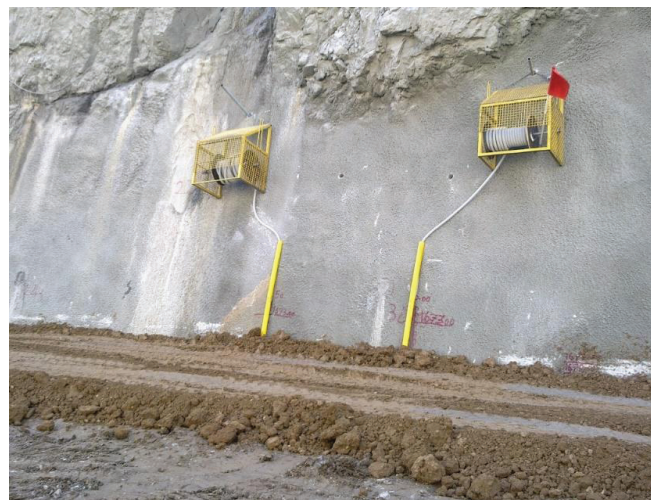
Figure 4 : View of 5 m wide plastic contact clay zone at the abutment, treatment of rock surface in the core and filter zones by shotcrete and slip measuring devices (TDR) installed on abutment.

In the case of Rudbar Lorestan dam, located in a narrow gorge with steep abutments, monitoring of the displacements of the clay core in the contact with abutments is important. For that purpose, time-domain reflectometers (TDR) installed on both abutments (Fig. 4). A TDR is a relative slip gauge measuring device.

Time domain reflectometry is based on the transmission of an electric pulse as a waveform within a medium and watching for reflection of this transmission. As the ground displaces, the installed cable is sheared or displaced. This causes a change in the material property of the cable. This change in property is detectable and allows us to locate the actual location of displacement. If the cable is deformed and altered due to displacement of the contact clay in the vicinity of abutment, then the characteristic impedance is altered and a transmitted pulse will be reflected showing the location of deformation.

The TDRs recorded the location where deformations took place in the contact clay zone near the abutments; however, they do not provide the value of the deformation. This can be obtained, for example, by extensometers. Rudbar Lorestan is the first dam in Iran where these instruments were used. The sensors are not in use anymore.

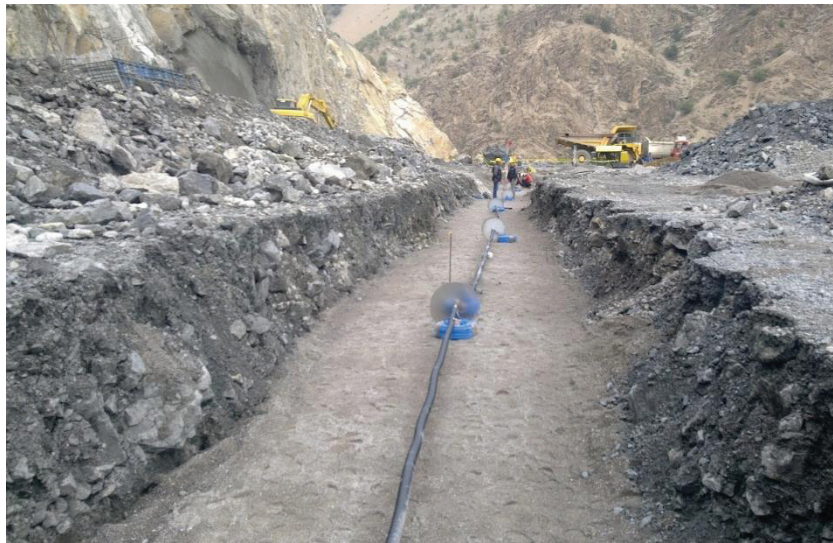
Figure 5 : Installation of horizontal extensometers in dam body.

The horizontal embankment extensometers are used to measure horizontal deformations in large earth structures. They are incorporated in the filling material, chained together by means of extension rods. The system consists of several measuring units connected by extension rods to the anchor plates. The measuring unit is a telescopic section equipped with displacement transducer. In the Rudbar Lorestan project, extensometers were installed in the rockfill shell, filters, and the clay core (Fig. 5).

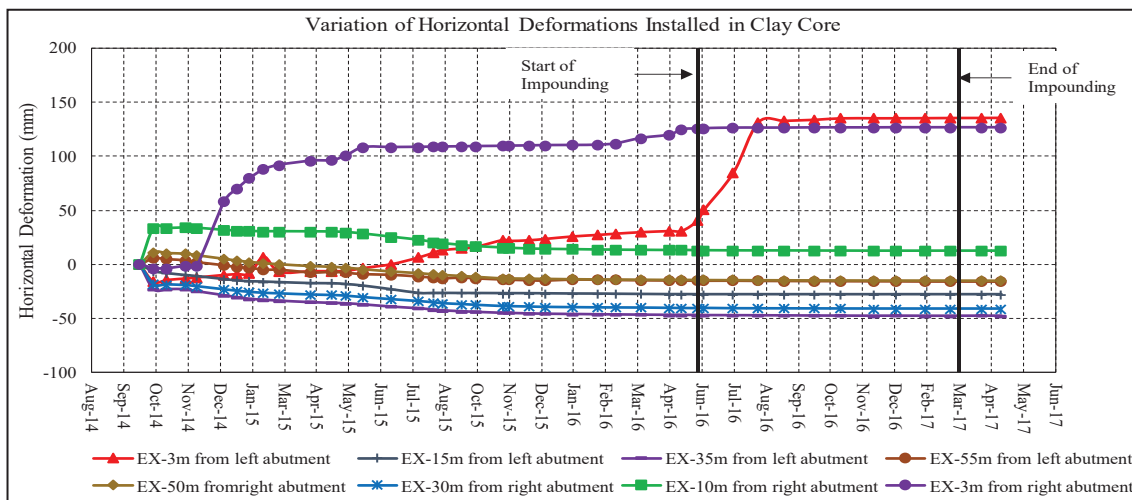
Figure 6 : Time histories of horizontal deformations recorded by extensometers in the clay core located 40 m below the dam crest.

As shown in Fig. 6, the sensors installed close to rock slope (3 m from abutment) and in the contact clay show the maximum deformations. This behavior also approved the positive performance of the contact clay composed of highly plastic material which could resist toward this deformation and decrease the arching effect on the abutments. Worth noting, most sensors shows deformation during and at the end of construction and (except one) do not show special change during impounding.

4. The horizontal extensometers installed in the contact clay in the vicinity of the abutments show maximum horizontal deformations of 130 mm, whereas the other extensometers recorded maximum values of up to -50 mm and have not shown any remarkable deformations from the start to the end of impounding.

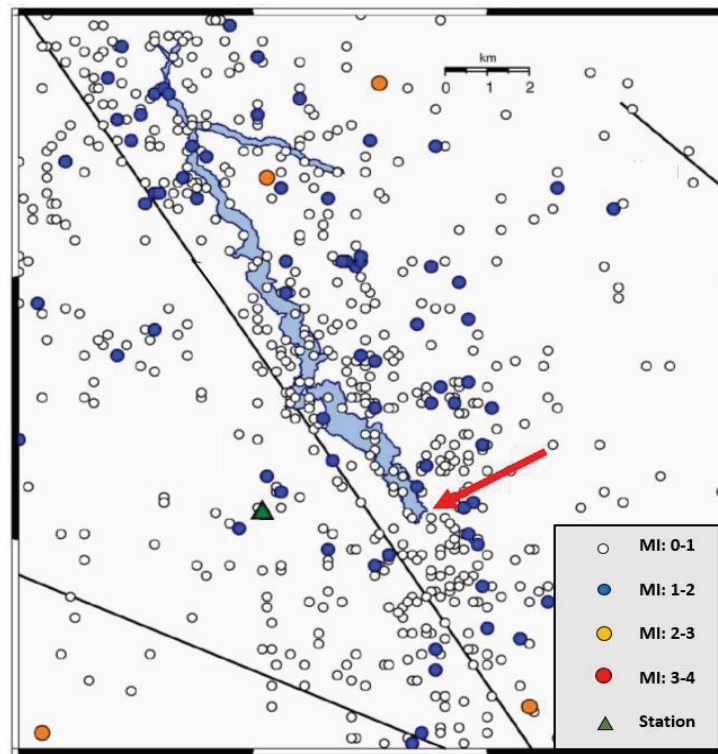
Figure 7 : Seismic events recorded from 2015-2018 by the microseismic network of Rudbar Lorestan project (the red arrow indicates the dam site, and the fault parallel to the reservoir is the Saravand-Boznavid Fault, which has an estimated upper bound magnitude of 7.5).

The microseismic network installed in 2014 consists of seven stations with velocity sensors with 24-bit resolution. The system is capable of recording and localizing seismic events with magnitudes down to zero. In Fig. 7 the seismic events recorded in the project area from 2015-2018 are shown together with the Saravand-Boznavid fault. The great majority of local events had magnitudes of less than 1, which cannot be felt by people. There are four events with magnitudes in the range of 2 to 3. There is no clear indication that these events are RTS events. However, it is recommended to continue operation of the microseismic network for some time so that the first few years of reservoir operation can also be covered. Afterwards monitoring by the national seismic network of Iran may be sufficient
