SEEPAGE CONTROL IN MASONRY GRAVITY DAMS THROUGH DAM BODY GROUTING - A CASE STUDY

R.VIGNESWARAN, RIZWAN ALI, S.J. PILLAI, SARBJEET SINGH, K. BALACHANDRAN, JAI PRAKASH MEENA AND ANKIT SAHU
Concrete Technology Division, Central Water and Power Research Station, Pune

6. CASE STUDY - DOMIHIRA DAM, MAHARASHTRA

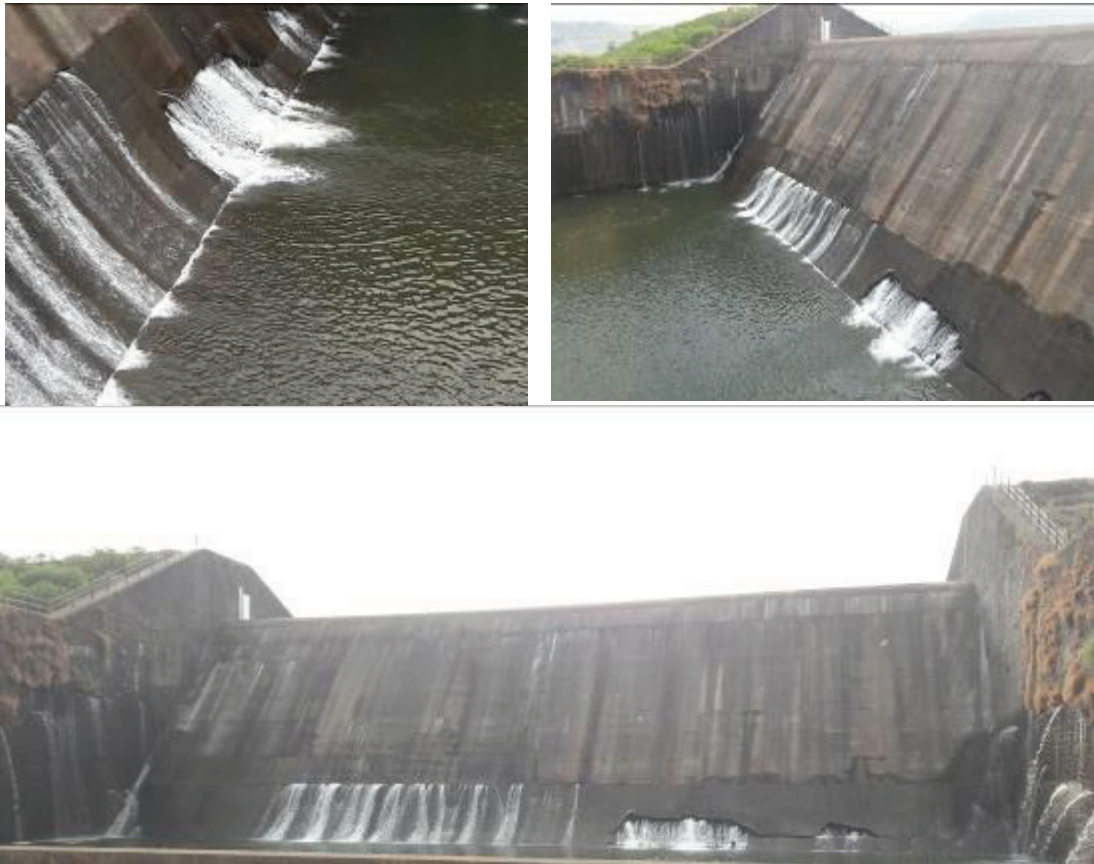
Domihira dam constructed across Domihira river, is located in Palghar district, near Thane in Maharashtra. It is a composite gravity dam with earthen portion of length 705.45 meters and masonry Non Gated Ogee Spillway of length 58 meters as shown in Figures 1, 2 & 3. The earthen portion of the dam has maximum height of 51.5 meters from the deepest foundation level and masonry spillway portion is of 20 m height along with two masonry flank walls extending from upstream to downstream of the dam. The construction work of the dam was completed in the year 2009 and full storage was impounded during the same year. Just after first impoundment of reservoir during 2010, heavy seepage has been observed at RL 352 m on spillway portion, construction joints and below RL 357 m on the right and left flank walls. Due to pressure of heavy leakage, apron concrete of glacis has damaged after every filling. To arrest seepage through foundation strata, some grouting work has been carried out in the dyke portion, but it has not been much successful in reducing seepage (Figures 4 & 5).

Fig. 1, 2 & 3 : Seepage observed through the spillway and cavities on the glacis concrete

The dam body and both the right and left flank walls have been observed to be in a very hazardous condition needing some urgent strengthening measures in order to avoid further damages and restore its structural integrity. Hence, CWPRS Scientists suggested Project Authorities to carry out cementitious grouting for spillway portion upto foundation interface from top of the dam and key wall at spacing of 3 m, from u/s side of dam body in horizontal direction and grouting of guide wall from u/s side in lateral direction on priority basis.

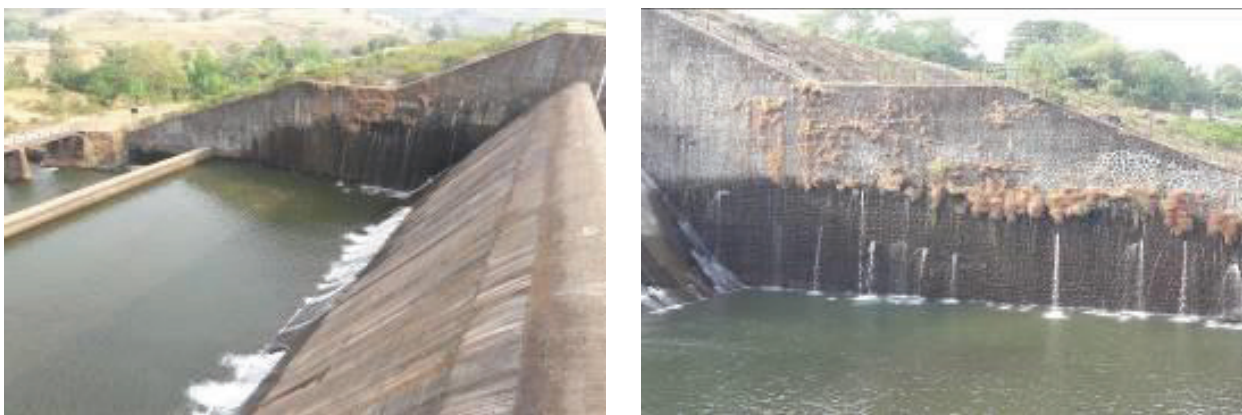
Fig. 4 & 5 : View of seepage observed in right and left flanks of Domihira dam.

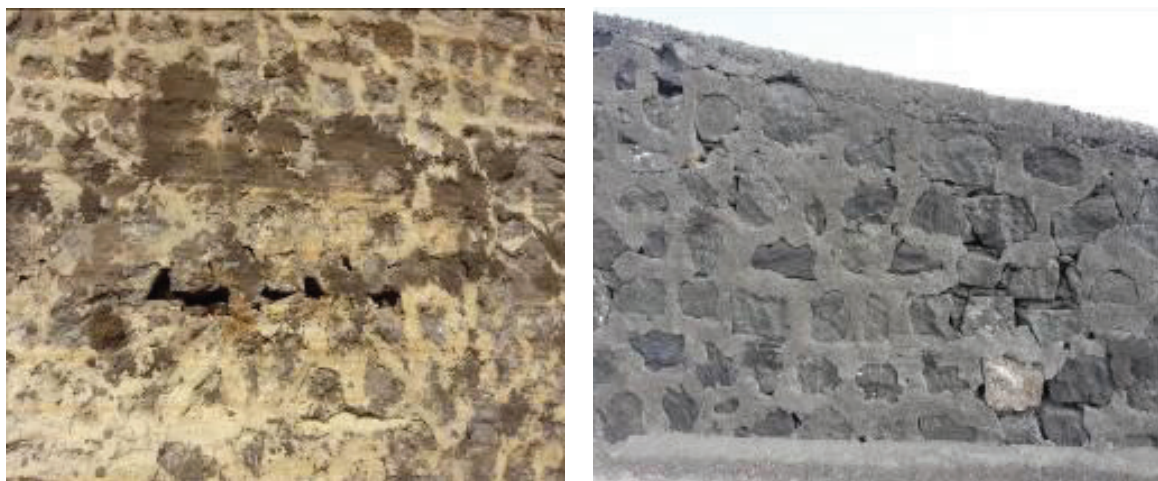
On inspection from u/s face (Figures 6 & 7) prominent cavities and loss of pointing mortar at many places on the face of the spillway portion of dam, inner and outer portions of both left and right guide walls/flanks have been observed.

Fig. 6 & 7 : U/s portion of Domihira dam showing cavities in spillway portions and flank walls

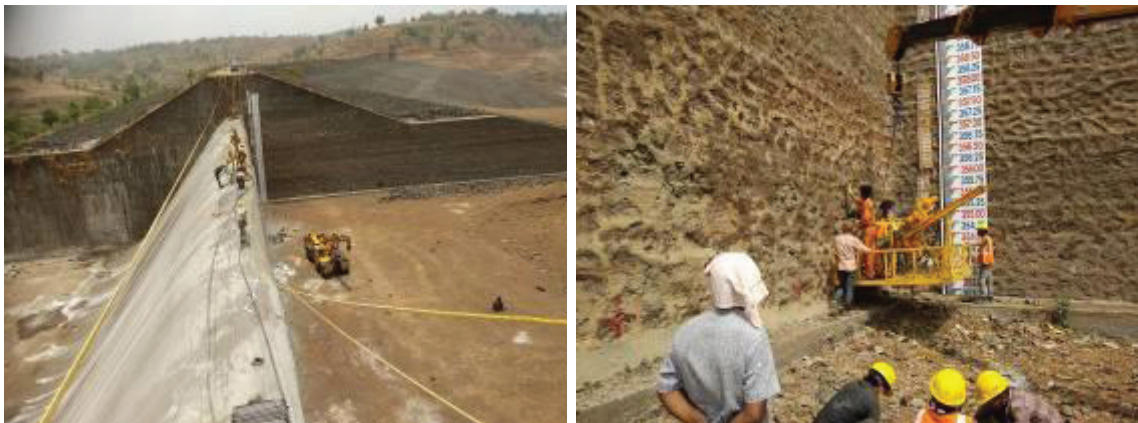
For the both flank walls, since the structure is very weak, initially the grouting shall be carried out horizontally from the upstream face up to the mid portion of the walls at a horizontal spacing of 3 m and vertical spacing of 1.5 m in a staggered manner. Once the horizontal grouting is completed the vertical grouting from the top of the walls can be carried out by adopting a spacing of 3 m c/c. Grouting and testing Process in site as shown in Figures 9, 10 & 11.

Fig. 9 & 10 : Grouting in Progress in Domihira dam

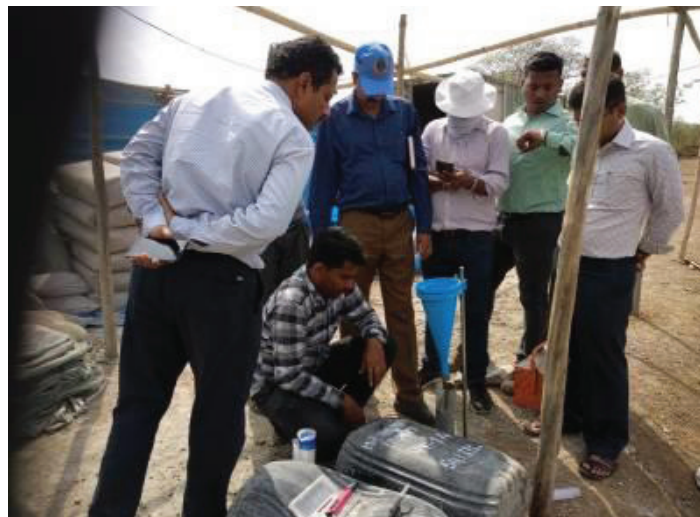
Fig. 11 : Testing of Marsh cone flow value in Domihira dam site before grouting

- Quality control of grouting should be maintained by conducting tests on site such as marsh cone test, settlement test, setting time etc.
- The sampling frequency tests for Marsh Cone, Settlement and pH value need to be followed at site as per the guidelines prescribed in USWES manual EM 1110-2-3506 and may be kept at least “Once per mix design per day on all mixers”.

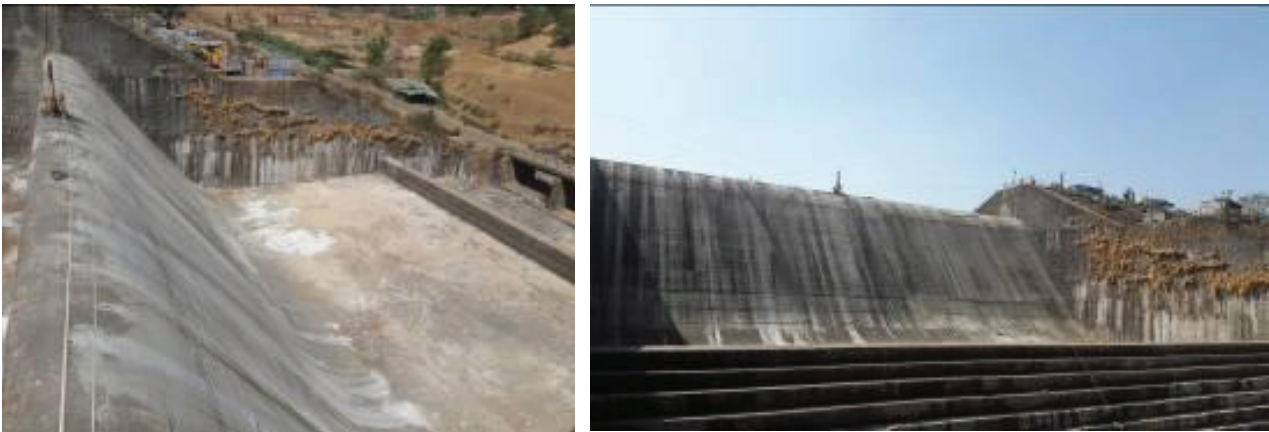
Fig. 12 & 13 : View from top and d/s of Domihira dam after Grouting

- After the completion of grouting works of spillway portion and flank walls, shotcreting of the u/s faces of both the spillway portion and flanks walls need to be carried out (Figures.12 & 13).

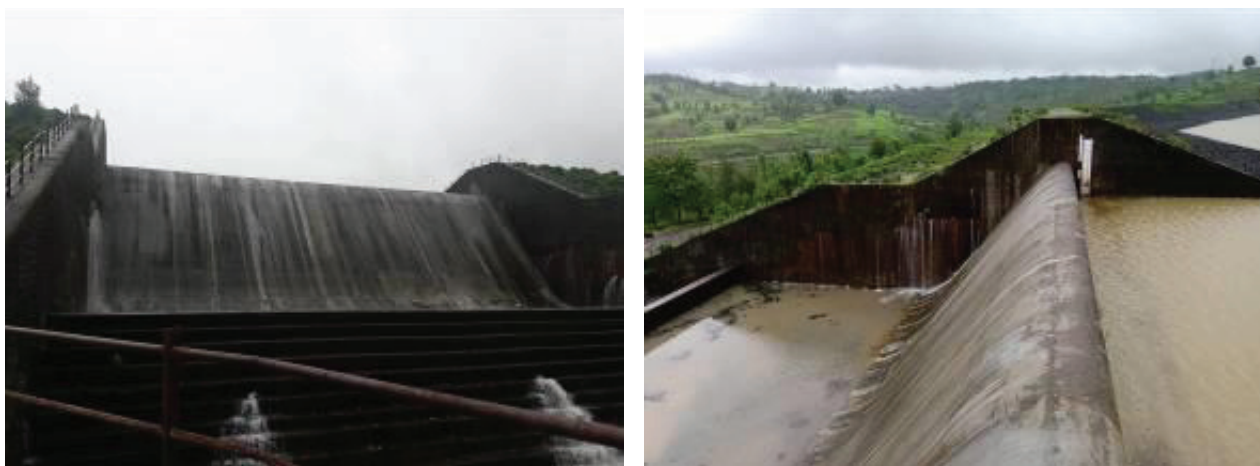
Due to grouting, the seepage/leakage through the spillway portion has been observed to be completely stopped (Figures 14 & 15). Since, the grouting and shotcreting of the flank walls is required to be carried out, seepage of water has been observed through the flank walls. The overall seepage rate has reduced from 300 lps to about 60 lps after the successful grouting of the spillway portion.

Fig. 14 & 15 : View of spillway after grouting.

The Project Authorities informed that the grouting of spillway portion, has been completed as per the recommendations of CWPRS. As reported by the Project Authorities, the grouting of the spillway portion of Domihira dam has been completed in three stages i.e. June 2018 to 05th July 2018, Jan 2019 to March 2019 & April 2019 to May 2019 and the total consumption of cement bags has been observed to be about 20,000 bags with a total grout intake of about 1532 MT. The total cement intake per Cum of dam masonry worked out to about 1.92 bags/m³ and dry grout intake of about 146 kg/ m³. Hence, mass density of dam body masonry has enhanced by more than 5% resulting in improvement of structural safety of dam.
