ICOLD Symposium on Sustainable Development of Dams and River Basins, 24th - 27th February, 2021, New Delhi

SEEPAGE CONTROL IN MASONRY DAMS WITH MODERN TECHNOLOGY USING INNOVATIVE TECHNIQUES AND EXECUTION METHODOLOGIES : CASE STUDY : THE BHAVANISAGAR DAM, TAMIL NADU, INDIA

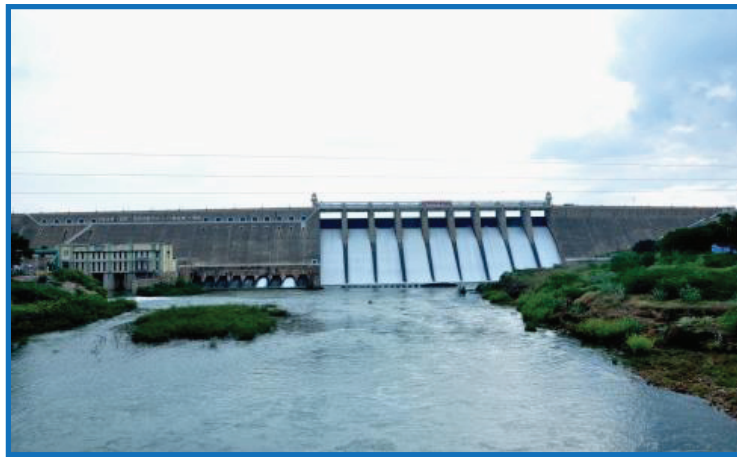
Figure 3 : Front view

The masonry dam which is located in the central portion of the dam across the river for a length of 464M and 62.18 M from the lowest foundation level consists of ogee curve spill way section of 120.70M in profile length for discharging surplus water to a depth of 6M over the spill way crest. In the masonry portion, a drainage gallery of size 1.52 x 2.13 M has been provided with three Exits, two on the left and right flanks and the third at the center portion adjacent to the guide wall separating the spillway and the river sluices. These galleries facilitate inspection inside the dam, besides enabling further maintenance. Three numbers of V notches are provided in the drainage gallery at various sill levels for

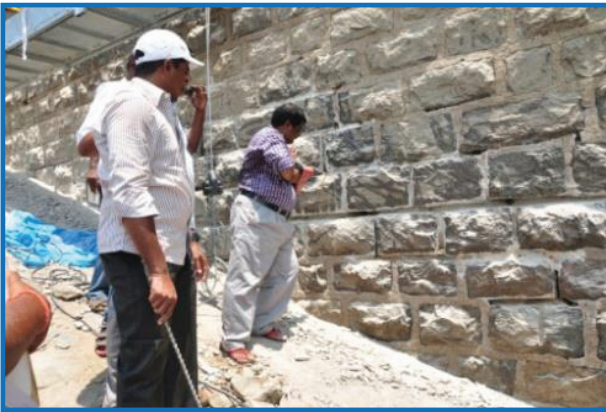
Figure 4 : Surface Preparation- During Execution

Raking out the horizontal and vertical joints of RR masonry in the upstream face of dam to remove all the loose pointing using hand grinding machine with diamond wheel (manual/ mechanical means), cleaning the raked joints with wire

brush followed by compressed air and water jets with variable pressure of 30 – 250 bars, drying the raked joints.

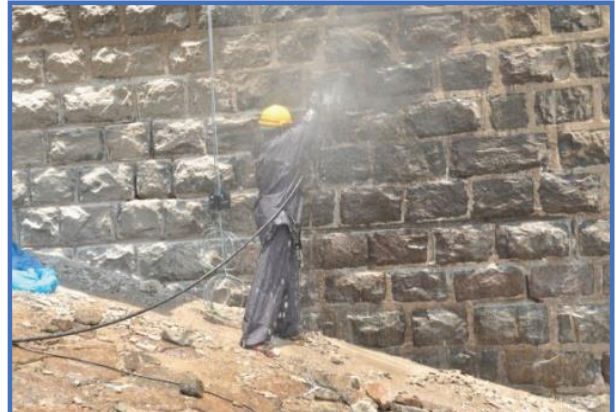
Figure 5 : Surface Preparation (Water Jet)- During Execution

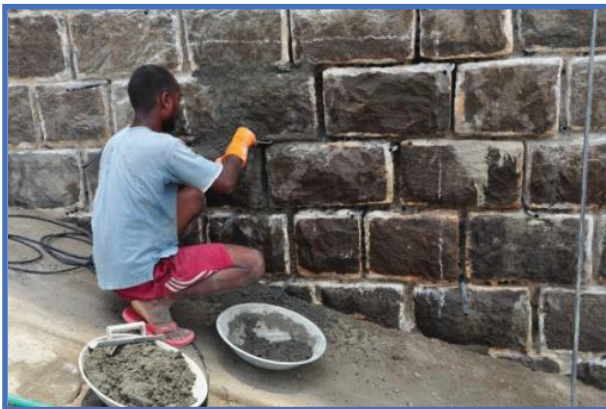
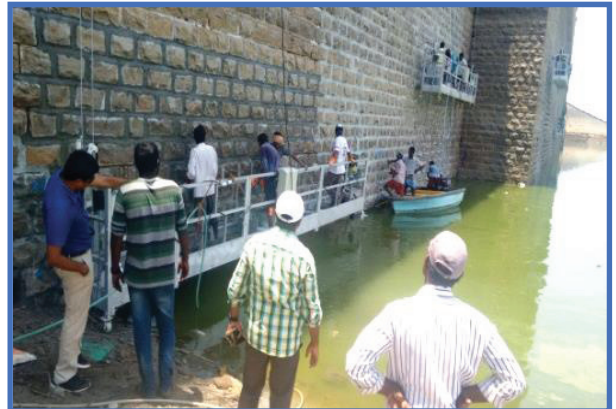
Figure 6 : Application of cavity Filling- During Execution

Providing and filling the deeper cavities of the RR masonry which are beyond 5 cm and up to 18 cm using non-shrink, cementitious micro concrete mixed with water at ratio 0.16 to fill the gaps where normal access is restricted and to achieve proper compatibility and placement without vibration. The micro concrete shall contain no-chloride admixture and provides minimum compressive strength of 40 N/mm² in 7 days & 50 N/mm² in 28 days when tested in 70.7mm

cube. The product shall have controlled expansion characteristics of 1 to 4% when tested as per ASTM C 827 – 1987.

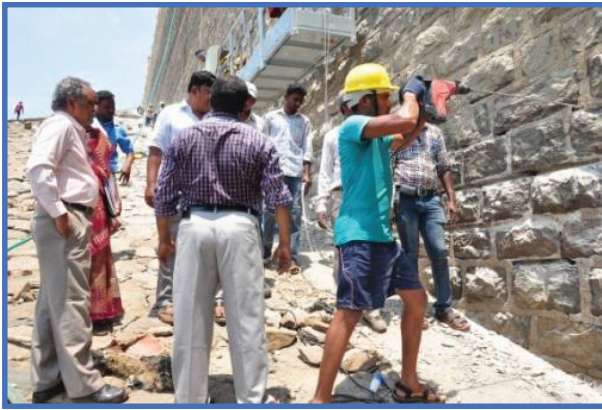
Figure 7 : Drilling Hole- During Execution

Treating the internal cavities up to 1 metre deep in the RR masonry using injection pressure grouting by drilling hole of 25mm dia and 300mm deep in triangular pattern at inclined position. Fixing PVC nozzles of 12mm dia & 200mm deep using quick setting cement. Mix OPC 43 grade cement with water in ratio 0.35 - 0.4 as per the consistency required and by adding polymer rubber based latex @ 1 liter per bag of cement and plasticized expanding non shrink grout admixture @ 225 grams per bag of cement and grouting the same by using 2.812 kgf/Sq.cm (40 psi) grouting pump. The grouting

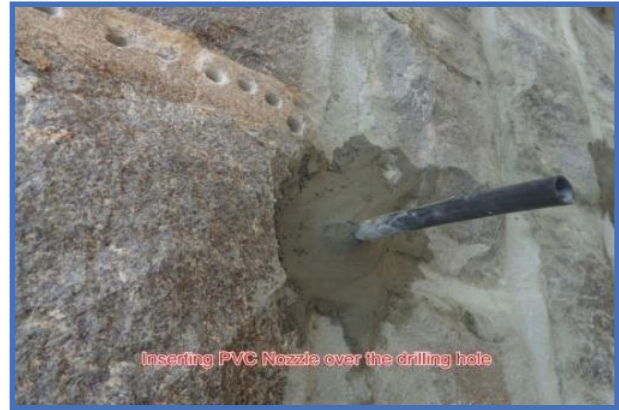
Figure 8 : PVC Nozzle Insertion- During Execution

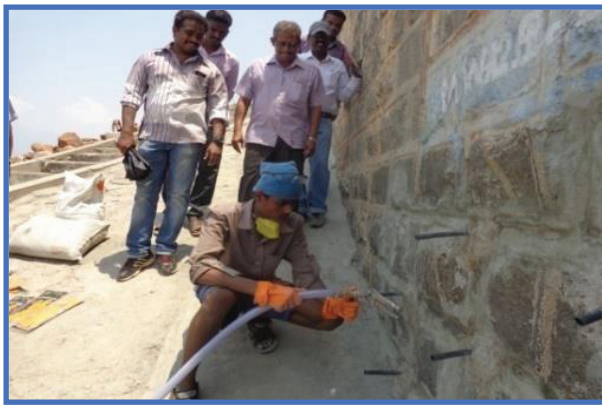
Figure 9 : Water Permeability Test- During Execution

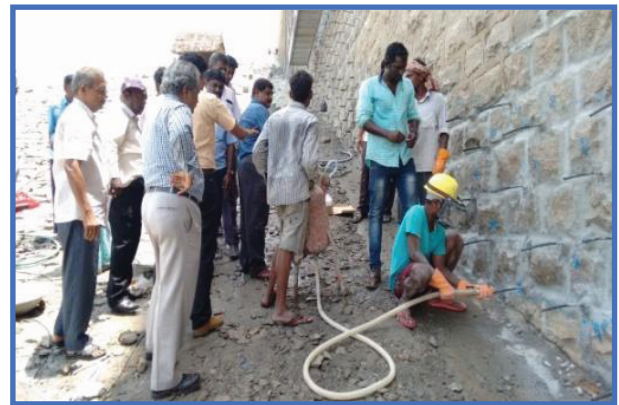
Figure 10 : Cement Grouting Test-During Execution

material shall give minimum compressive strength of 35 N/mm² in 28 days when tested in 10cm cube. On completion

of grouting, the top portion of the PVC pipe shall be cut and sealed with cement putty.

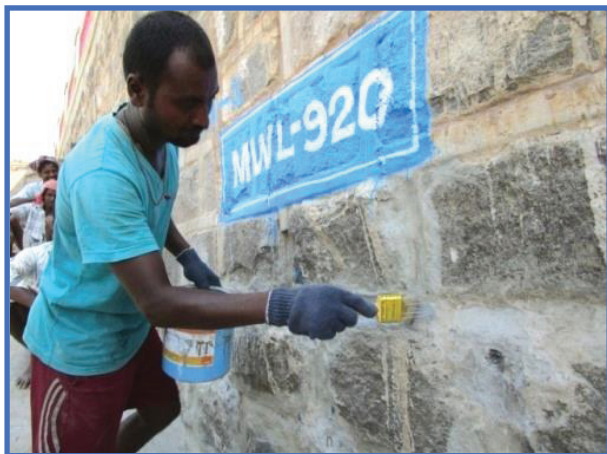
Figure 11 : Epoxy Pointing Coat- During Execution

Providing and filling the pointing mortar in the horizontal and vertical joints of RR masonry in the upstream face of Dam to an average depth of 2 times the thickness of joint, (25mm thick and 50mm depth) by applying a priming coat with solvent free epoxy bonding agent inside the joints with a brush and filling properly these joints with “shrinkage controlled non shrink, abrasion resistant, UV resistant, polymer modified cementitious high specification repair mortar system” mixed with water in the ratio of 0.16, which should prove fully adequate and will give compressive strength of minimum 45 N/mm² in 7 days & 70 N/mm² in 28 days; tensile strength of minimum 4 N/mm² in 28 days; flexural strength of minimum 9 N/mm² in 28 days, permeability less than 5mm, Water Absorption less than 2%, Rapid Chloride

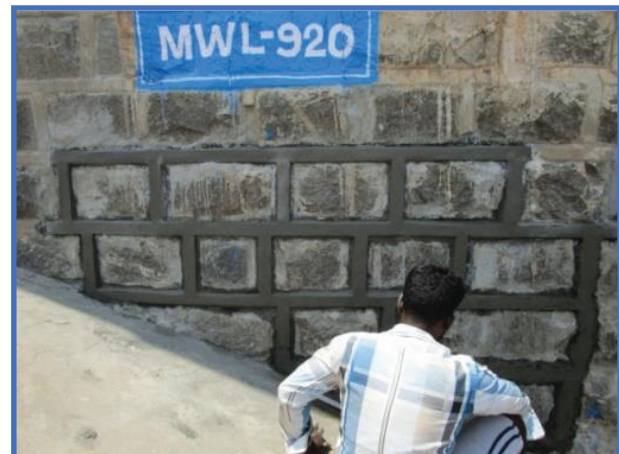
Figure 12 : Application of Pointing Mortar- During Execution

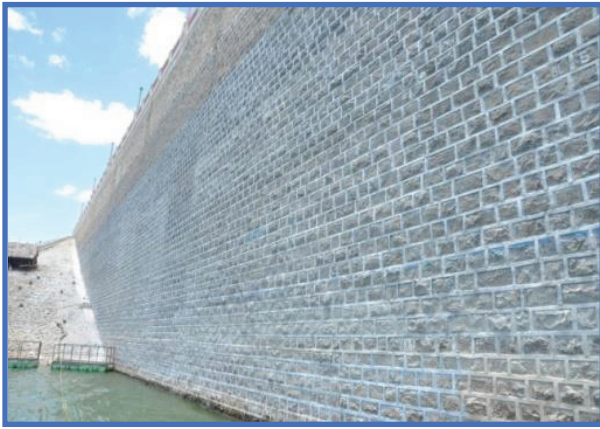
Figure 13 : Application of Pointing Mortar - After Execution

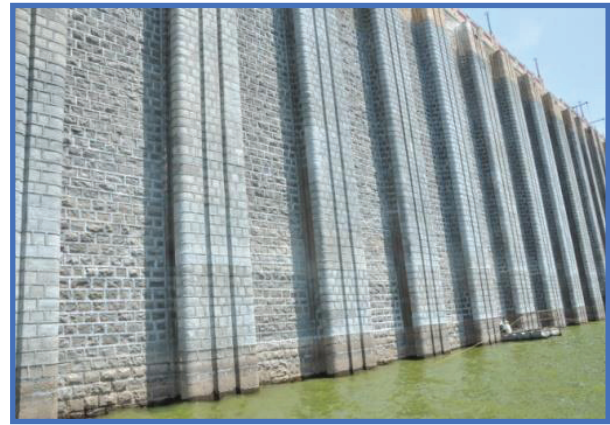
Figure 14 : Application of Pointing Mortar - After Execution

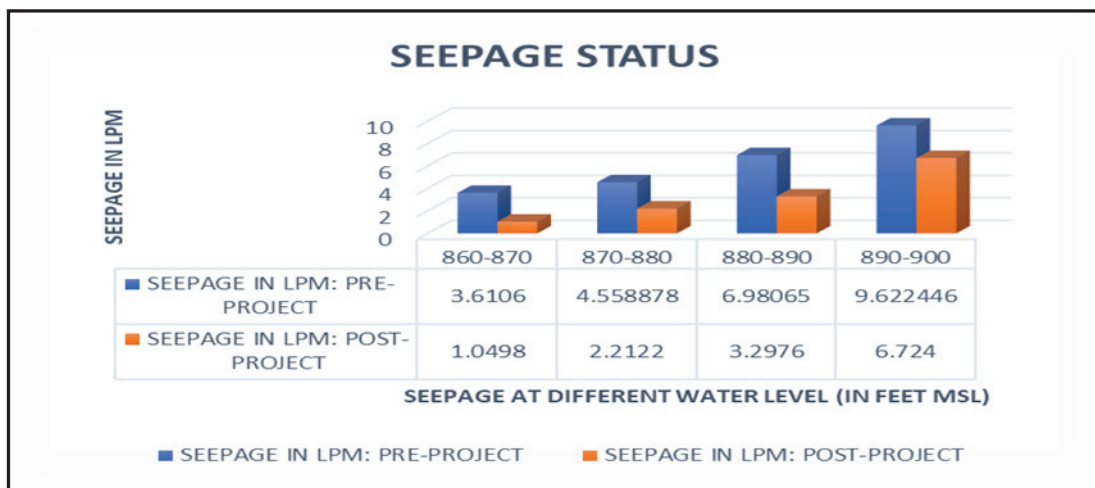
in seepage control in the masonry segment of the dam structure, to a tune of 30% – 71% reduction of seepage at different storage levels.

Graph : Seepage Status before & after Rehabilitation

The embedded modern technology using innovative techniques and execution methodologies has proved its successfulness
