ICOLD Symposium on Sustainable Development of Dams and River Basins, 24th - 27th February, 2021, New Delhi

THE REHABILITATION OF LEVEES WITH LARGE TREES BY EQUIVALENT STATIC SYSTEMS

R. HASELSTEINER AND D. KERRES

Bjoernsen Consulting Engineers, Koblenz, Germany

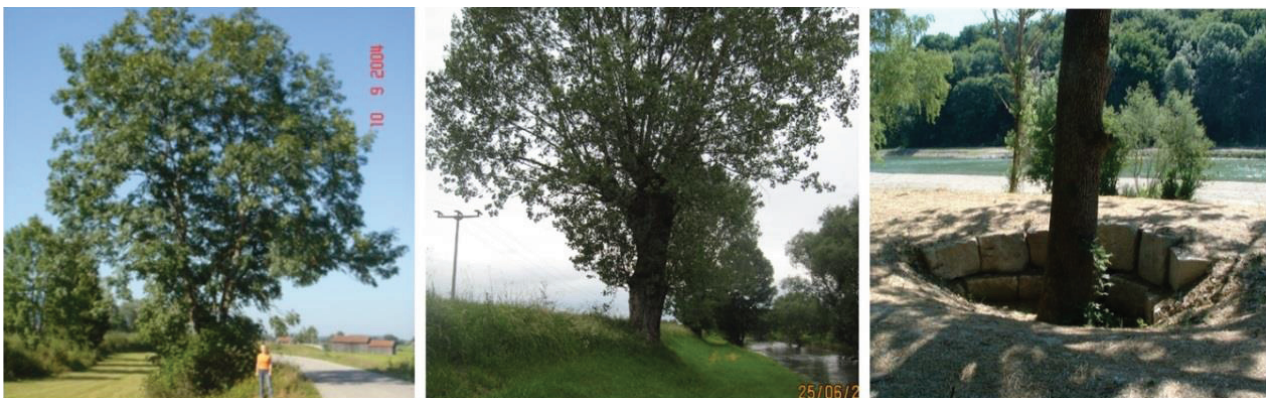
Figure 6 : Single large trees on and close to levees at the River Loisach (Bavaria) (left), the River Gera (Thu-ringia) (middle) and the River Isar (Bavaria) (right) (taken from Haselsteiner, 2019).

Many examples of similar conditions are available throughout Germany (see Figure 6 and Figure 7). During storm events many tree failures are documented which have torn huge crater into the dike body (Figure 8). The simultaneous appearance of wind storms and flood events is unlikely to occur but cannot be excluded. In Germany beginning of the year 2018 medium floods occurred on the Rhine River and its tributaries which were accompanied by a major storm event which stroke large parts of France and West Germany.

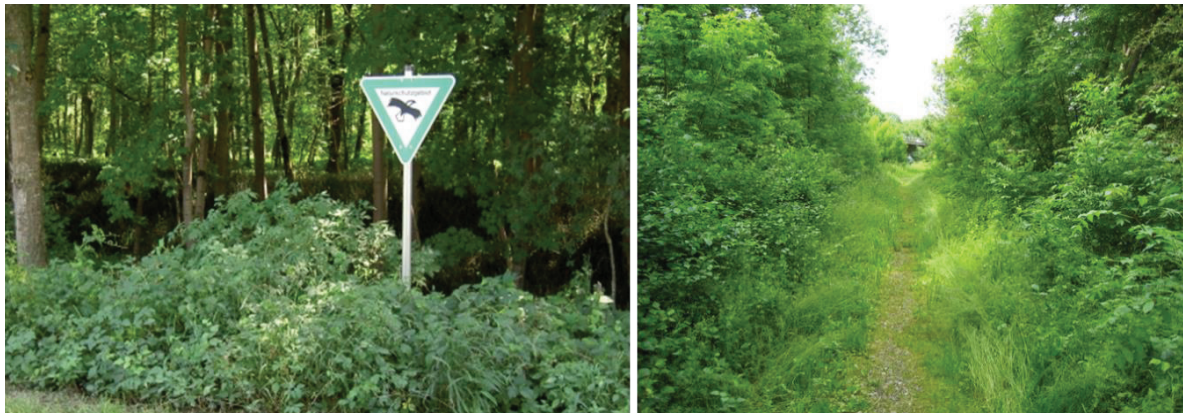
Figure 7 : Forests developed around levees at the River Danube (left) and River Iler (right) in the south of Germany.

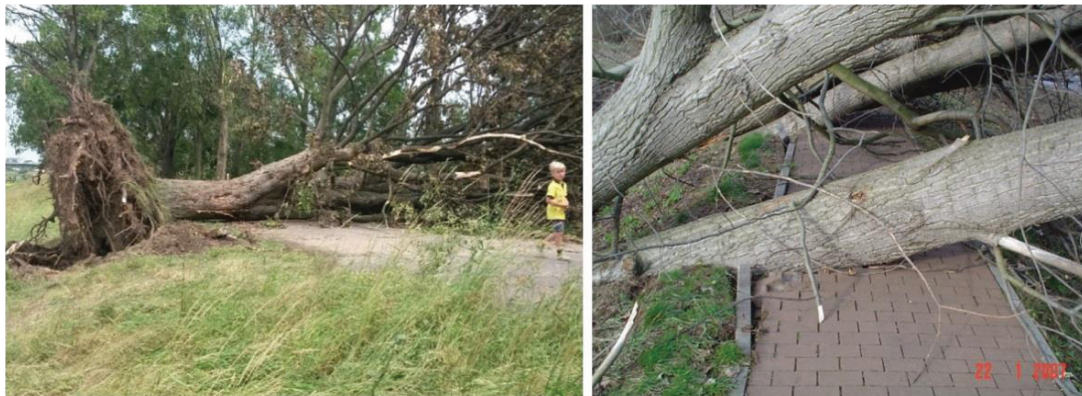
Figure 8 : Tree failures at levees as a cause of strong storm events after a storm 2014 (left) (Source: SEB Düs-seldorf) and 2007 (right) (Source: LUA Brandenburg).

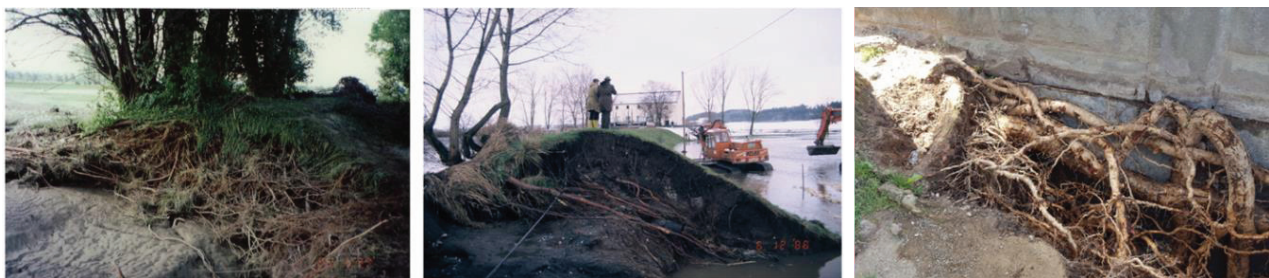
For levees not only the tree itself and a failure of it is a major risk but the effect on the seepage conditions. The roots may completely penetrate a levee body which may lead to strong seepage flow accompanied by suffusion and erosion processes which again may lead to a total levee failure. Case studies report quite abnormal root growth and development which may differ to the typical root characteristics fundamentally (see LfW BY, 1990; Winski, 2004; Haselsteiner & Strobl, 2005). Selected examples are presented in Figure 9.

Figure 9 : Rooted levees at the River Ammer (left) (Source: WWA Weilheim) and River Danube (middle) (Source: LfW BY) and excavated roots of a poplar at a flood protection wall in Düsseldorf (right)

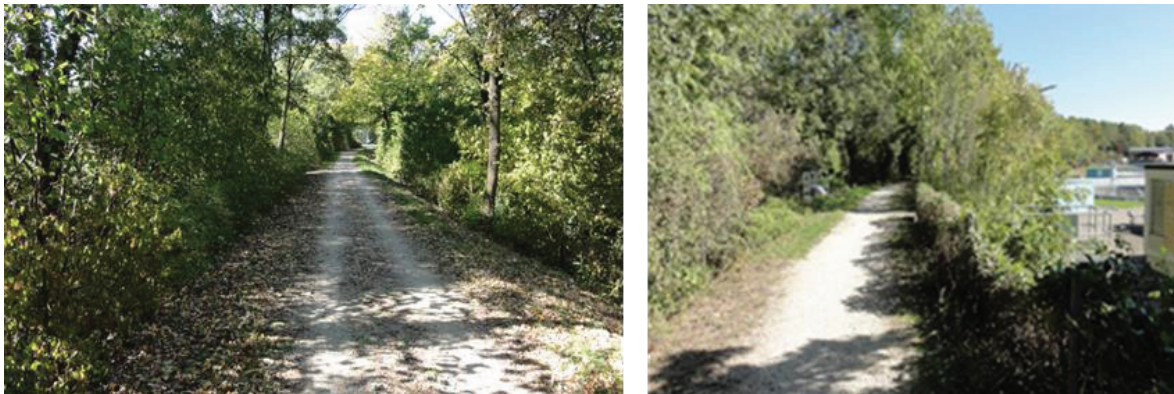
In Nuertingen at the River Neckar close to Stuttgart flood protection measures are under design. The existing levees need rehabilitation due to stability concerns, height deficits and the occurrence of large trees (Figure 13). In the Neckar valley the available areas for compensation are very limited so that the owner put a high priority on the avoidance of environmental impact. Thus, the present design includes steel sheet piles and soil mixing walls in order to conserve existing woody vegetation as much as possible. Further, the steel sheet piles shall be hydraulically pressed so that no heavy equipment is required and the levee crest need not to be widened to approximately five meters in order to enable the access for heavy machinery. For this approach the owner accepts additional costs since the levees themselves show a height of maximum three to four meters.

Figure 13 : Existing levees along the Neckar River at the city of Nuertingen with large trees on both slopes (taken from Kerres & Haselsteiner, 2018).
