ICOLD Symposium on Sustainable Development of Dams and River Basins, 24<sup>th</sup> - 27<sup>th</sup> February, 2021, New Delhi

# ASSESSMENT OF CONCRETE PROPERTIES OF BHAKRA DAM IN INDIA

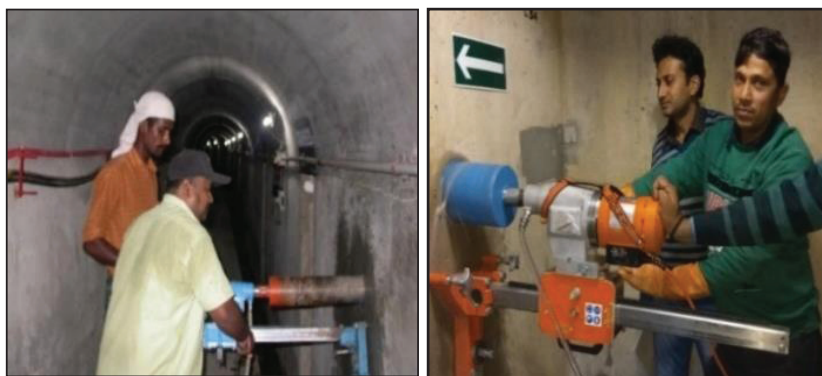
**Figure 1 :** Concrete Core Extraction in Gallery of Dam

The concrete core samples were extracted (Figure -1) from all the accessible portions of the dam covering the entire structure. Total numbers of 100 concrete core samples of 150 mm and 100 mm diameter were tested. Visual observation of all the accessible portions of four Galleries including the upstream and downstream portion of the dam was carried out at the site and the concrete core samples extracted from different locations were also observed for any abnormal reaction in concrete. During the site inspection, based on data recorded by dam authority, it was informed at the site that the upstream side of the dam face is most exposed to solar radiation during the summer period. No signs of distress in concrete was apparently visible during the site inspection. The visual inspections of concrete cores as extracted indicated dense and well-compacted concrete.

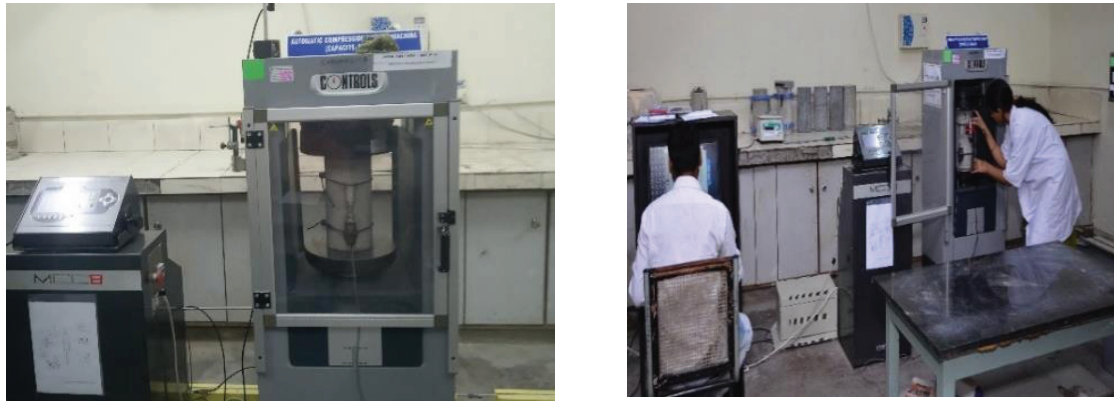
**Figure 2 :** Test setup for uni-axial compression testing of concrete in Strain Controlled Machine (3000 KN)

The equivalent cube compressive strength was determined on hardened concrete core samples of 150 mm and 100 mm diameter extracted from the dam as per IS:516. The concrete core specimens were tested in a strain-controlled compression testing machine of 3000 KN capacity (Figure 2) at room temperature of 27±2oC and relative humidity 65% or more. Two extensometers in the middle half of the height were used to get strain and two strains were averaged. Both ends of concrete cylinders were finished parallel by grinding.

The comparison of designed concrete strength for type A (3 ft. thick concrete on surroundings of galleries), B (Mass Concrete) and C (6 ft. thick concrete on upstream face) concrete used in the dam and experimentally obtained equivalent cube compressive strength under present investigation is given below in Table-1. For Concrete Type A: Poisson’s Ratio: 0.21, Modulus of Elasticity: 25265 N/mm<sup>2</sup> & Split Tensile Strength: 2.04 N/mm<sup>2</sup>. For Concrete Type B: Poisson’s Ratio: 0.20, Modulus of Elasticity: 25955 N/mm<sup>2</sup> & Split Tensile Strength: 3.39 N/mm<sup>2</sup>. For Concrete Type C: Poisson’s Ratio: 0.20, Modulus of Elasticity: 27691 N/mm<sup>2</sup> & Split Tensile Strength: 2.52 N/mm<sup>2</sup>. The coefficient of thermal expansion values for Type-A concrete vary from 9.09 X 10<sup>-6</sup> to 14.71 X 10<sup>-6</sup>, for Type-B concrete vary from 9.91 X 10<sup>-6</sup> to 14.05 X 10<sup>-6</sup> and for Type-C concrete vary from 9.21 X 10<sup>-6</sup> to 13.92 X 10<sup>-6</sup> respectively. The average coefficient of Permeability values for Type-A, Type-B, and Type-Concrete are 3.07 X 10<sup>-11</sup>, 3.10 X 10<sup>-11</sup> and 4.54 X 10<sup>-11</sup> respectively.

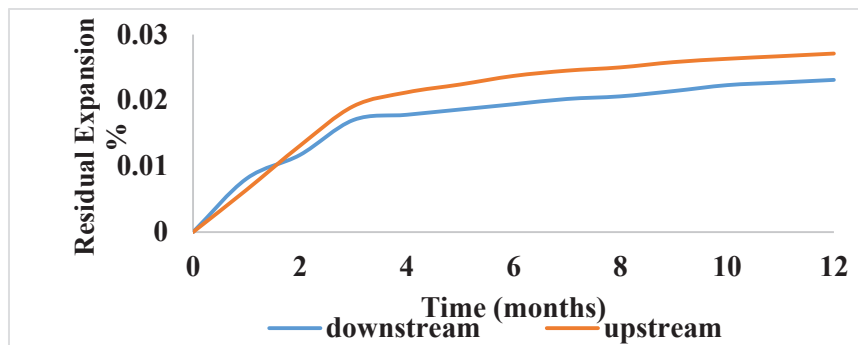
Figure 6 : Residual expansion of concrete cores by ASTM C1293 (2018) method

The 14 days results of accelerated Mortar Bar Test as per ASTM C-1260 (2014) for coarse aggregate taken from concrete cores and measured using mortar bars of 25 mm x 25 mm x 285 mm indicated that the net expansion in the coarse aggregate sample is 0.08 %. The test results of accelerated Mortar Bar Test conducted on the concrete core in similar lines to ASTM C-1260 (2014) for determining residual expansion indicated the net expansion 0.04 %. As the residual net expansion of concrete samples is less than 0.1 % the aggregates were not under potentially reactive category and there is no potential ASR in concrete. The concrete core specimens from both wet and dry portions of the dam were selected for residual expansion testing in a similar line to the procedure in ASTM C 1293 (2018) to determine the susceptibility of concrete to the alkali-silica reaction. The concrete core was tested with a deviation that temperature was changed from 38 °C to 60 °C. The change in temperature was done from 38 °C to 60 °C because it was seen in the past studies done by NCB that the slow reactive aggregate gives expansion at 60o C. The higher temperature has been also recommended in IS: 2386 Part VII and IS: 383-2016 also. The average residual expansion of concrete cores in the case of a gravity dam varied from 0.0231 to 0.0271 % (Figure-6). This average residual expansion after more than 50 years of age is not significant keeping in view that the limit is 0.04 % at the age of one year and thus, it indicates no potential of Alkali-Silica Reaction.
