ICOLD Symposium on Sustainable Development of Dams and River Basins, 24<sup>th</sup> - 27<sup>th</sup> February, 2021, New Delhi

# APPRAISAL OF SPILLWAY CAPACITY AND STORAGE AUGMENTATION FOR DAM SAFETY USING PIANO KEY WEIR AND FUSE PLUG FOR CLIMATE CHANGE EFFECTS

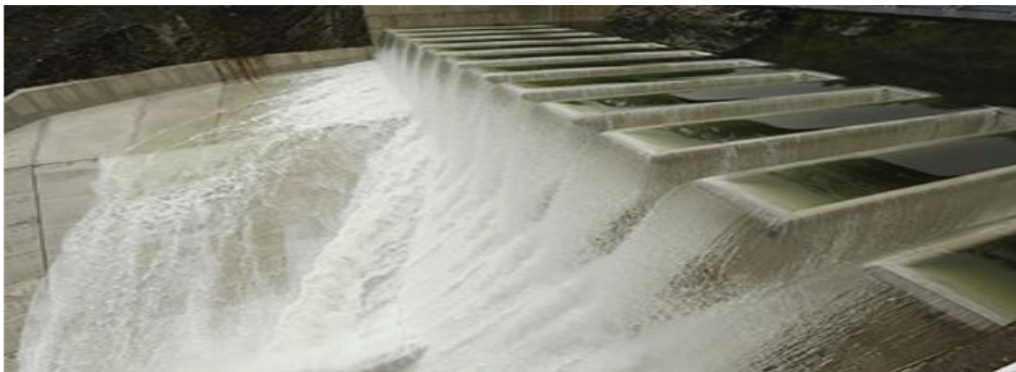
A Piano Key Weir is a kind of labyrinth hydraulic structure, in general, placed transversely to rivers that causes flow discontinuity and affects the hydraulics of rivers. The inclined bottom of these keys alleviates the transition of sediment over the structure, reducing upstream sedimentation and minimizing the morphological change impact on the regime of the alluvial river as shown in figure 1 below. Piano Key Weir is an innovative, cost effective solution to increase the active storage capacity of the reservoirs and also for improving the safety of dam in case of erratic catastrophic flood events in the backdrop of climate change uncertainties (Leite Ribeiro et al., 2012).

Figure 1 : Piano Key Weir in operation (Laugier, 2016)

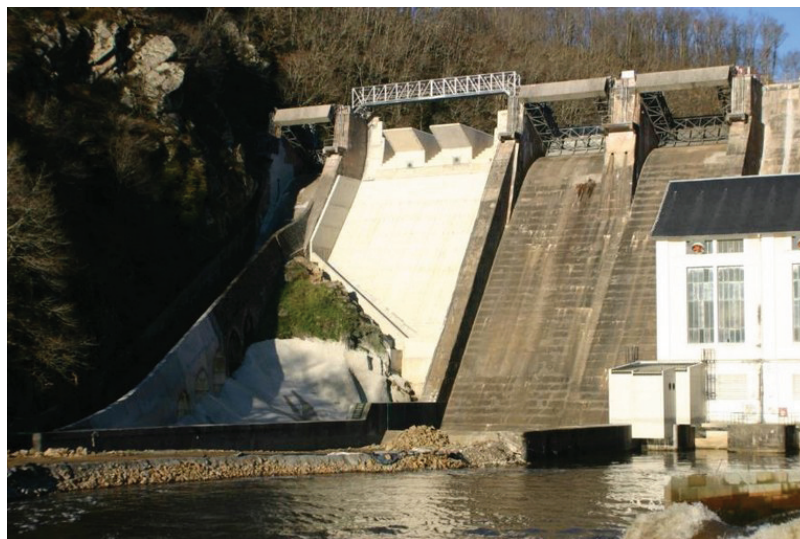
The PKW design was constrained by the available space on the dam crest as only a 20 m wide pass was affordable. The structure is cantilevered upstream and downstream equally. It is thus well self-balanced. The PKW has a capacity of 134 m<sup>3</sup>/s at 283.50 m NGF (Normal altitude in France), which corresponds to an upstream hydraulic head of 1.35 m. The total spillway capacity increased up to 757m<sup>3</sup>/s, slightly higher than the design flood. The downstream view of the dam is shown in figure.

**Figure 5 :** The PKW system at the EDF Saint-Marc dam in France (Laugier,2009)

The Saint Marc dam (Leite Ribeiro et al. , 2011) is a 40 m high concrete gravity dam with an overall crest length of 170 m. The original spillways include 3 sluices with Creager type crests: one 7.5 m wide equipped with a radial gate on the right bank and two identical 10 m wide also fit out with radial gates. Before the construction of the PKW, the maximum spillway capacity was 623 m<sup>3</sup> /s. The update of hydrological studies showed that the existing discharge capacity is smaller than the 1,000 years return period design flood (750 m<sup>3</sup> /s). In order to satisfy the required dam safety, feasibility study suggested providing an additional discharge work to the existing spillways. A technical-economical comparison of several designs was carried out, among them the Piano Key Weir (PKW) turned out to be the best solution.

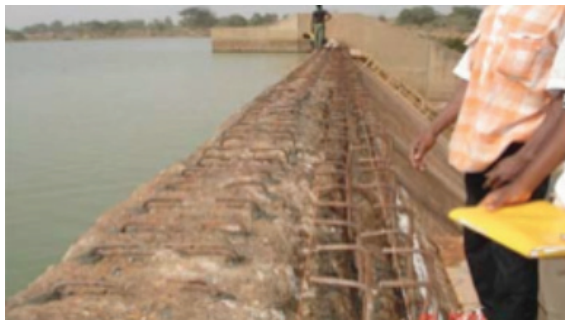
The existing free overflow spillway has a length of 70 m. the project consisted of installation of seven (07) concrete fuse plugs, 0.50 m high and with Upstream/Downstream width varying between 0.78 m to 1.03m and unit length of 9.70 m. The first block tilt for the 10-year flood and all the blocks tilt in order to keep the existing MWL for the Design Flood. The tilted blocks can be easily and quickly replaced by provisional bags before replacing the block seen in the figure below.

Figure 6 : View of the spillway crest widening operation

The Wedbila dam (Low cost technologies to improve reservoirs storage, 2013) is located in Burkina Faso. It is situated to 30 Km south from Ouagadougou, the capital city of Burkina Faso. The dam has been constructed in 1980 by the World Federation of the Evangelical Churches (FEME). It is a small earth fill dam with a storage capacity of 2 Mm<sup>3</sup> intended for the irrigation of 45 Ha of land downstream of the dam. The dam has a reservoir capacity of 2.08Mm<sup>3</sup> with the Length of the spillway as 70 m and the length of the dam is 600m and maximal height of 4 m. The technical features of fuse plugs have been obtained by design model developed by Hydrocoop France team with the collaboration of IFEC Consulting Engineers. The fuse plugs are designed to be overtopped by water nappe before tilting. The blocks placed on the same sill may have the same height but different thickness, so that they tilt progressively for different water levels. The water elevations for tilting can be predicted quite accurately since the blocks are designed with a total uplift at their base.

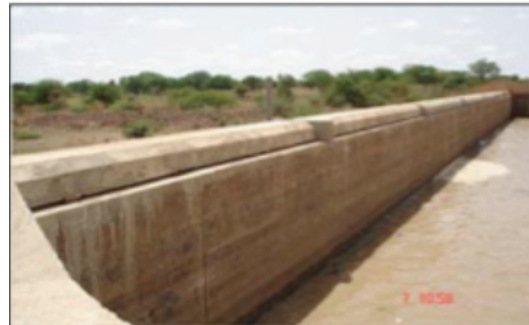
Figure 7 : View of spillway heightened by fuse plugs
