Upgrading Pikes Creek Dam Spillway with a Fusegate System^(*)

Hasan T. KOCAHAN
Project Manager, HYDROPLUS, INC.
Tampa, FL, UNITED STATES

Chad HOOVER
Project Manager, GANNETT FLEMING, INC.
Camp Hill, PA, UNITED STATES

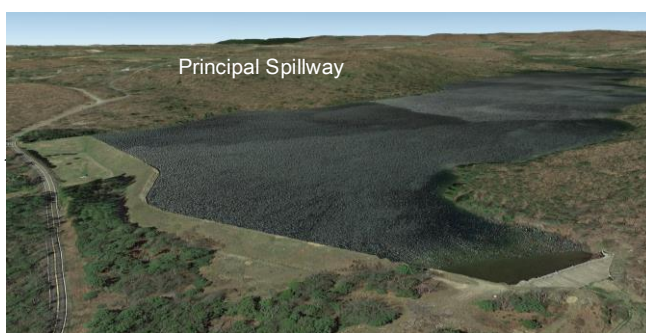
Fig. 1
View of Pikes Creek Dam before construction
French translation

The dam is a 19.8 m high and 657 m long homogenous earthfill embankment with a reinforced concrete core wall. The principal spillway is a 22 m long ogee crest located on the right abutment. The auxiliary spillway consisted of a 74 m long ogee crest equipped with 0.6 m high flashboards. The dam is as a high hazard structure (Class 1) due to the potential for economic damages and loss of life should it fail. Therefore, the design flood was established as the Probable Maximum Flood (PMF).

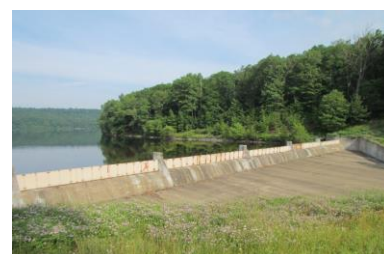
Fig. 2
View of auxiliary spillway
F..

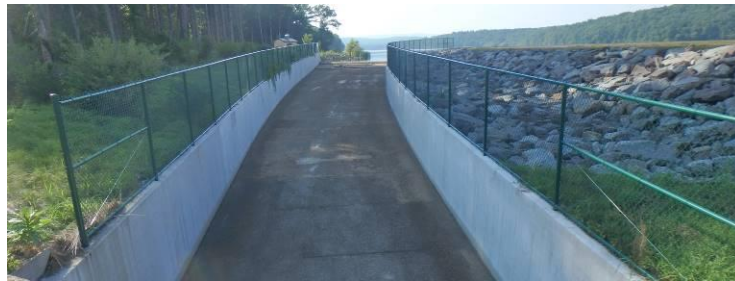
Fig. 3
Principal spillway chute and left wall berm (looking upstream)
F..

Hydraulic analyses of the principal spillway determined that the spillway chute had a discharge capacity less than the principal spillway weir. Modifications to the principal spillway included construction of a riprap-lined berm along the left chute wall to confine the flow to the chute and increase the capacity of the principal spillway. Concrete deterioration of the principal spillway ogee crest, chute walls and slabs were also repaired.

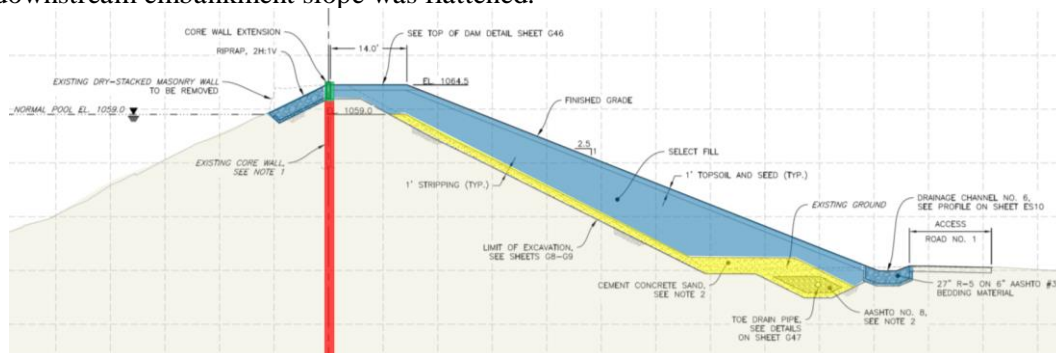
Fig. 4
Slope stability and seepage collection solution
French translation

Stability analyses for the downstream slope of the dam embankment revealed that the factor of safety against slope failure was less than the required factor of safety of 1.5. Unfiltered seepage also existed at several discrete locations throughout the length of the dam embankment. To remedy the embankment stability and seepage issues, a filtered chimney drain was installed and the downstream embankment slope was flattened.

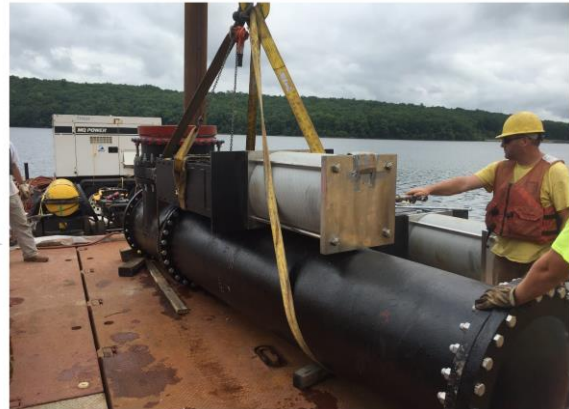
Fig. 5

Upstream closure pneumatically-operated knife gate valve installation F..

To meet Pennsylvania Department of Environmental Protection (PADEP) dam safety requirements, the three 76.20 cm water supply conduits that penetrated the dam's embankment at its maximum section were modified to provide upstream closure by installing pneumatically-

operated knife gate valves. This work was performed with a full reservoir under 20 meters of water.

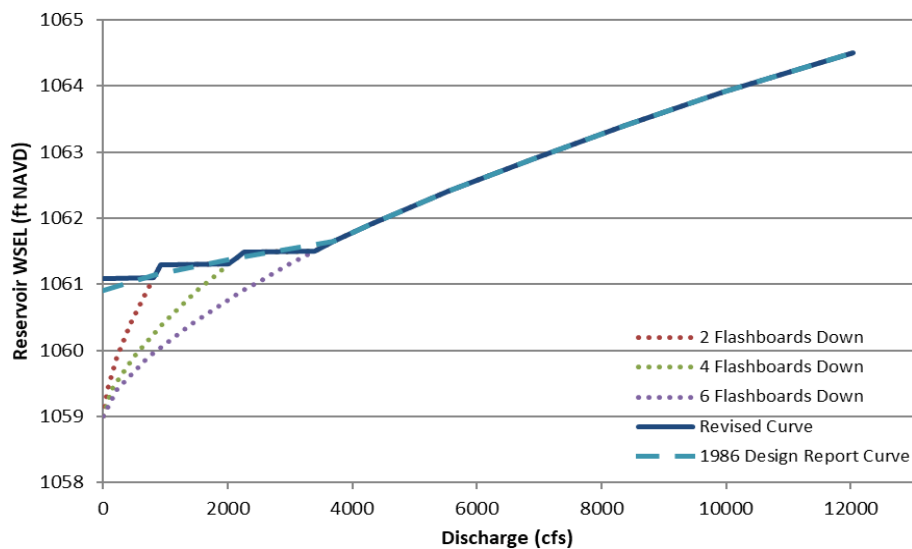
Fig. 6

Existing auxiliary spillway discharge rating relationship F..

The maximum capacity of the auxiliary spillway after all flashboards collapsed was 341 m³/sec. In order to increase the capacity of the spillway to pass the PMF inflow of 1,110 m³/sec, significant modifications to the existing auxiliary spillway were required. Project design restrictions applied to all rehabilitation alternatives considered included not changing any of the following:

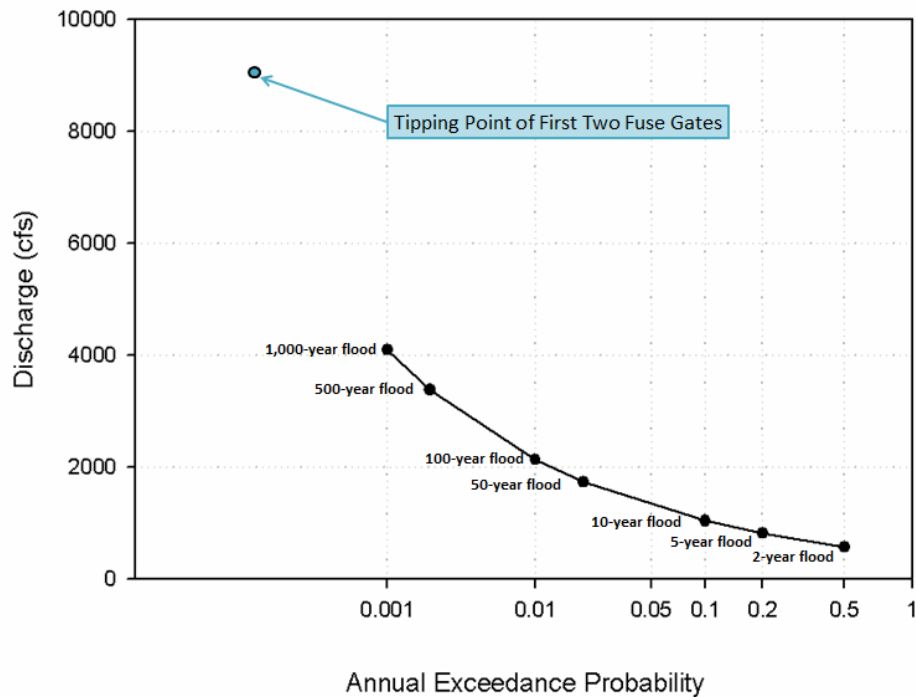
Fig. 7
Initial tipping point for Fusegates relative to estimated flood recurrence intervals F..

The Fusegates with the straight alignment was determined to be the most economical and technically feasible solution. The Fusegates were designed to limit their initial tipping sequence to an extreme flood event (~23% PMF) which was estimated to be less frequent than a one in a 2,000-year event as shown in Figure 7.

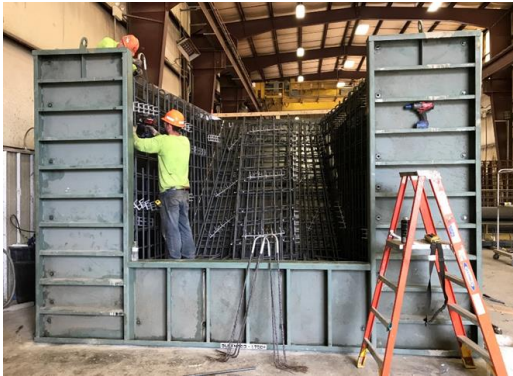
Fig. 11
Custom-made formwork and steel placement
F..

The Fusegates at Pikes Creek Dam were made of pre-cast reinforced concrete and weighed approximately 36 tons each. The Fusegates were fabricated by Old Castle Precast located in Telford, Pennsylvania. After each Fusegate was fabricated, it was weighted to verify the concrete ballast requirements. A hydraulic jack was used to weigh each Fusegate.

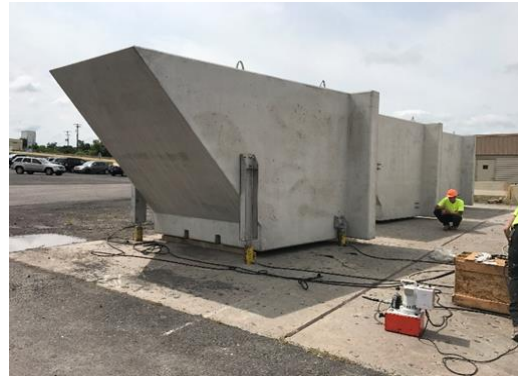
Fig. 12
Fusegate jacking to verify ballast requirements
F..

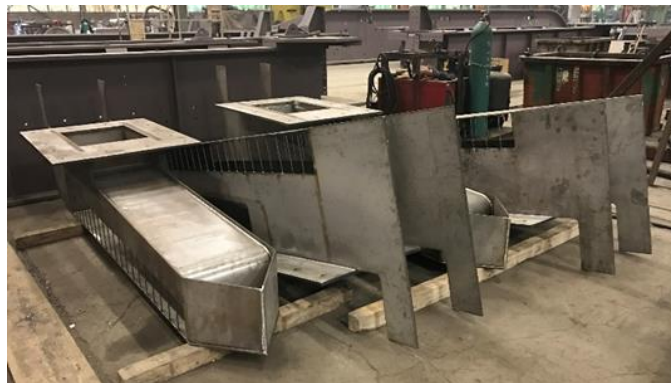
Fig. 13
The production of the steel Fusegate components
F...

The steel components of the Fusegates were manufactured at Johnson Machine Works plant in Charito, Iowa. Figure 13 shows the completed inlet wells.

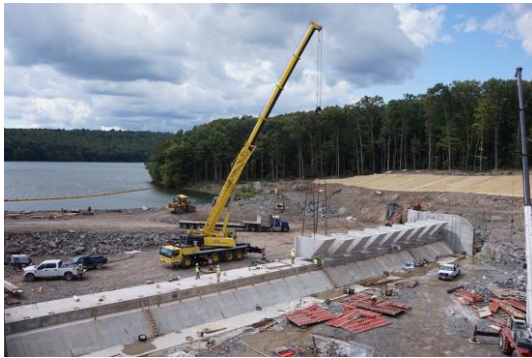
Fig. 14
Fusegate Installation at Pikes Creek
F..

When the Fusegates were delivered to the site, they were placed on the spillway sill using a mobile crane. The inlet wells, ballast blocks and deflectors were installed after the Fusegates were placed on the spillway sill.

The watertightness system was installed last. This involved installing stainless steel angle bars on the Fusegates to allow EPDM rubber compression seals to be wedged between the angle bars and the foundation. After completion of the seals, leakage tests were performed on selected Fusegates by enclosing the upstream 30 cm section of the Fusegate up to its crest using formwork and sandbags. Compression seals were adjusted and additional sealant was applied when necessary. The Fusegates were installed by December 2017.

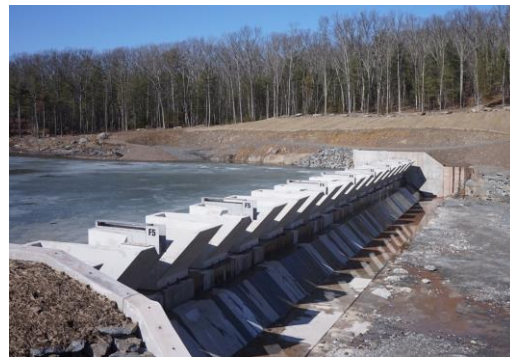
Fig. 15
Completed Fusegate System at Pikes Creek
F..

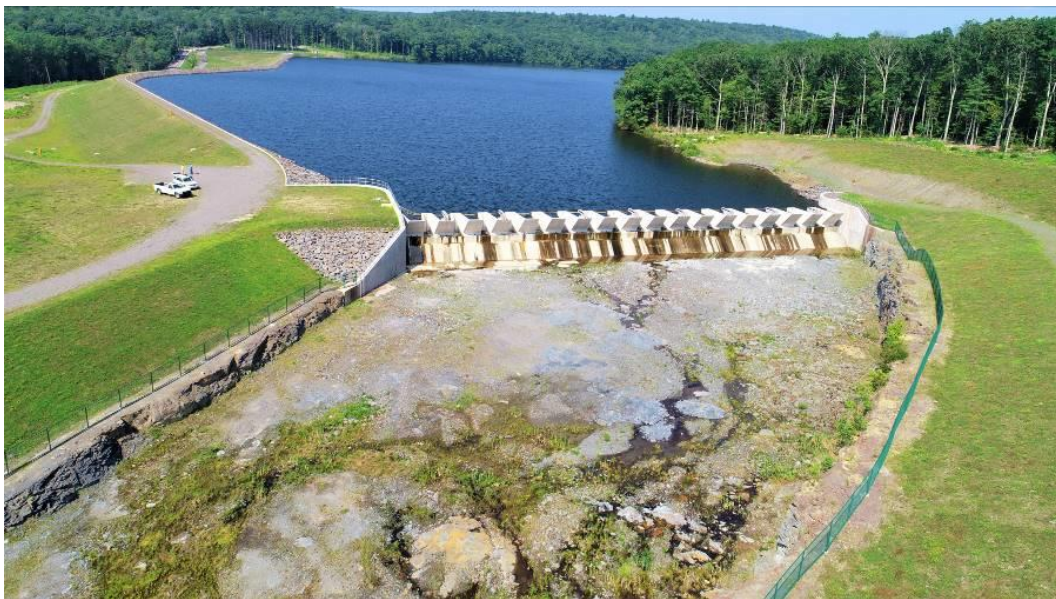
Fig. 16
Completed Auxiliary Spillway at Pikes Creek
F..
