ICOLD Symposium on Sustainable Development of Dams and River Basins, 24th - 27th February, 2021, New Delhi

CONSTRUCTION OF THE KISHANGANGA HYDROELECTRIC PROJECT CONCRETE FACED ROCK FILL DAM, INDIA

ABSTRACT

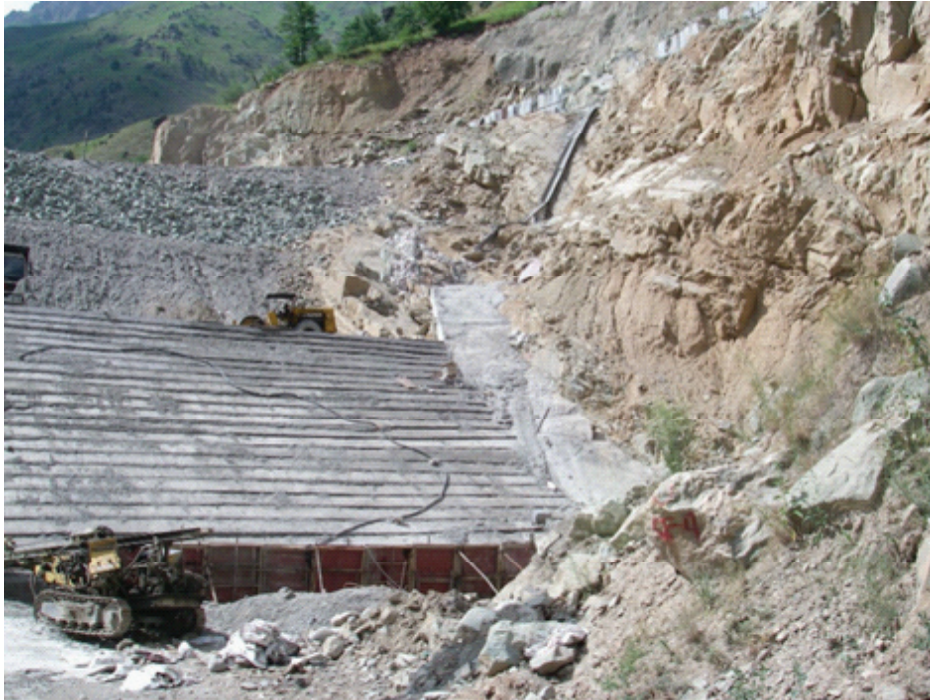
The right abutment has been blasted to achieve the design formation level for the plinth. There has been considerable overbreak in the foundations. As a consequence, the lower portion was made up with mass concrete to the approximate formation level. There were also localized places where additional trimming was necessary to achieve the minimum 4m width for the plinth. Adjacent to the plinth, the rock level was required to be a minimum of 1m below plinth level to provide a minimum thickness of Zone 2B material between the rock and the underside of the face slab. Again, some additional trimming was needed to meet this requirement. Modification was needed on site to appropriately set out the plinth and position the waterstops and the resulting solution was to increase the concrete face slab thickness and/or reduce the thickness of the plinth to 400mm where the make-up concrete is too high.

Figure 5 : Right abutment plinth

The toe plinth in right abutment was connected to the rock by grouted anchors to resist uplift and gravity induced sliding. The top of the plinth on the right abutment varies from elevation 2365.30m to 2391.45m. The uplift pressure beneath the toe plinth (on the river bed) is not significant due to presence of cut off wall and pervious zone towards downstream end which do not allow build-up of water pressure.

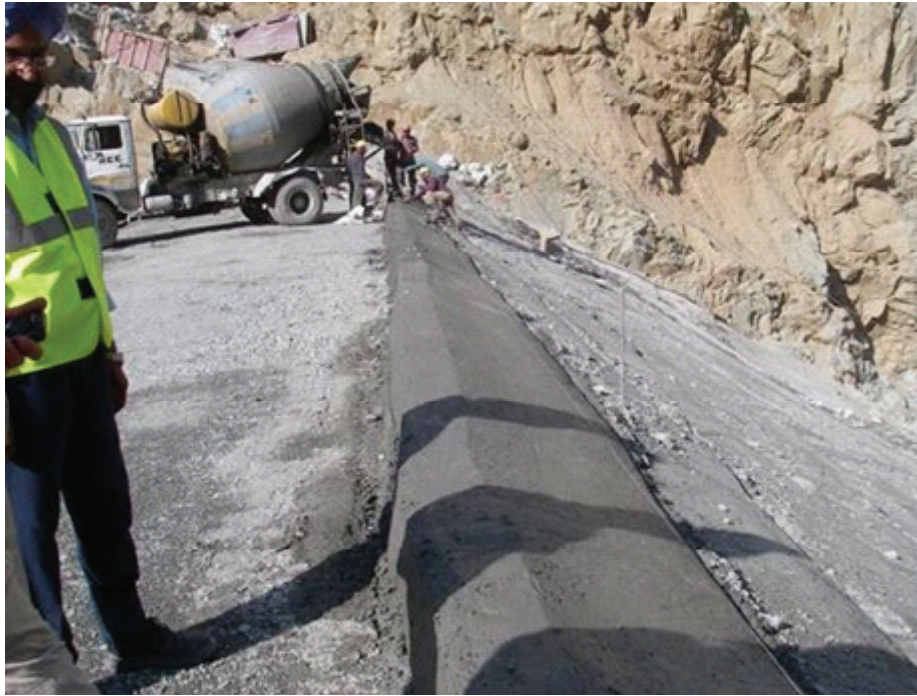
The extruded curb (Figure 7) has a low percentage of cement providing an intermediate stiffness between that of concrete slab and underlying filter material. The kerb allows Zone 2B to be fully compacted across the full width of the zone

and promoted the regularization of the face, allowing confinement and consequently the compaction in the transition zone. The technique worked well on site. However, some areas of kerb were constructed such that they were standing proud of the design profile and needed to be trimmed back to ensure that the design thickness of the concrete face slab (400mm) was achieved.

Figure 7 : Placement of Extruded Curb

Initially it was proposed to apply a 75mm layer of shotcrete on the upstream face to protect the upstream face prior to placement of the concrete facing slab. However, during construction the concept of an extruded trapezium-shaped kerb was introduced. This is the first time this technique has been used in India although it has been applied elsewhere in the world.
