ROCKFILL TEST FILL TO DETERMINE THE IMPACT OF COMPACTION PASSES ON ROCKFILL SETTLEMENT AND TO COMPARE DRY DENSITY AFTER 6 AND 8 PASSES IN EL LLAGAL TAILINGS DAM

L. MORENO, C. LOGUE AND C. QUEZADA
BGC Engineering Inc., Vancouver, BC, Canada

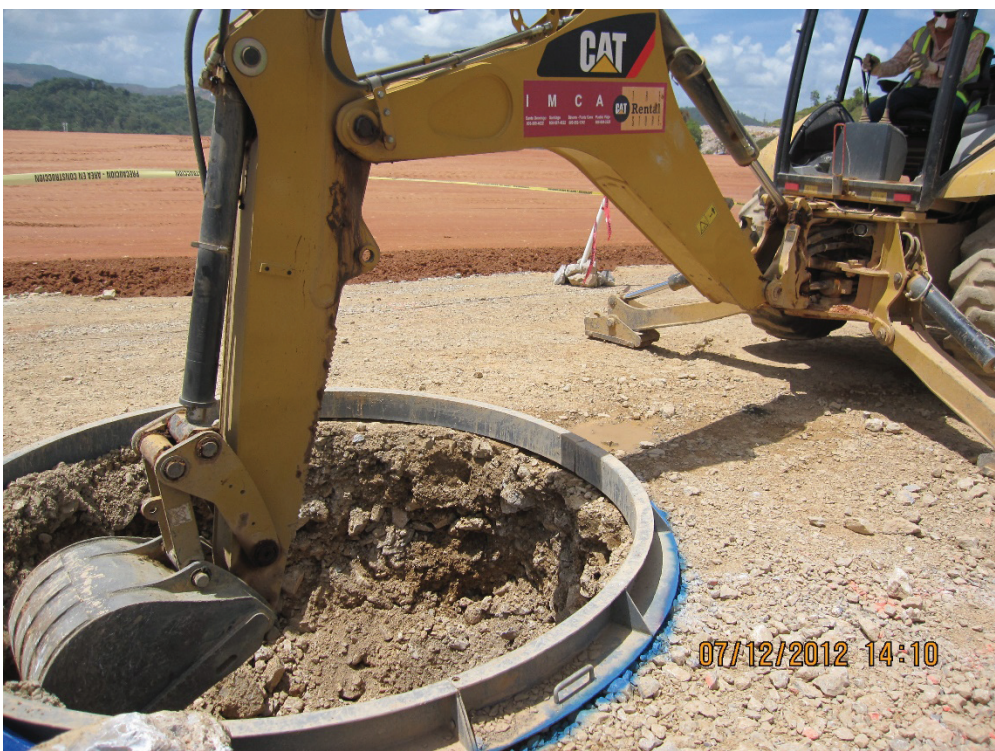
Photograph 3 : Backhoe excavation within steel ring for density tests.

At each location, a 2.5 m diameter steel ring was placed on the compacted rockfill surface to act as a guide for the backhoe. The backhoe carefully removed rockfill from within the limits of the ring to create a hole. The weight of the removed rockfill was measured by quality control personnel. The volume of each excavated hole was measured using two methods: water replacement and scanning survey. In the water replacement method, quality control personnel placed a plastic membrane into the excavation and measured the volume of water required to fill the hole. In the scanning survey method, mine operation survey personnel used specialized equipment to form a 3D model of each hole for later volume determination. Photograph 3, 4 and 5 show a sequence of excavation and volume determination by two techniques.

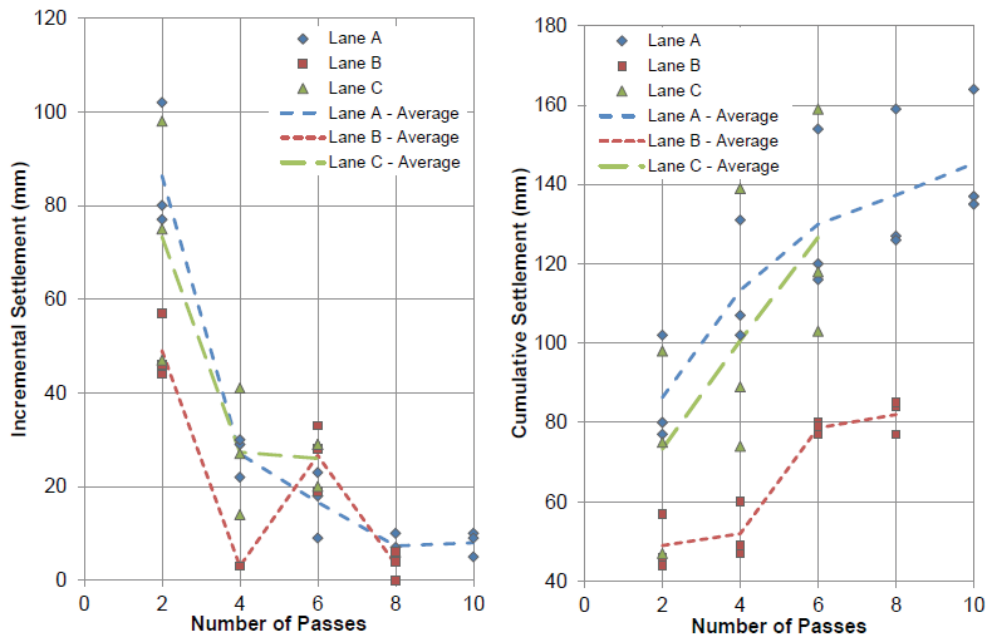
Figure 3 : Rockfill settlement observations.

For the purpose of this test fill, the subgrade material (i.e. already constructed LLSD upstream rockfill shell material) was assumed to be incompressible relative to the test fill material. The elevation of the subgrade at each reference measurement location was assumed to stay constant. Settlement was measured after every two passes, as shown in Table 2 and plotted in Figure 3.

Figure 3 shows the expected general trends of increasing settlement with the number of passes, with the most settlement occurring in the initial two passes. For all lanes, 50% to 60% of the ultimate recorded settlement was achieved after the first two passes. Lanes A and C (10 and 6 passes, respectively) exhibited similar behavior, both in the rate and magnitude of observed settlements. However, Lane B (8 total passes) showed significantly less total settlement after application of similar compactive energy.

In general, settlement increases with increasing number of compaction passes. However, the magnitude of settlement induced after each compactor pass decreases with increased compactive effort. Assuming that the final measured settlement in Lane A (10 total passes) represents the ultimate expected settlement, 59% of settlement has occurred after two passes, and 94% of settlement has occurred after 8 passes. Between 8 passes and 10 passes, settlement increased by 8 mm. Thus, the number of passes (eight) required by the technical specifications fulfills the design intent of optimizing the applied compactive effort while minimizing potential for large future settlement.

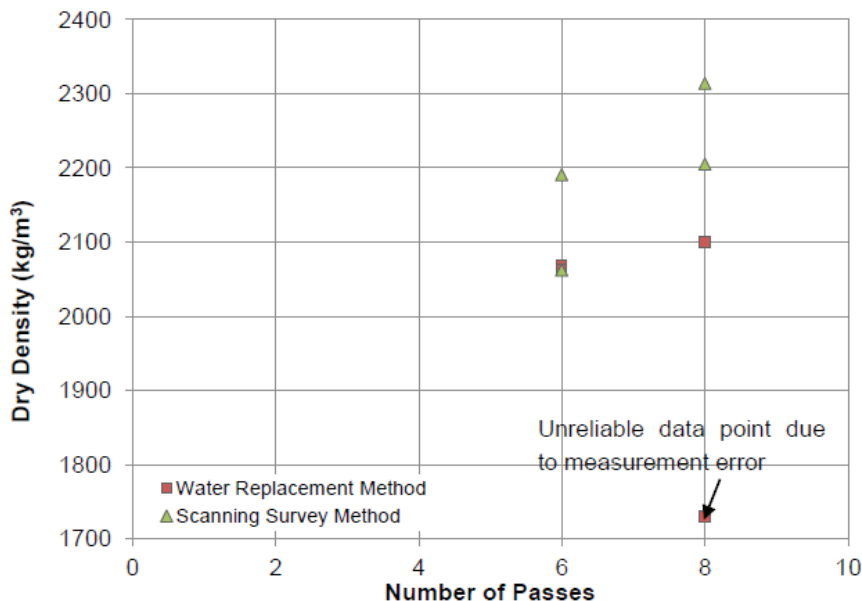
Figure 4 : Relationship between measured dry density and compaction effort.

In-situ density tests were performed at two locations in each Lanes B and C, as illustrated in Figure 1. Excavation volumes were determined by both a water replacement method and scanning survey method as described in section 2.2. The test results are summarized in Table 3 and Figure 4 below.

As determined by scanning survey, the average rockfill dry density reached after 6 and 8 passes is 2,126 kg/m³ and 2,260 kg/m³, respectively. The average rockfill dry density measured by water replacement after 6 passes is 2,066 kg/m³. Dry density calculated using the water replacement method at control point B3 is not reliable due to an inaccurate volume determination caused by flow meter reading error, preventing an average density from being reported for the 8 passes case.

As expected, rockfill dry density was observed to increase with an increasing number of compactor passes. Also, the scanning survey volume measurement method was noted to provide higher densities than the water replacement measurement method.
