Sedimentation management utilizing sluicing operation at the Setoishi dam

ABSTRACT:

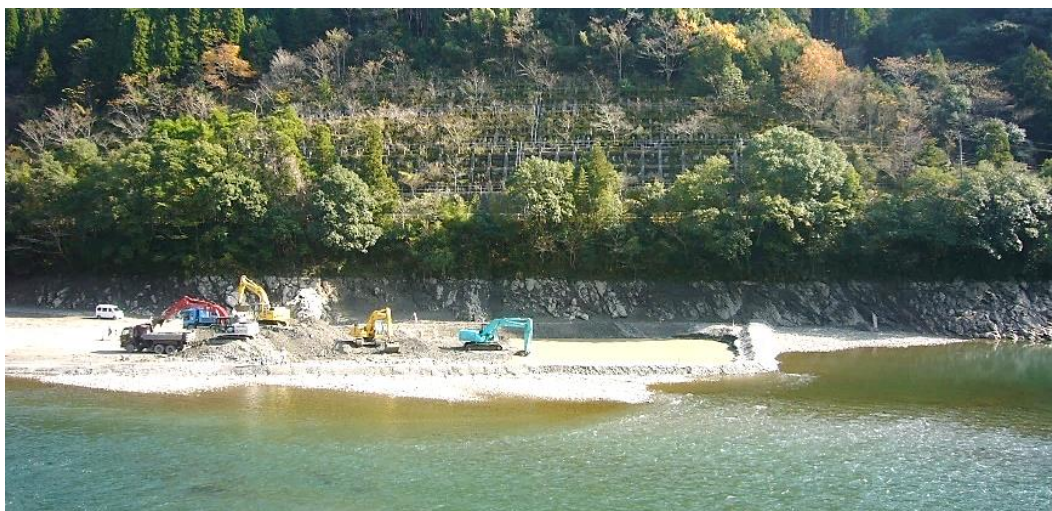
Figure 2. Excavation in the Setoishi Reservoir with emptying

But access to the reservoir inside and sediment to be excavated in dry area are limited, then it is difficult to execute excavation as well as plan. Sometimes excavation under water had to be executed shown in Figure 2.

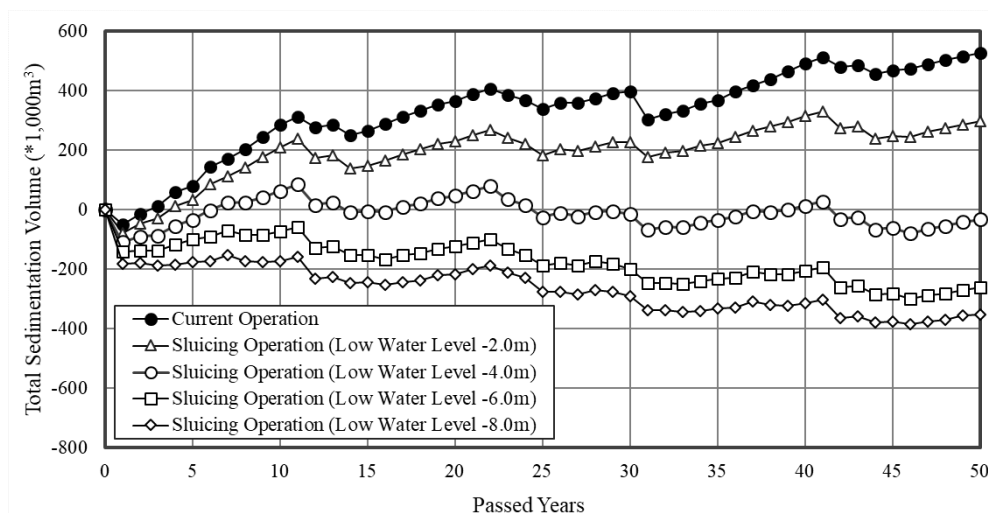
The calculation result is shown in Figure 4 and it indicates that not to increase sediment in the reservoir, sluicing water level should be set low water level -4.0m, -6.0m and -8.0m. It is not desirable to change the environment in downstream of the dam by large volume sediment from the reservoir, therefore low water level -4.0m is selected as the sluicing water level. The operation rules including this water level will be feedbacked by experiences.

Figure 4. Calculation Result of Sluicing Operation at the Setoishi Dam

The most important point of the operation rules is dam water level of sluicing during flood. In order to fix the water level, riverbed change calculation is conducted. One current operation cases and 4 sluicing operation cases are calculated and 4 sluicing cases are different in dam water level during flood which are low water level -2.0m, -4.0m, -6.0m and -8.0m. Sluicing operation is conducted when dam inflow rate is over 1,000m³/sec and calculation time is 50 years using the record.

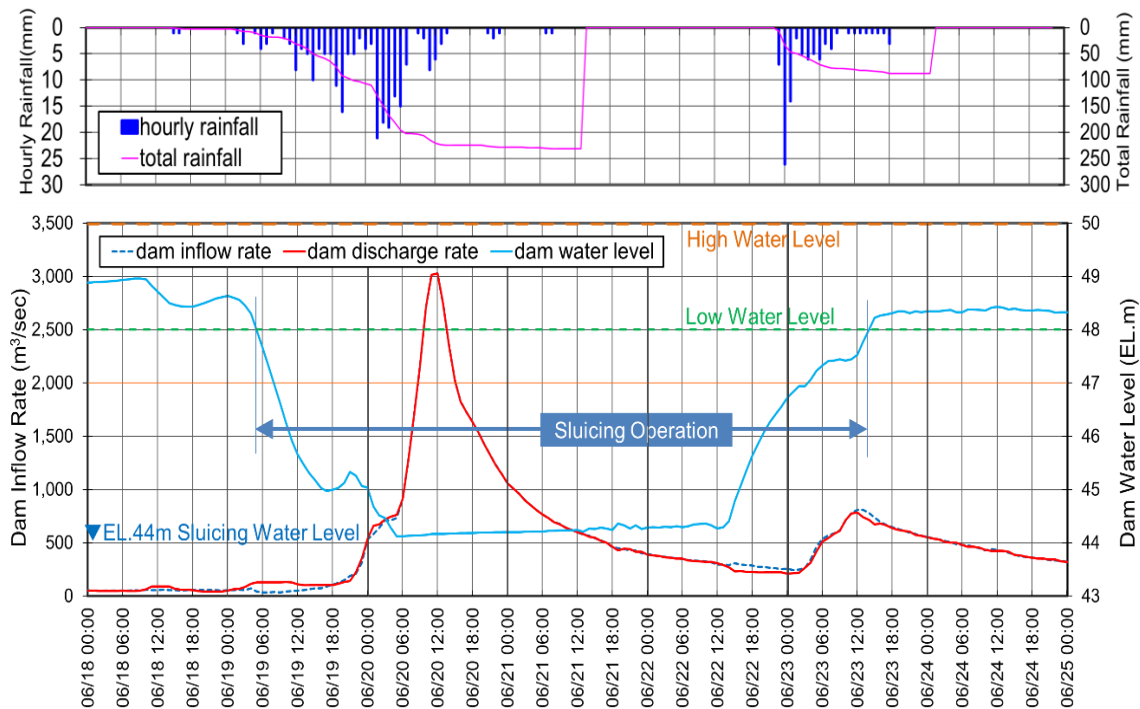
2 regular operations were conducted in 2018 shown in Table 4. The data of first operation in June are shown in Figure 5.

Figure 5. Operation Result of Sluicing in June 19th 4:00 – 23nd 14:00

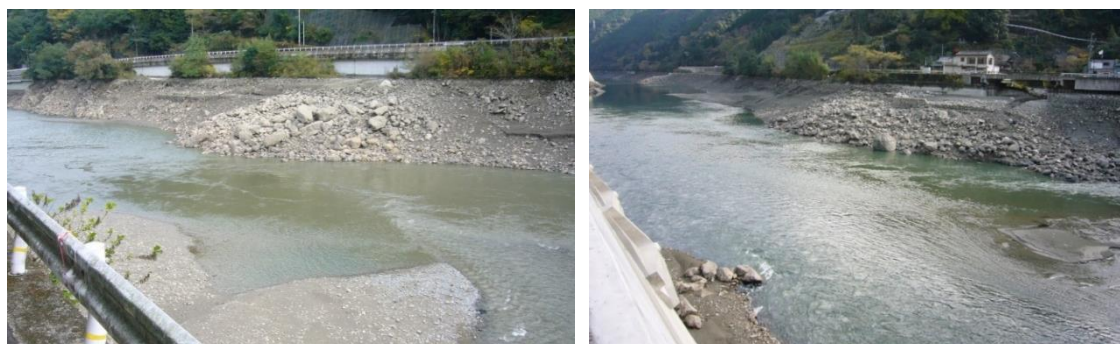
The riverbed was aggraded in 1,000m and 2,000m from the dam. In this 2 places, river width in downstream of them is narrowed by the deposits from the bank in Figure 7.

Figure 7. Deposits from the Bank at 800m(left) and 1,500m(right) from the Setoishi Dam

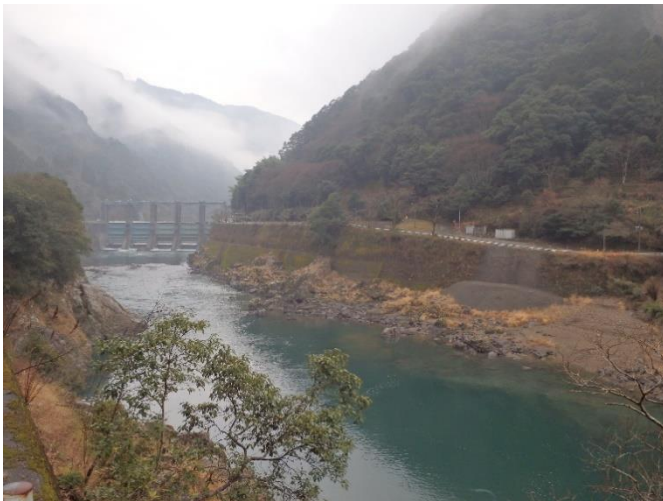
As countermeasure against the less coarse sediment in the downstream of the dam, it is effective to execute the sediment replenishment, and coarse sediment excavated in the reservoir is transferred to the downstream of the dam and restored in the river. In 2018 test sediment replenishment was executed in just downstream of the dam, shown in Figure 8. Amount of it was 500m^3 , and it flew down in flood and no sediment was left. It is planed that $5,000\text{m}^3$ will be replenished in 2019 and amount of the sediment replenishment will be larger gradually.

Figure 8. Sediment Replenishment at Downstream of the Setoishi Dam in 2018
