INTERNATIONAL DAM SAFETY CONFERENCE

**A breach modeling of debris-dammed lake formed
aftermath of the flash flood and debris flow on 07
February 2021 in the Rishiganga river valley**

Central Water Commission (CWC)

10-12 October 2022 at Jaipur, Rajasthan (India)

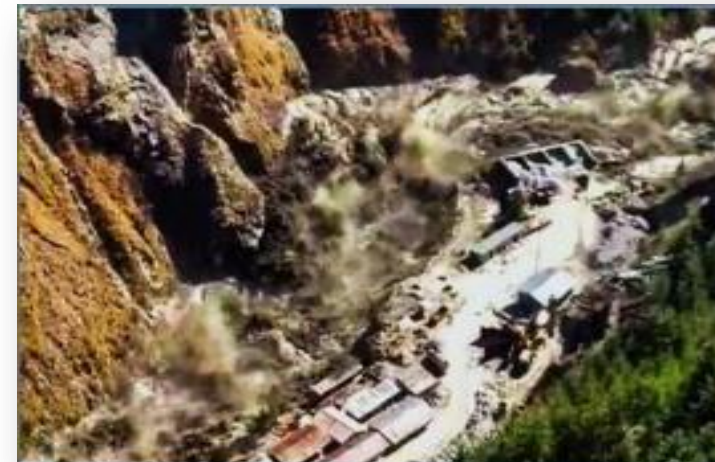
- ❑ What actually happened?
- ❑ Was it a GLOF? No.
- ❑ On 7th Feb 2021, at ~10:08 AM, a huge rock mass from Raunthi peak combined with a glacier avalanche detached.
- ❑ As per the NDMA report, the rock mass with ice descended from an altitude of about EL 5500 m to about 3700 m.
- ❑ The energy generated due to impact probably resulted into the melting of snow and ice along with crushing of rock mass into debris.
- ❑ It was followed by huge debris flow & flash flooding, which created catastrophe in the downstream areas of Rishiganga and Dhauliganga river valleys.

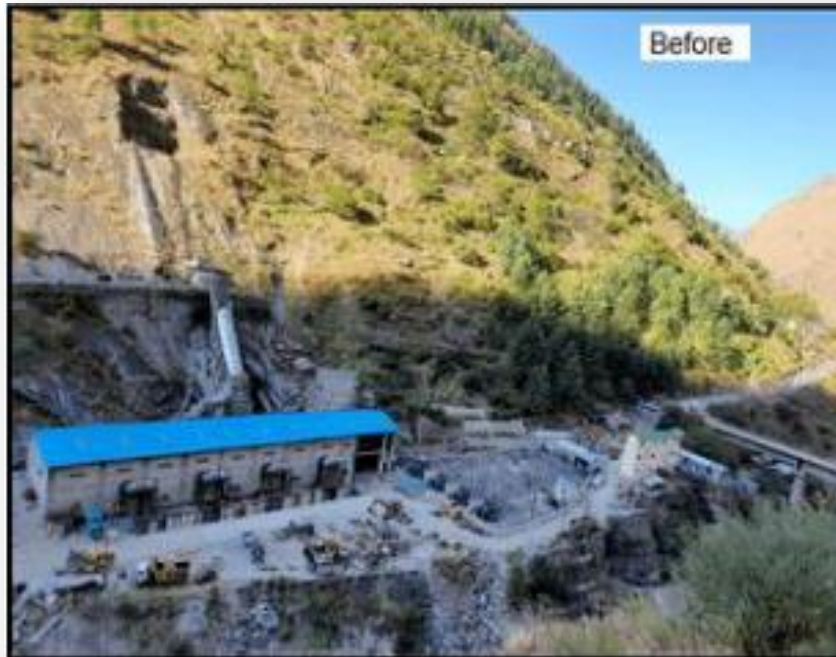
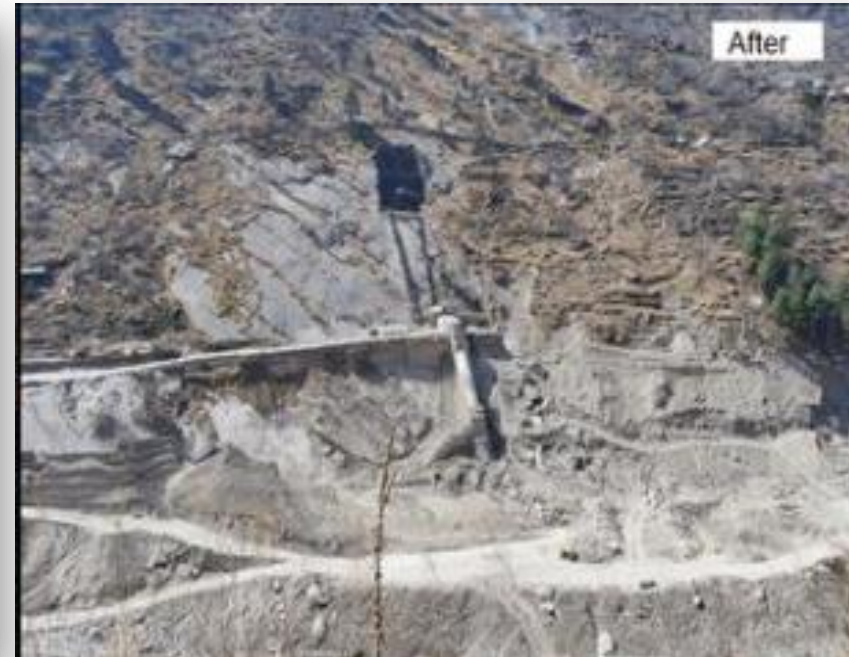
Pre and post disaster images of Rishiganga HEP

- ❑ The avalanche on 07 Feb 2021 in Rishiganga river valley led to the huge amount of mass consisting of rocks, mud, water, ice blocks, etc.
- ❑ This huge mass, flowing in the Rishiganga river valley, caused significant damage along its flow path.
- ❑ The debris flow damaged the operational **Rishiganga hydropower station** (13.2 MW), **under-construction Tapovan HEP** (520 MW), a road bridge and about 5 other pedestrian bridges.
- ❑ The devastation of road bridge, near Raini village, constructed and maintained by BRO, led to the disruption of physical connection of about 13 villages.
- ❑ This disaster also led to significant loss of life; about 204 human and many animals lost their life.

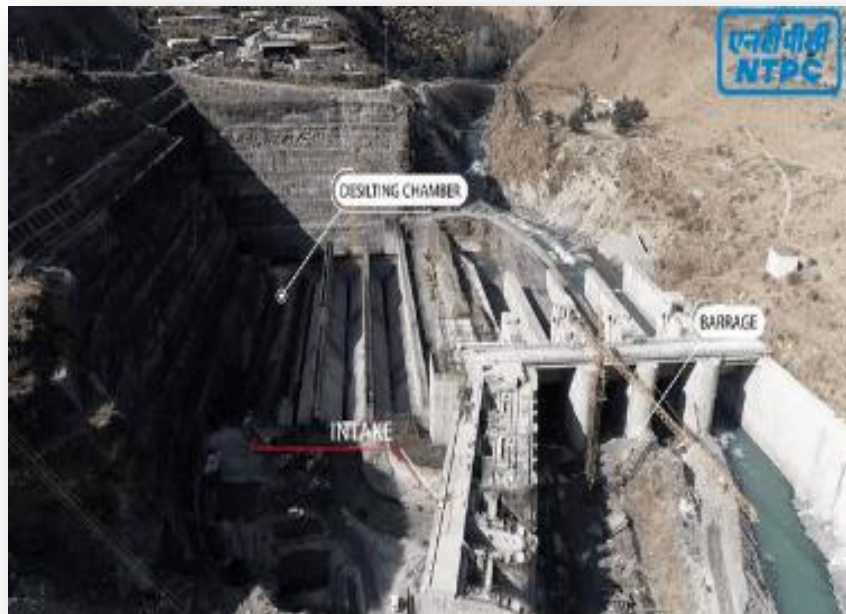
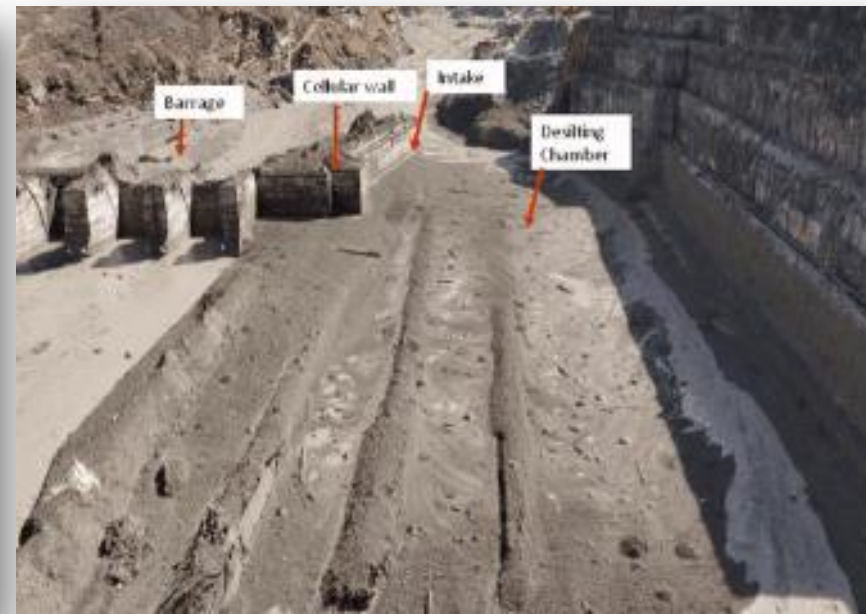
Pre and post disaster images of Tapovan HEP

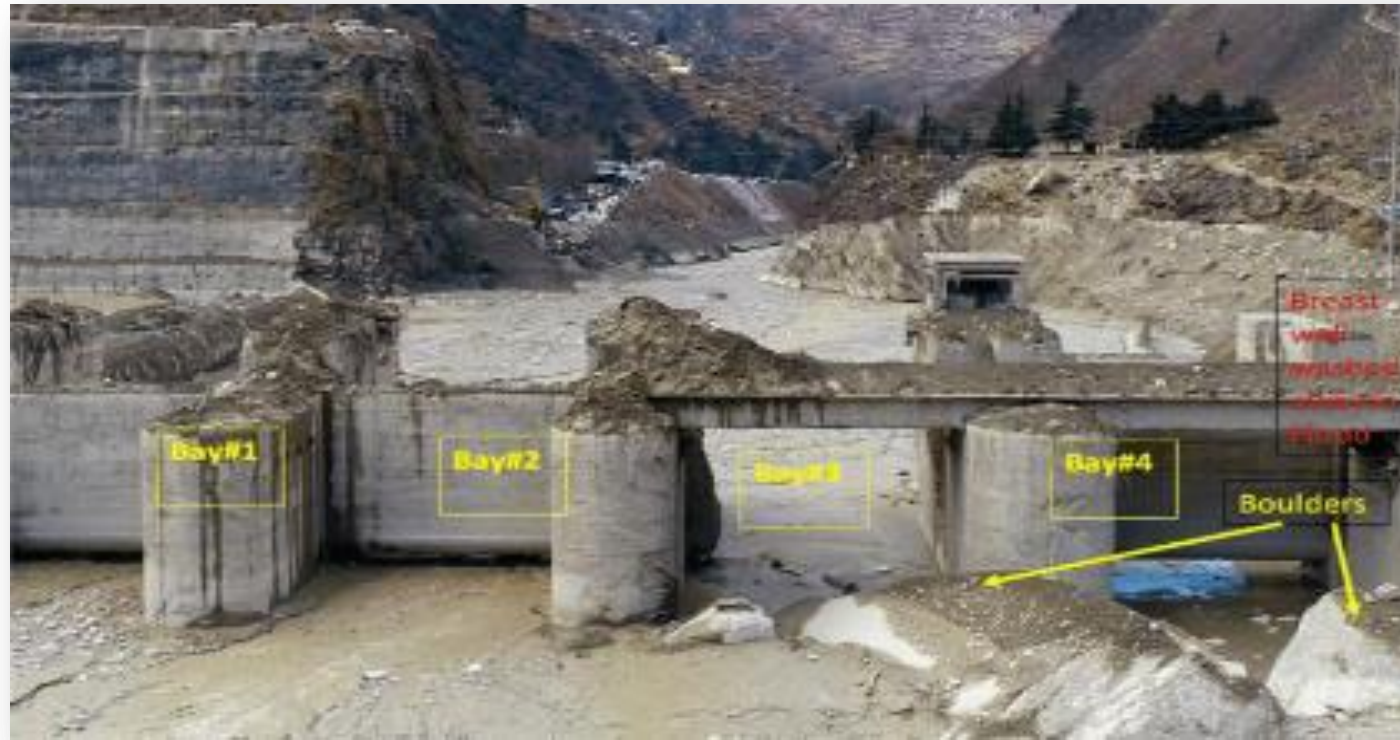
Damaged barrage of Tapovan HEP

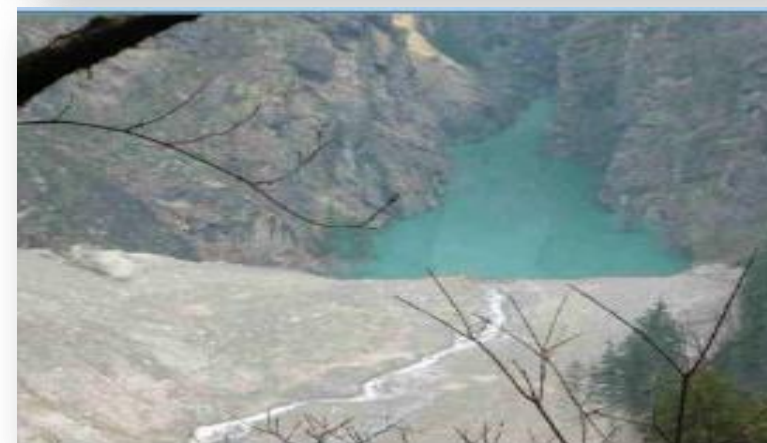
- ❑ The huge amount of debris flow blocked the valley by creating a landslide dam at confluence of Rishiganga and Raunthi river and resulted into formation of a debris dammed lake at an altitude of about EL 2400 m.
- ❑ This lake was growing in size and capacity due to continuous inflow of snow melt and might have breached in near future causing further catastrophe in the valley downstream.
- ❑ IMD forecasted precipitation in the region on 14th and 15th February 2021.

- The volume of the lake was estimated to be 0.7 MCM using the cross-section extracted from SRTM DEM of 30 m in HEC-RAS 1D software.
- The length of the obstruction and width of the lake was estimated to be about 500 m and 120 m respectively as per the available photographs and information provided by various disaster management agencies.
- Breach width and breach formation time are very crucial in any breach modeling and the landslide dam was having loosely deposited debris with boulders, silt and snow/ice.
- Hence, the breach parameters was assumed in line with the moraine dam.
- Breach Formation Time : 60 minutes**
- Average Breach Width : 75 m**
- The height of Breach : 12 m**

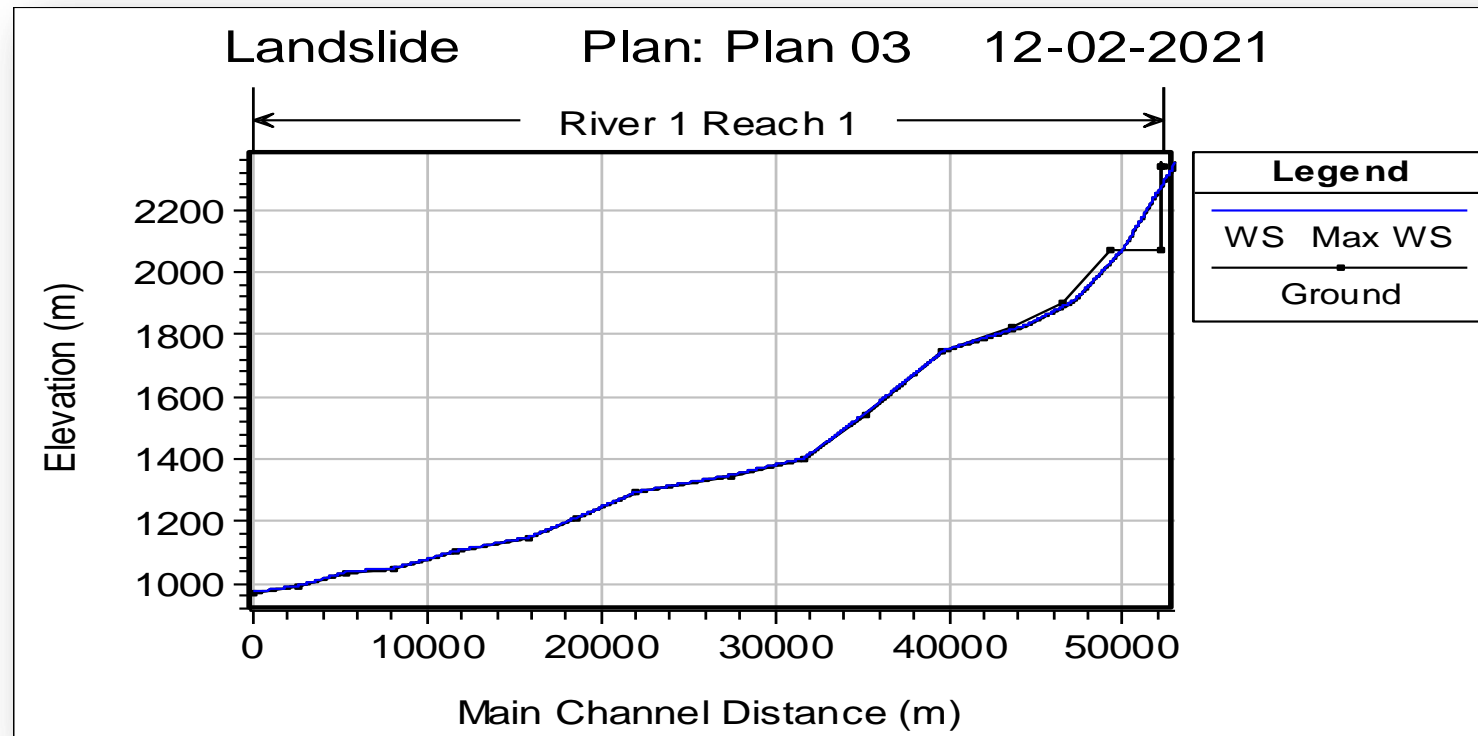
Longitudinal river profile developed using SRTM DEM of 30 m from the lake site up to 53 km downstream

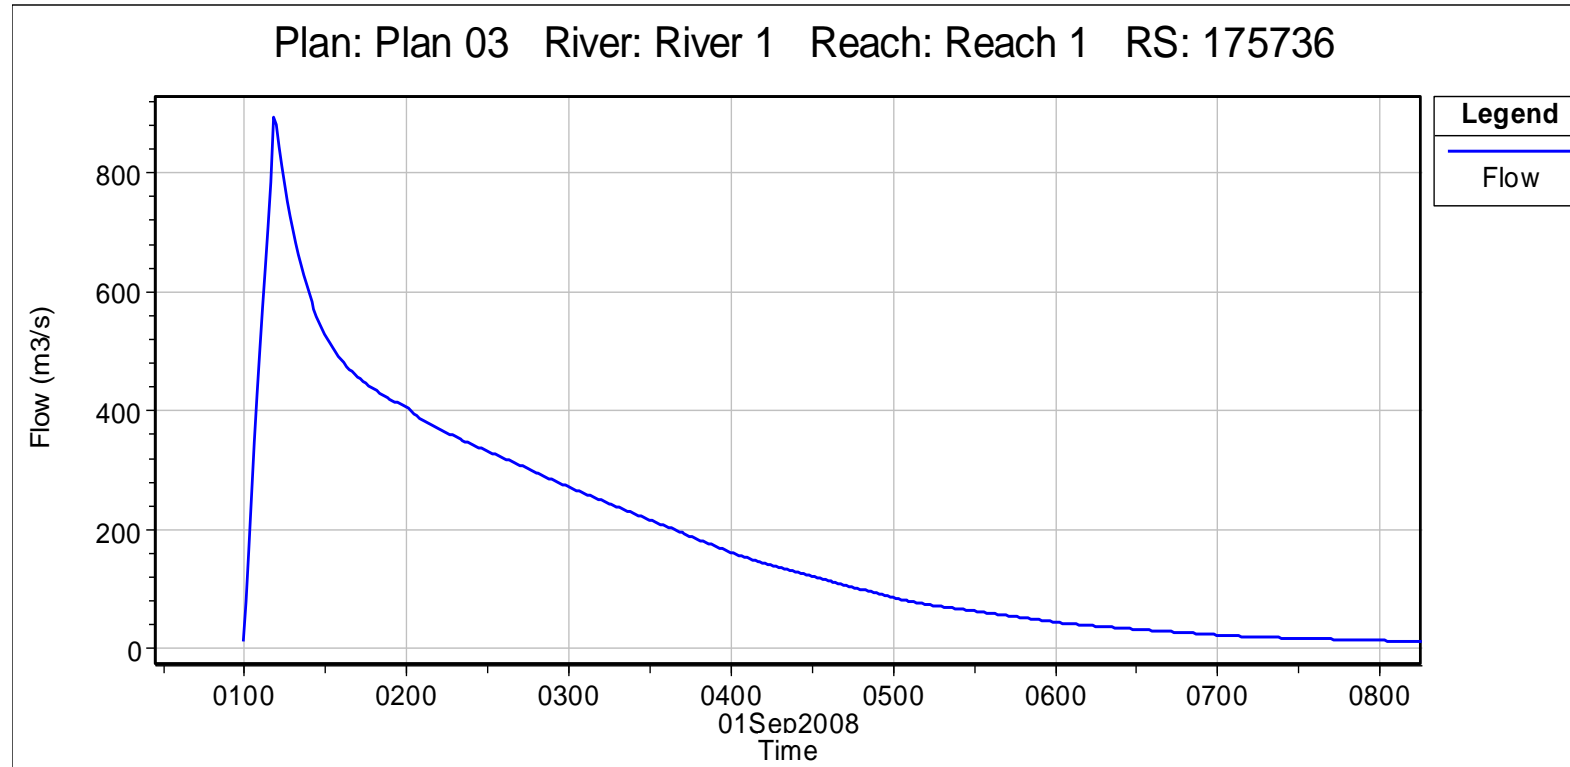
Breach flood hydrograph just downstream of lake site

S. No.	Chainage (km)	Maximum Discharge (cumec)	Increase in Maximum Water Depth (m)	Flood Arrival Time (min)
1	Lake Site	891	-	0
2	2.5	836	4.75	9
3	5	823	4.24	13
4	10	753	5.38	24
5	18	659	3.66	43
6	23	608	4.71	53
7	35	508	2.9	98
8	45	440	4.52	139
9	53	418	4.3	173

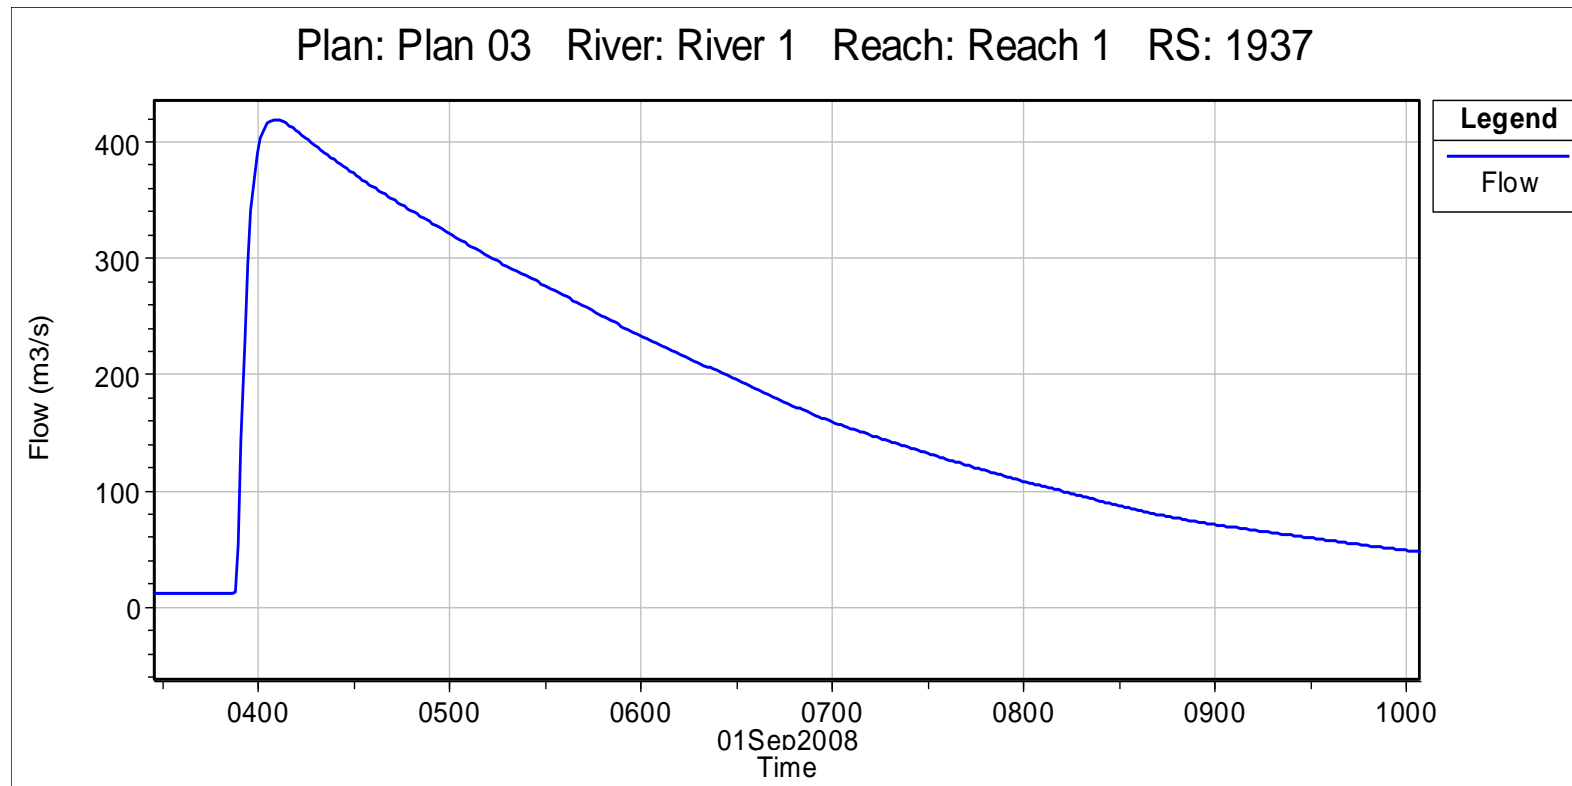
Breach flood hydrograph at 53 km downstream of lake site

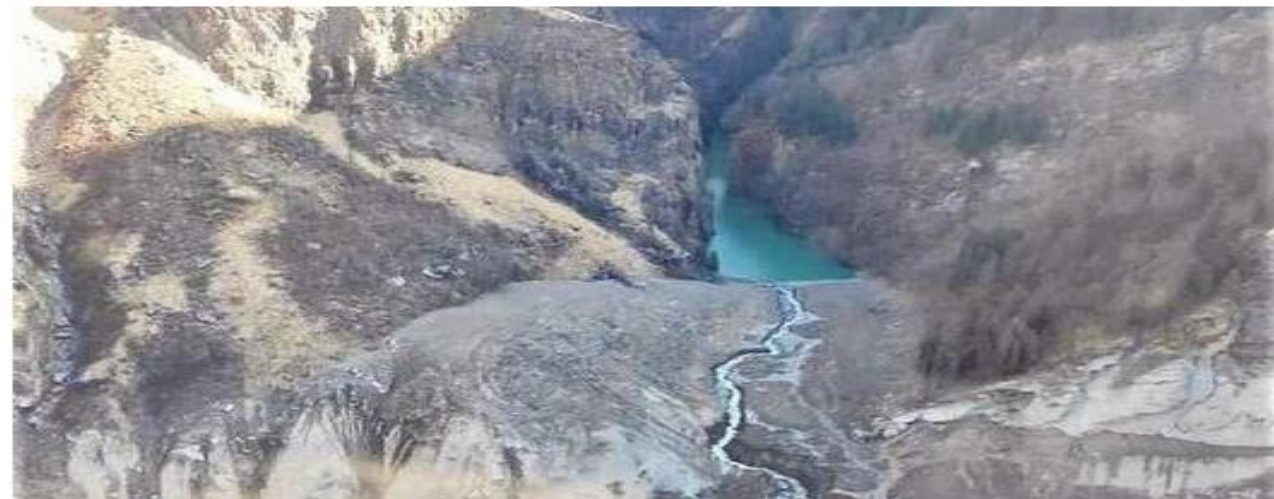
Expert team widens mouth of Rishiganga lake by 15ft to prevent repeat tragedy

Scientists, Indian military personnel, Indo Tibetan Border Police (ITBP) and disaster management personnel and experts analysed the lake including its depth before widening its mouth.
