Rectification in the operating system of non-functional stoplogs on an inclined track

Central Water Commission

10-12 October 2022 at Jaipur, Rajasthan (India)

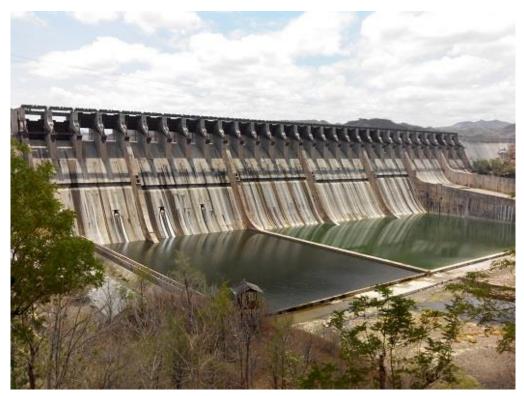
Sardar Sarovar Project

Multipurpose dam built on the Narmada River Navagam near Kevadia, Gujarat

- Largest water resources project in India in terms of concrete volume
- Third highest concrete dam (163 m)
- Length of dam 1210 m
- Two Power Houses
 - Main Power House 1200 MW
 - Canal Power House 250 MW
 - **Largest Irrigation Canal**
 - Length 468 km
 - carrying capacity 1133 m³/s
 - 35 branches

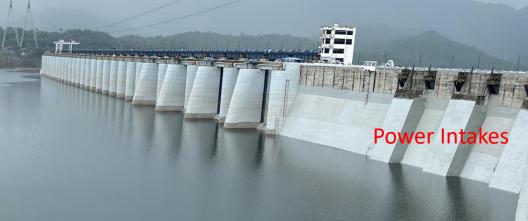
Stoplogs

- One set of stoplogs having six units of size 6200mm X 2250 mm (each) provided for maintenance of these gates.
- Weight of each stoplog unit = about 15T
- Positioned at bell mouth entry on an inclined track at an angle of 16 degrees to the vertical
- Operated by 100T gantry crane.

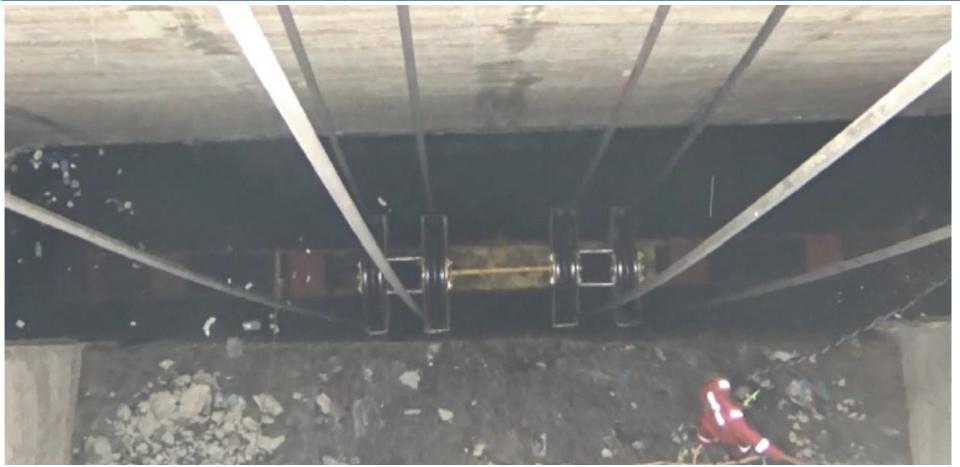
Modified Lifting Bean during trial in the groove
