Koldam Hydropower Station Flip Bucket issue and remedial measures

By Rakesh Rathee, S. K. Garg, Jagat Singh Yadav, S. K. Bharti

Koldam Hydropower station (4*200MW) of NTPC Ltd. is an earth and rockfill dam 167m high, having a spillway length of 460m with 6 radial gates and a flip bucket as an energy dissipating structure. Station was commissioned in July 2015 and since then spillage of water during monsoon season is a regular activity.

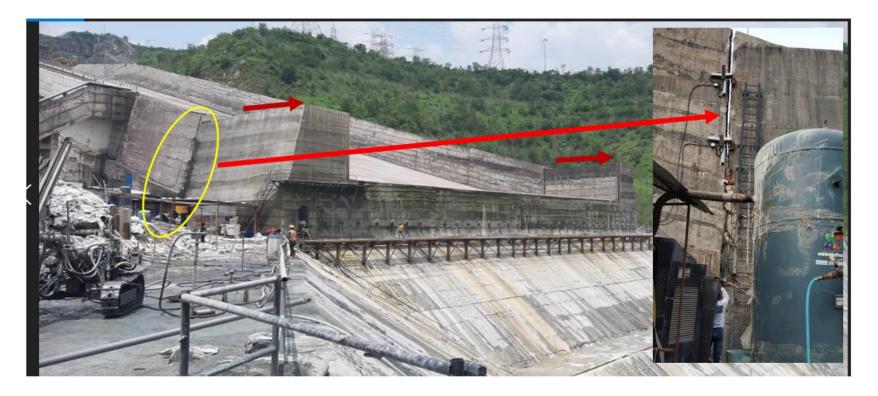
During the 2016 monsoon, a widening of the dilation joint between the spillway and flip bucket was observed. The same was monitored via manual and online Vinchon instruments which were under allowable limits. In 2019 the Joint widening crosses the allowable limits, and it was analyzed that there is some movement in the flip bucket on all axis.

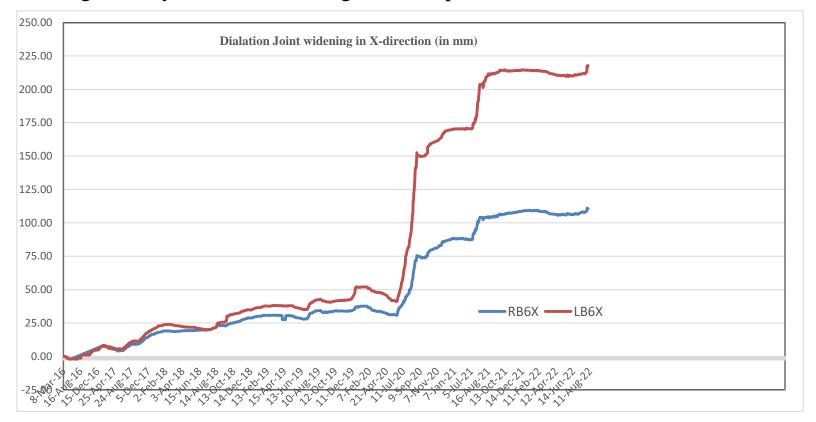
The readings for widening have been taken using online Vinchon and plotted and trends have been seen showing more widening in monsoon due to spillway discharge and dynamic force acting on the flip bucket.

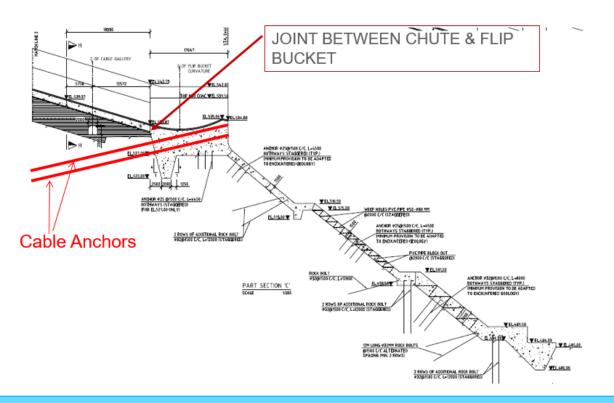
This movement was locked by using 100 Ton ultimate capacity 70 nos. 60 meters long 150mm dia. cable anchors for a spillway discharge of 3000 Cum. at a time. The anchors were installed from the front face i.e., from the plunge pool side by way of making a steel platform and using 02 numbers drilling machines for timely completion of work during 2020-21.

- •Cable anchors -Numbers- 70+3
- •Length 60 m,
- •Spacing: 2.14 m c/c staggered
- •End anchorage 12 m,
- •Ultimate Load Capacity- 100 T
- Lock off load- 31.35 T

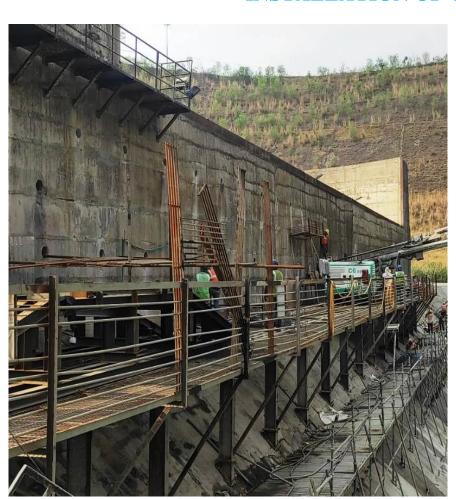
Based on the design criteria, site constraints and geological investigations 60m long, 150mm dia 100 Ton GUTS 70 numbers single corrosion protection at a spacing of nearly 2m were proposed and installed.

These cable anchors were installed by making a steel platform on the sloping face of the plunge pool keeping the platform width and loading on cladding.

Two number Casagrande drilling machines C6 XP were used for drilling 150mm dia holes through the heavily reinforced concrete

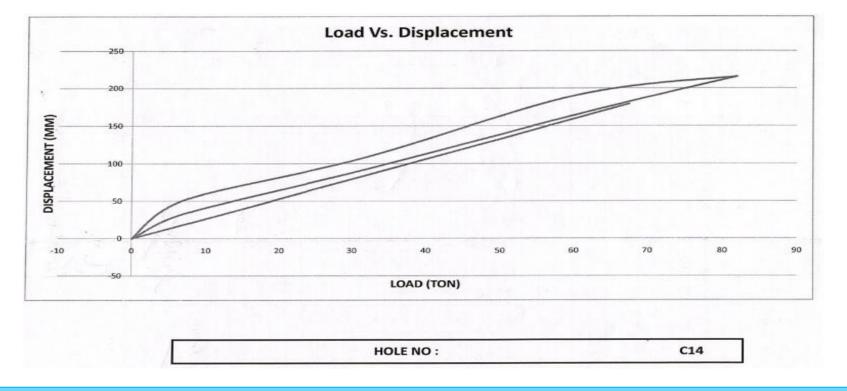
The test load to which rock anchors were subjected during various tests was 80% of the guaranteed ultimate tensile strength (GUTS) of the tendon, Lock- offload was 60% of GUTS of the tendon, which was then reduced to 30% for maximum anchors. All the cable anchors were tested. Test results are plotted

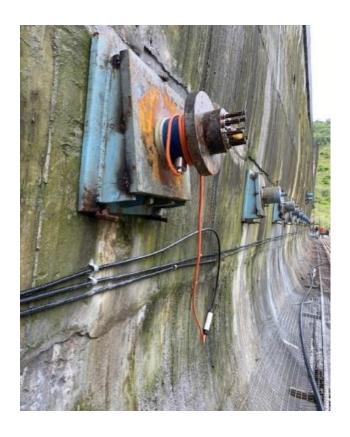
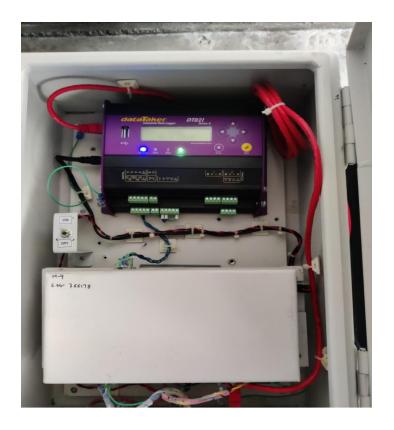
04 nos. *Load cells* of Capacity 1200 kN for Tendons were installed for monitoring the behaviour of rock anchors and flip bucket.

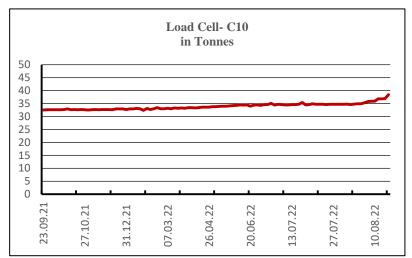
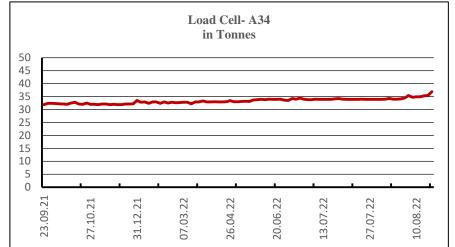
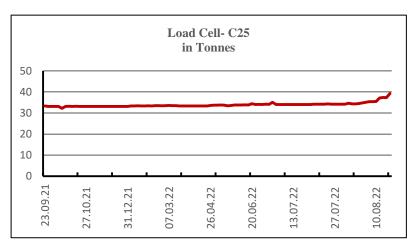
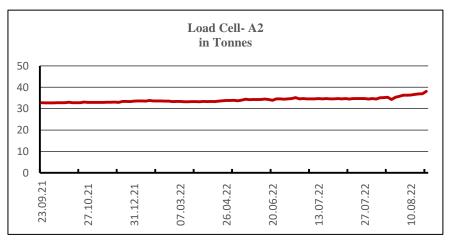
BEHAVIOR OF FLIP BUCKET AFTER CABLE ANCHORS INSTALLATION

It has been noticed from load cell readings that there is an appreciable restriction in the flip bucket movement after the installation of cable anchors even during monsoon spillway operations in July and August 2022
