**CLIMATE-RESILIENT DAMS AND
HYDROPOWER INFRASTRUCTURE
INTEGRATING
ENVIRONMENTAL SUSTAINABILITY
IN PLANNING AND DEVELOPMENT**

**Nano Grouting to Arrest Heavy Water Loss Through
Aging Dams Leading to
Major Reduction in Carbon Foot Print**

Dr. Surendra Manjrekar
CMD - Sunanda Speciality Coatings Pvt Ltd
Honorary Member - ACI, USA
Honorary Fellow - ICT, UK
Former Visiting Professor - University of Leeds, UK

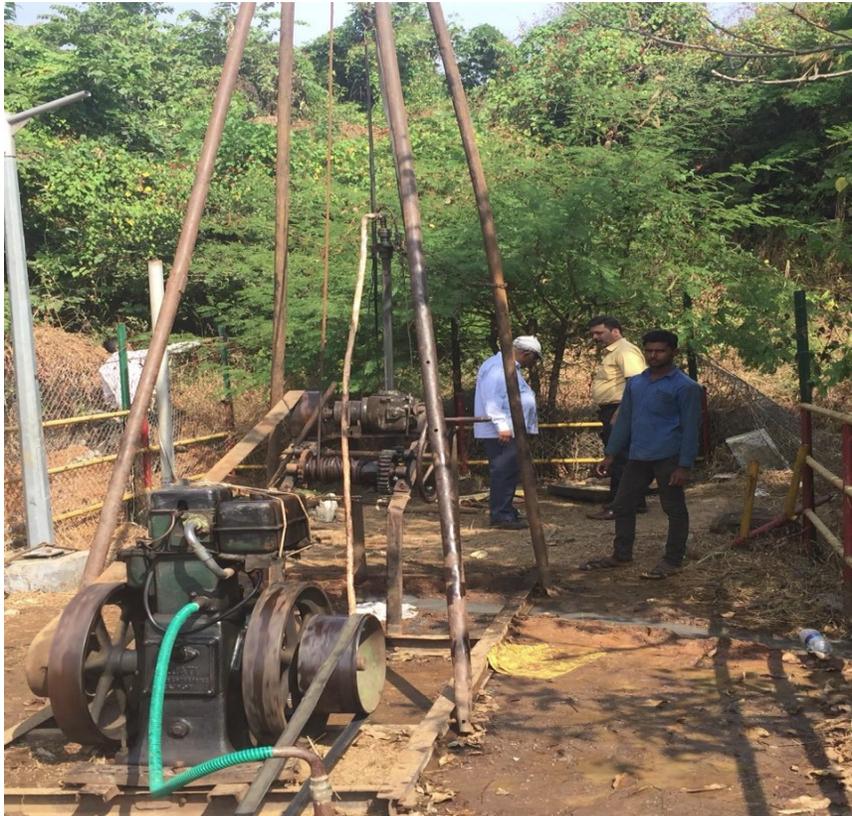
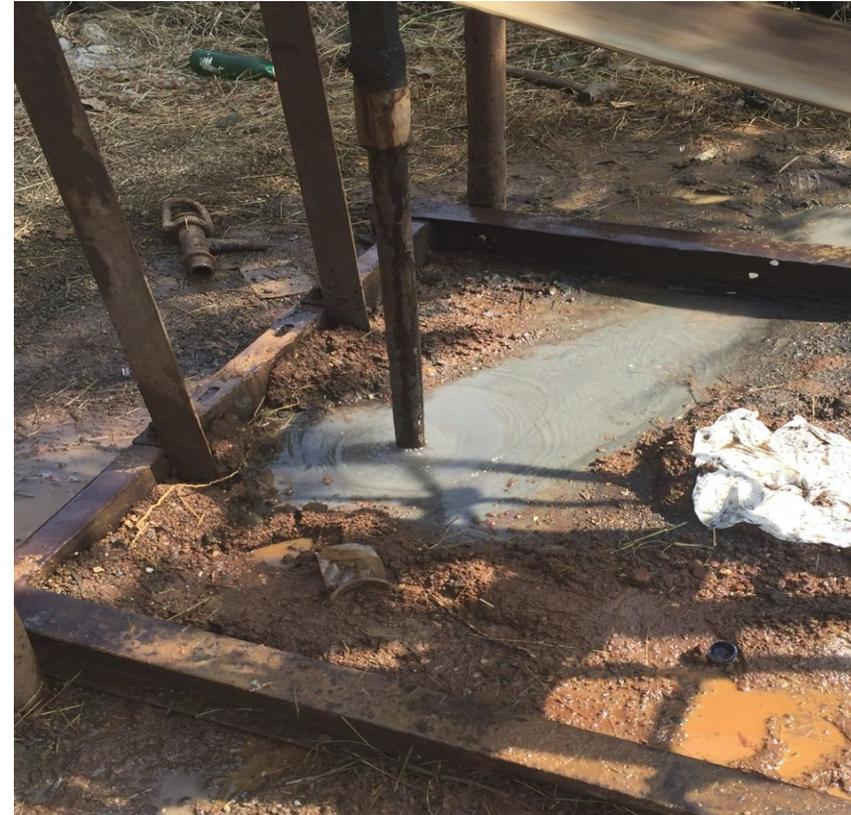
3. CONVENTIONAL METHOD OF ARRESTING SEEPAGES - CEMENTITIOUS GROUT

Grouting by using cementitious material

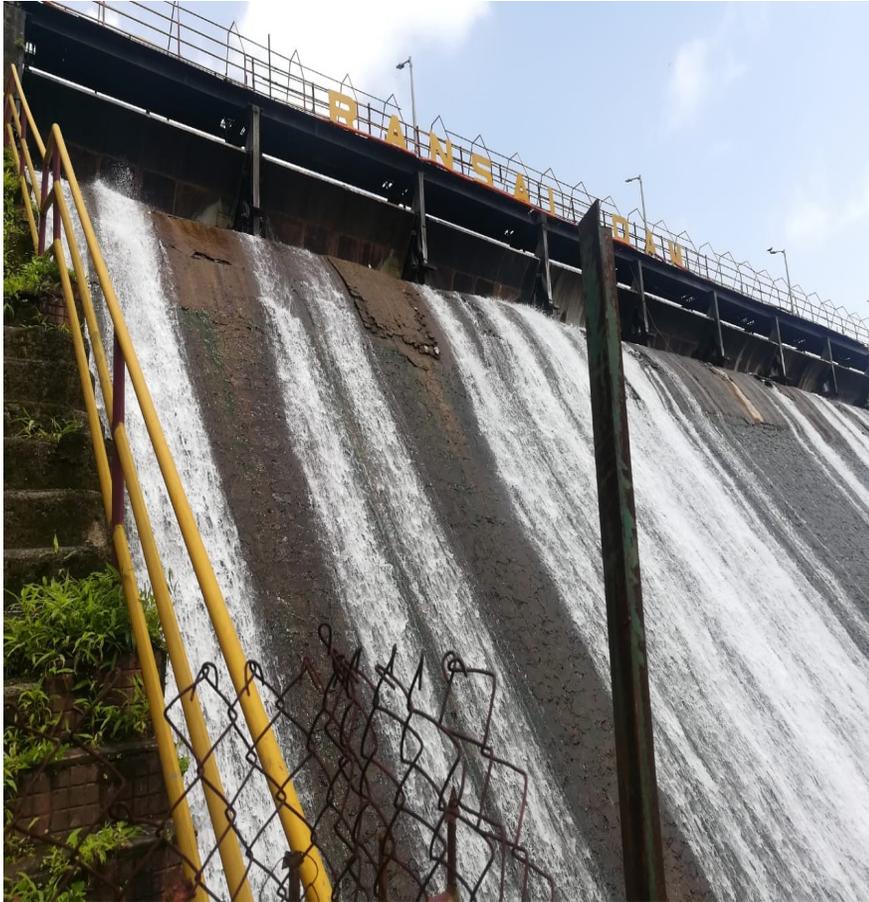
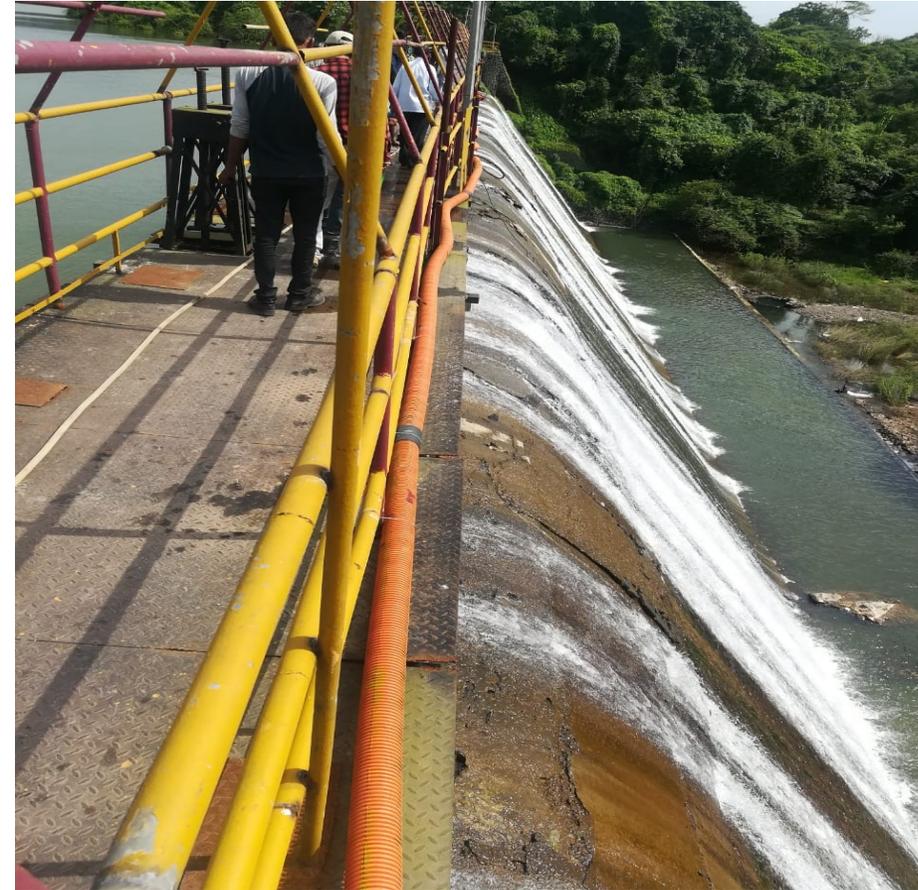
Leakages Through Body of Ransai Dam

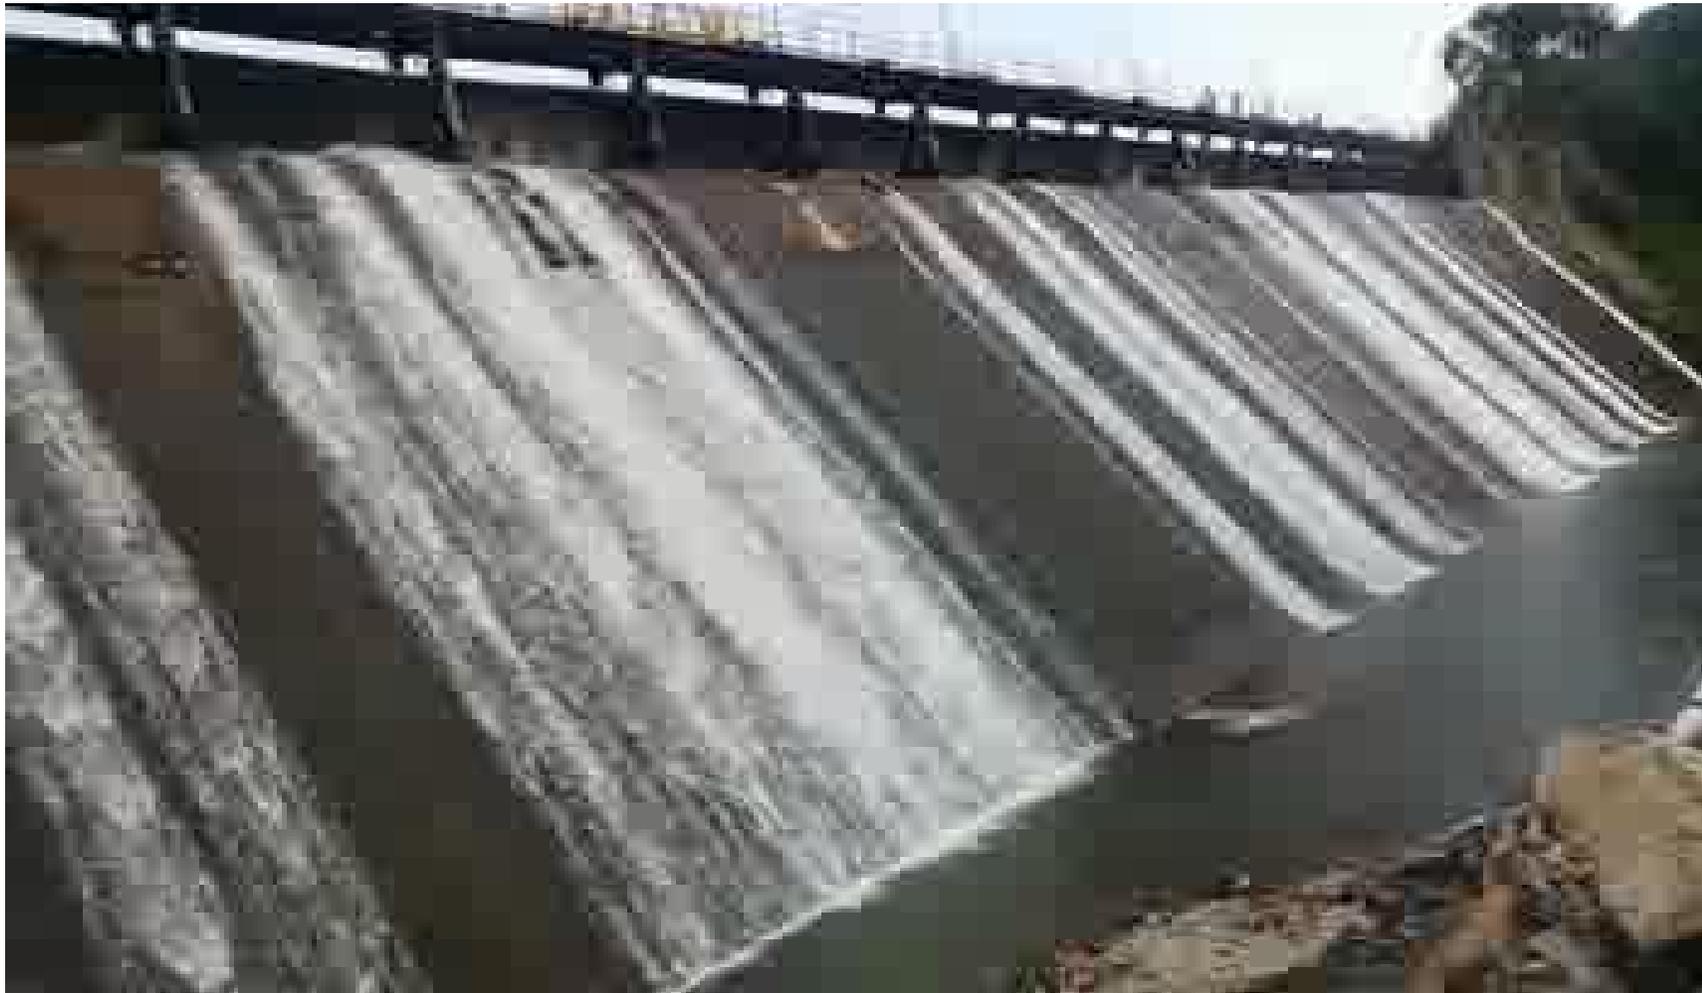
Leakages Through Body of Ransai Dam

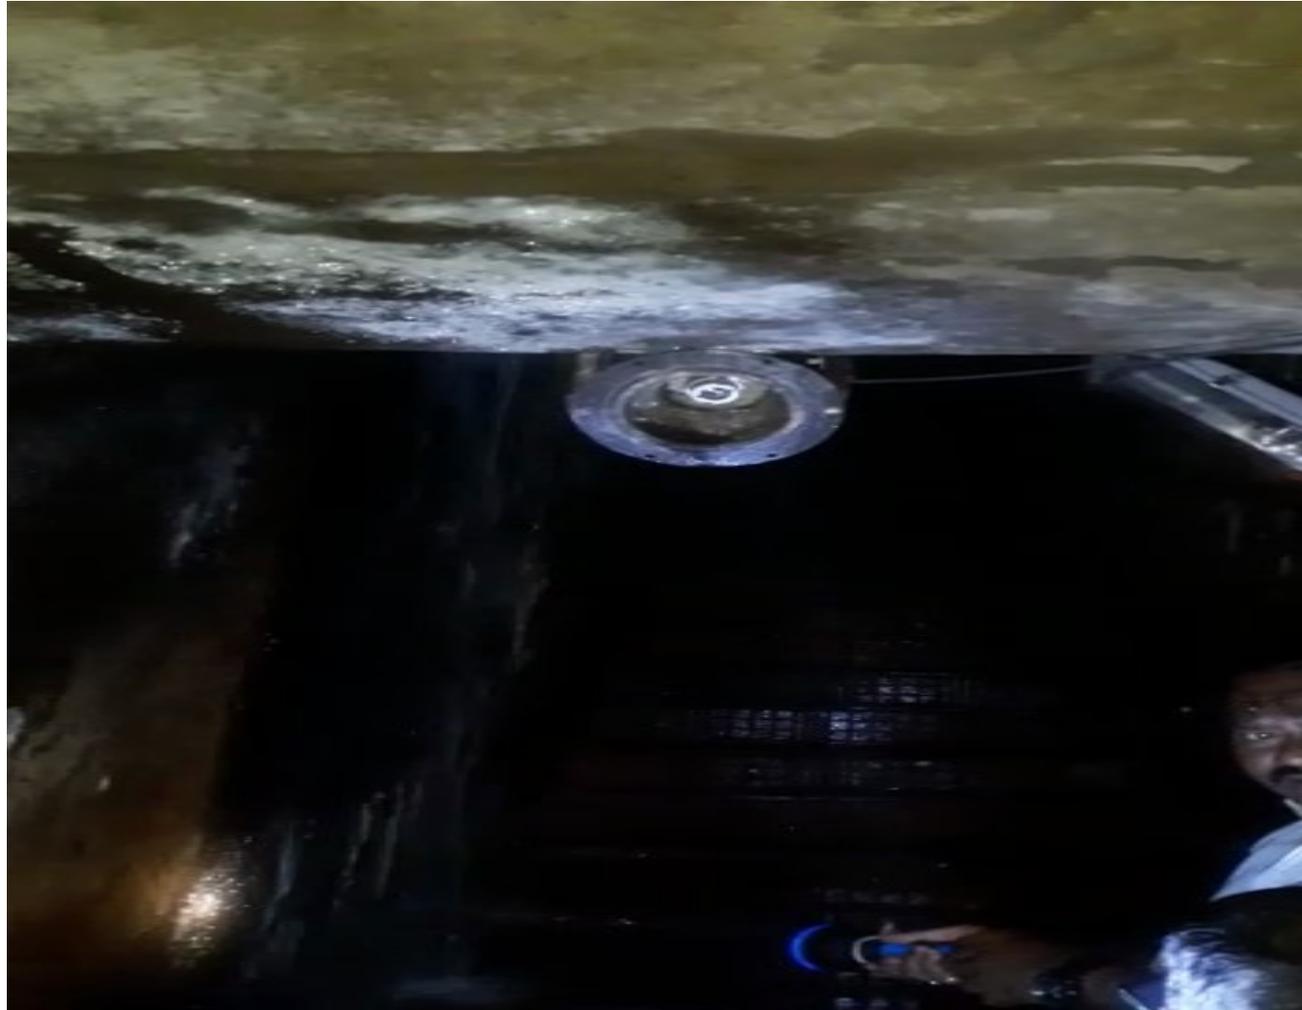
Leakages in the Inspection Gallery - Pre 2017

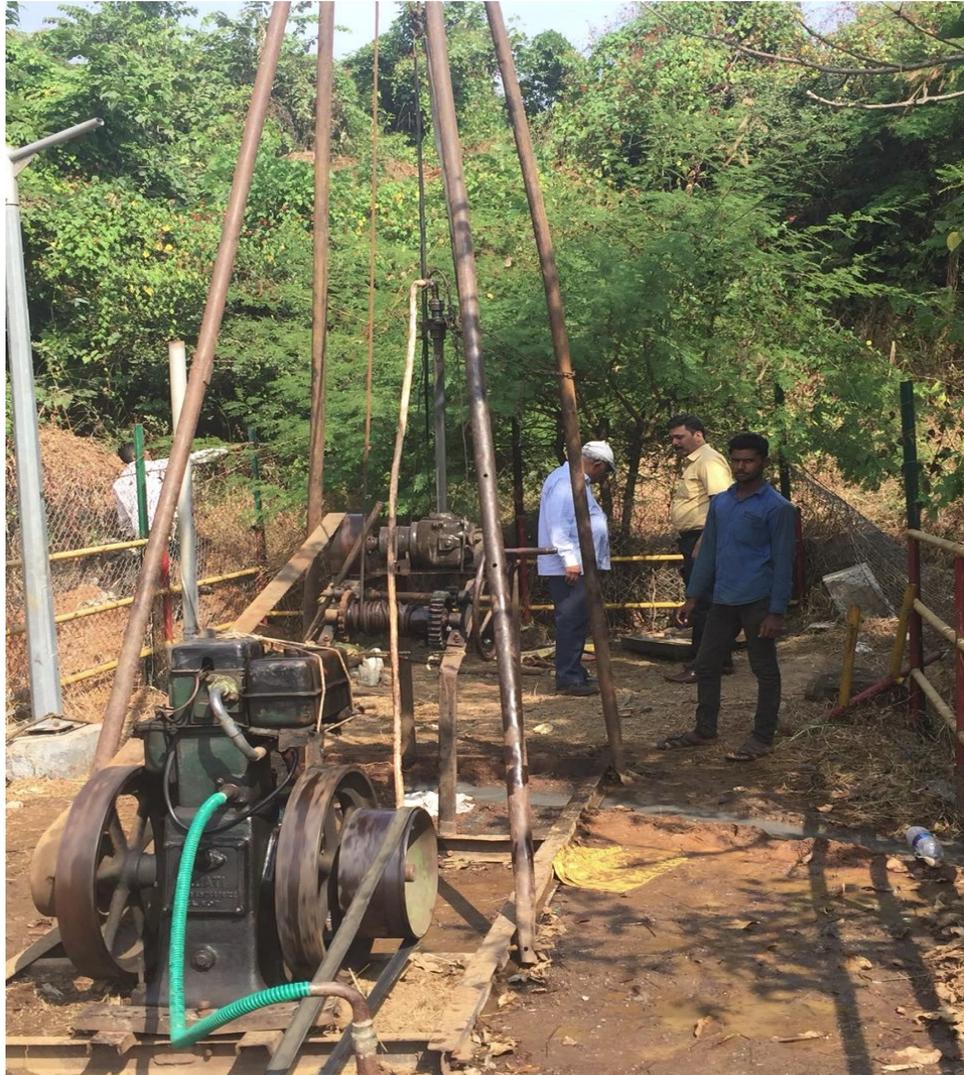
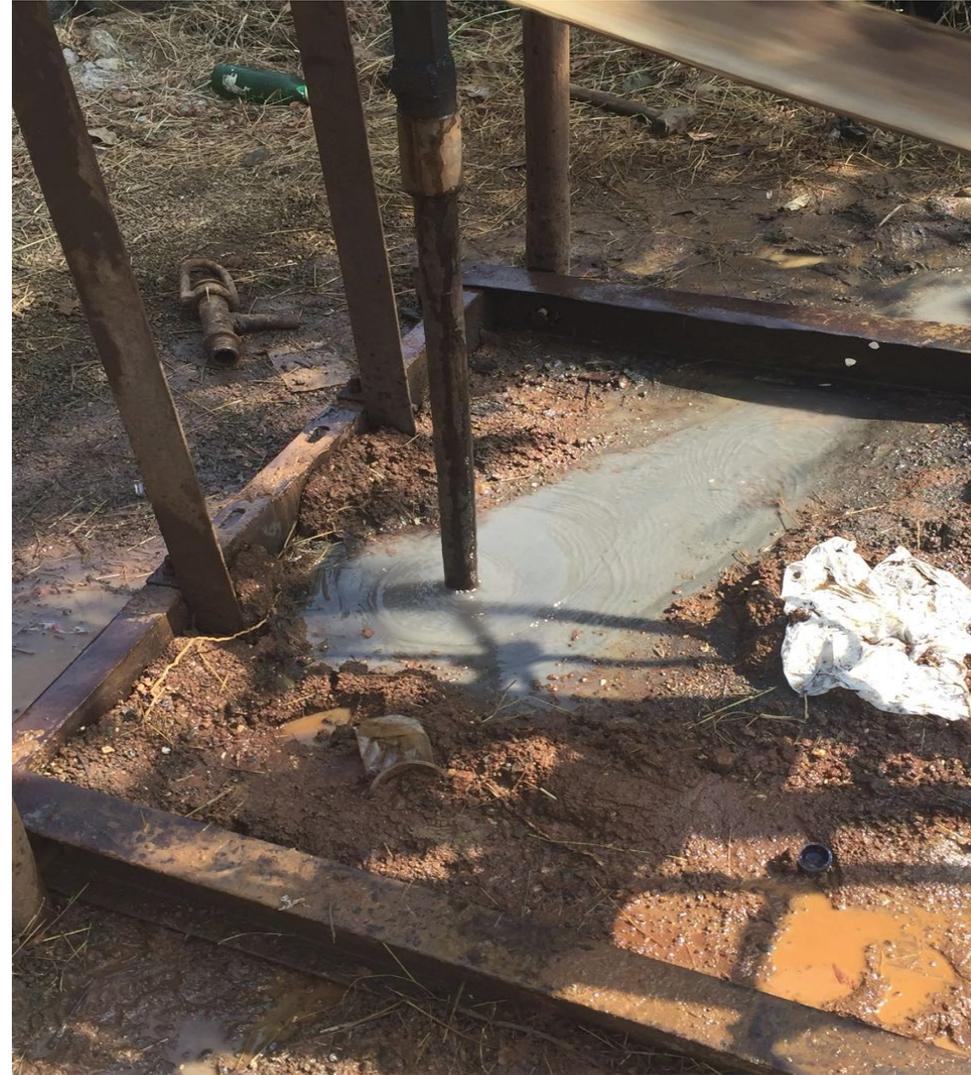
Cement Grouting

- i. Inject cement slurry to fill the larger gaps, pores, voids, tubings etc. This grout is mixed along with shrinkage compensating and w/c reducing agent - Sunplex. Allow to set.
- ii. Inject nano grout subsequently, which enters as free flowing liquid of water consistency and precipitates resulting in bonding firmly the co-matrix of a) Original dam core & b) Freshly injected and set cementitious grout. On precipitation it works as a micro filler cum binding agent.

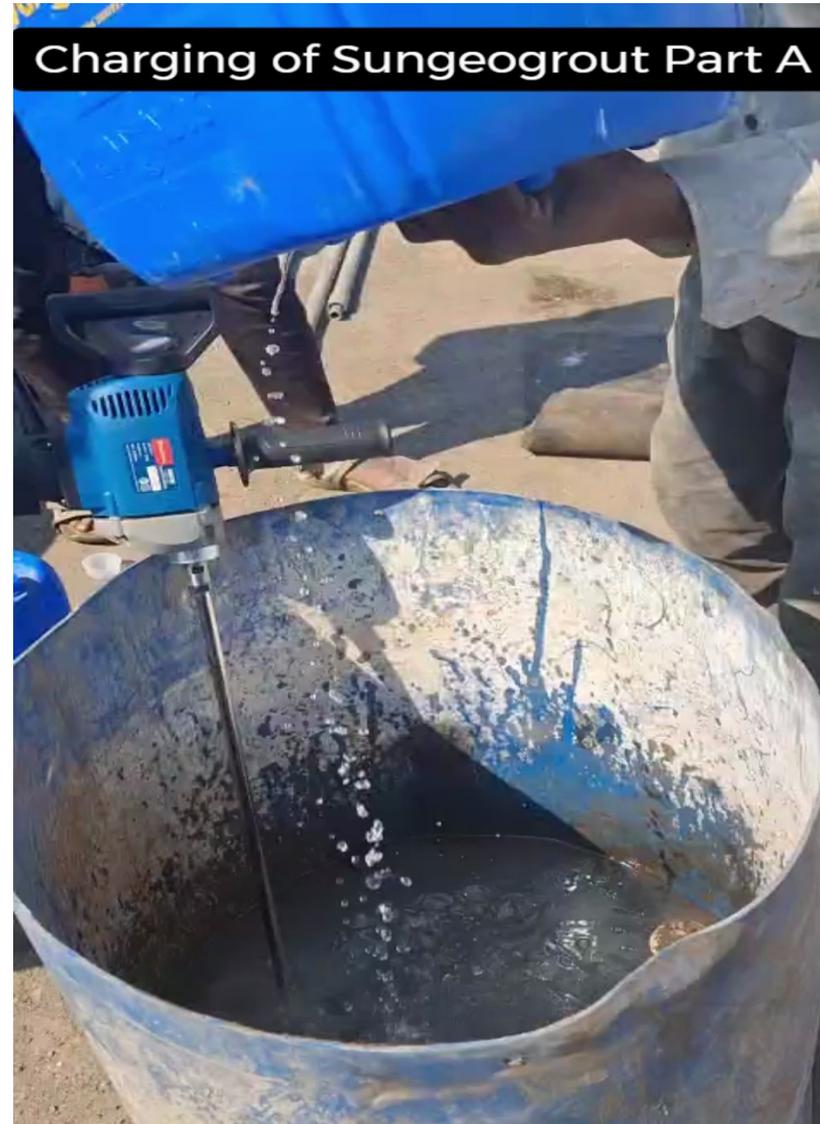
Mixing - SungeogROUT

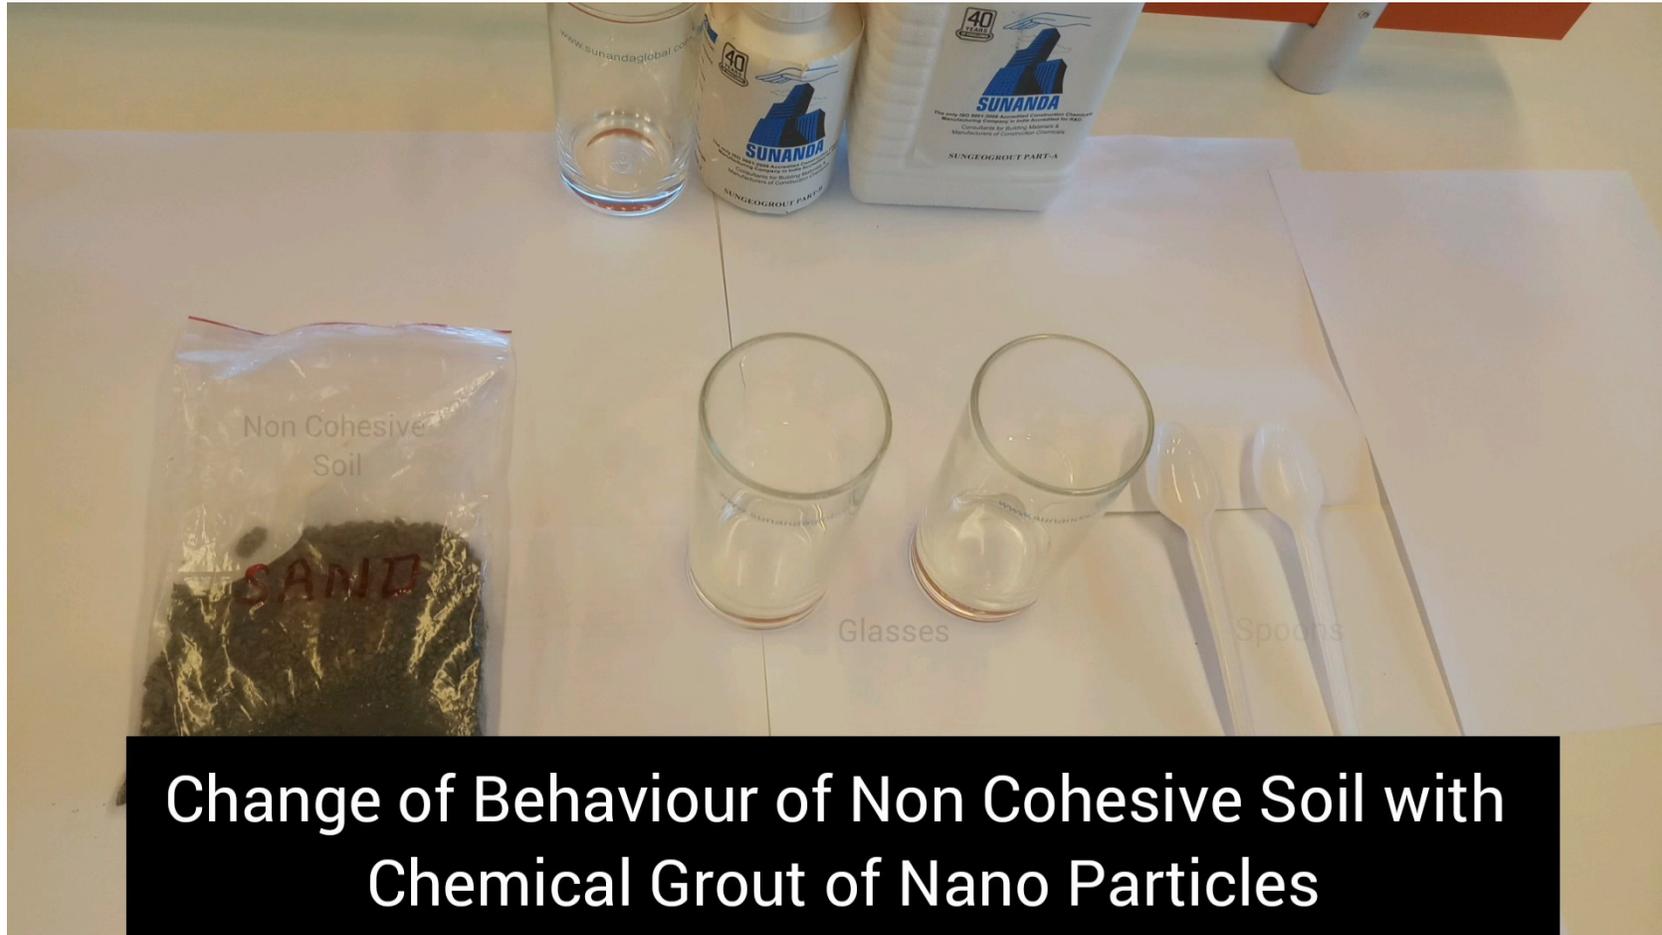
Sample Demo - SUNGEOGROUT

Change of Behaviour of Non Cohesive Soil with Chemical Grout of Nano Particles

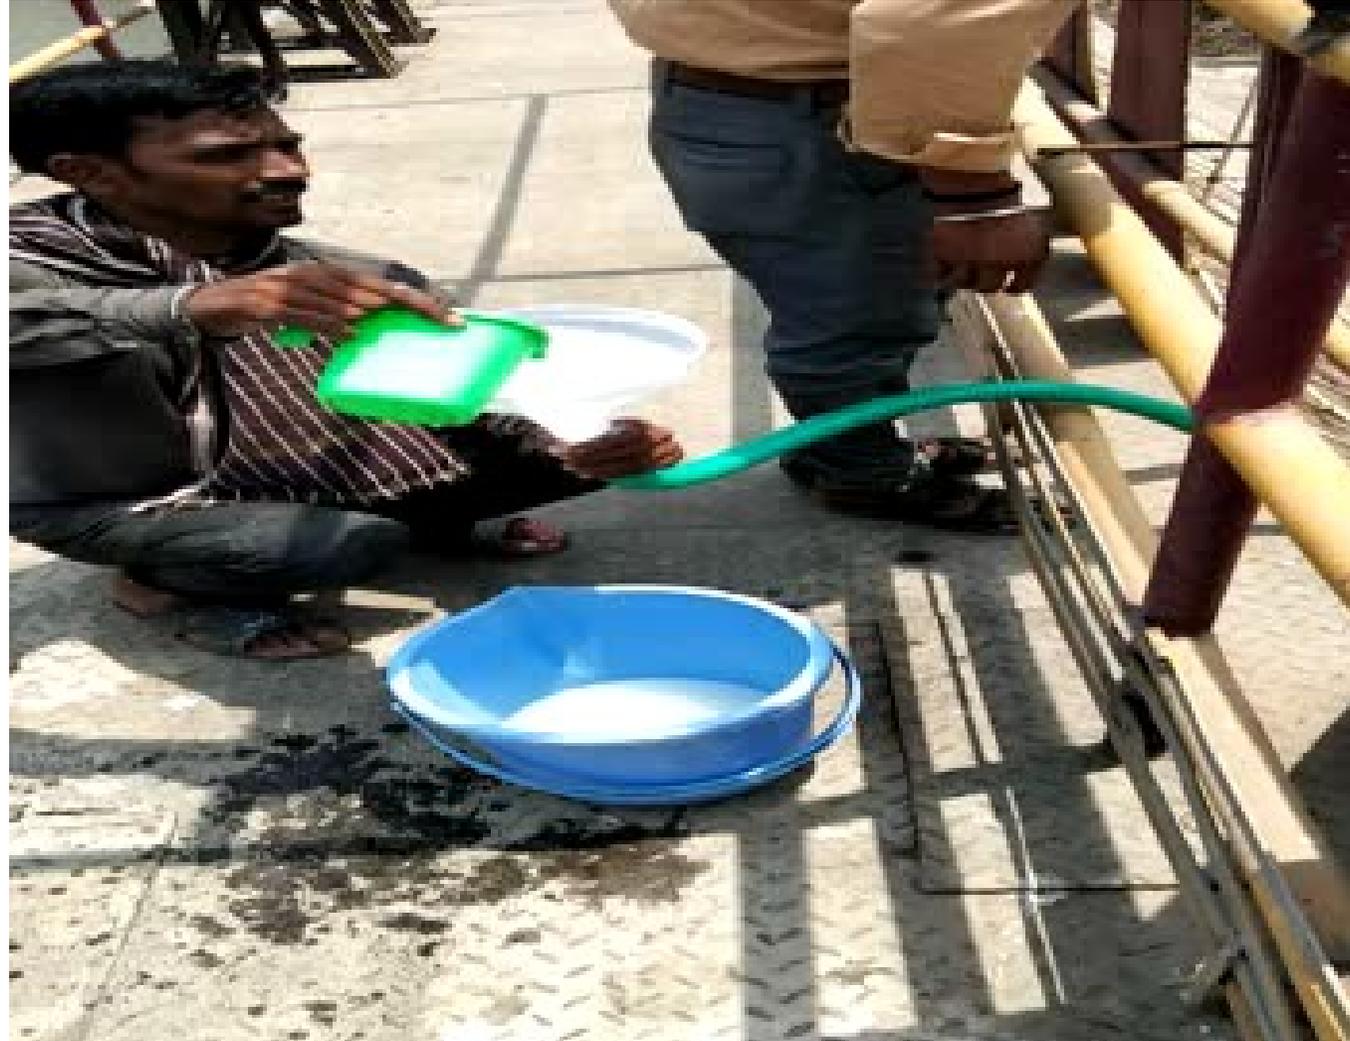
Grouting using SungeogROUT

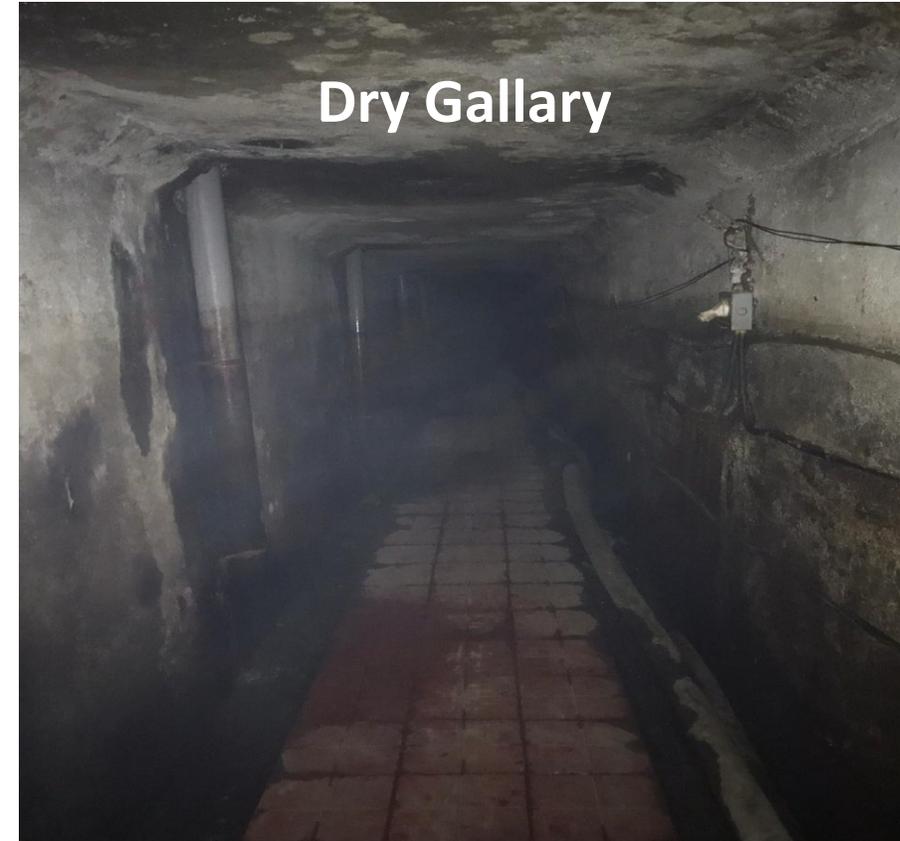
**Year 2017
After Treatment - No Leakages**

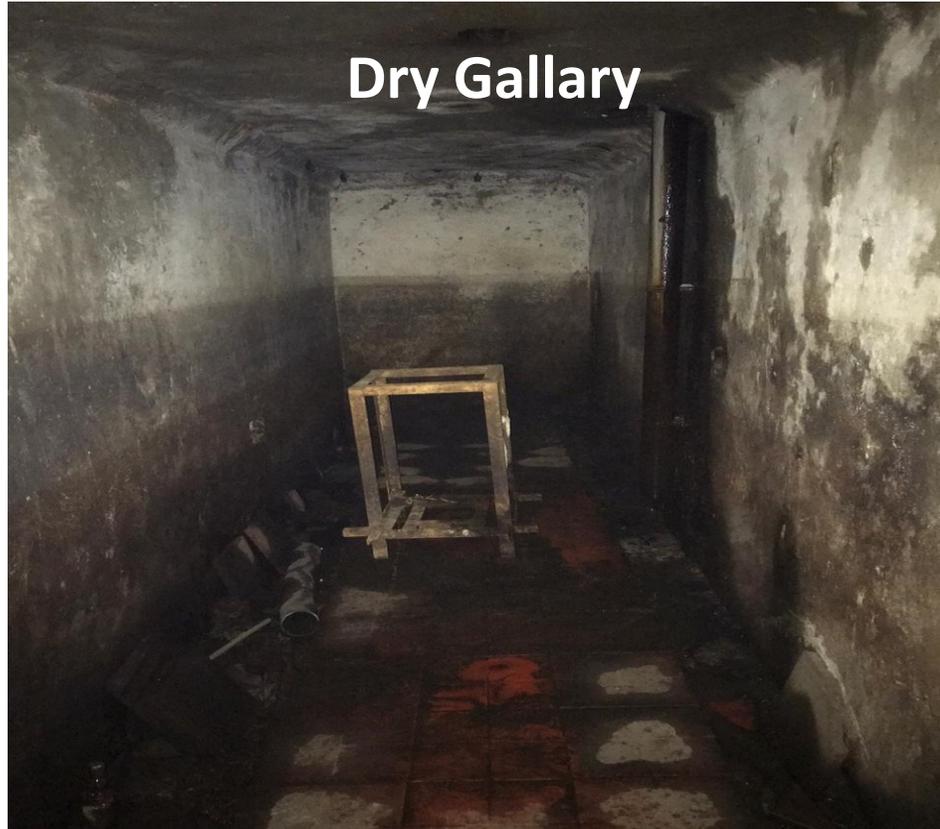
2023
Still - No Leakages

vii. Latest observations done by Dam Safety Organization (DSO) at the end of 6 years found to be without any seepage based on the conditions in the inspection gallery. DSO does the inspection visually and the permeability trials are mandatory only in the case of seepage.

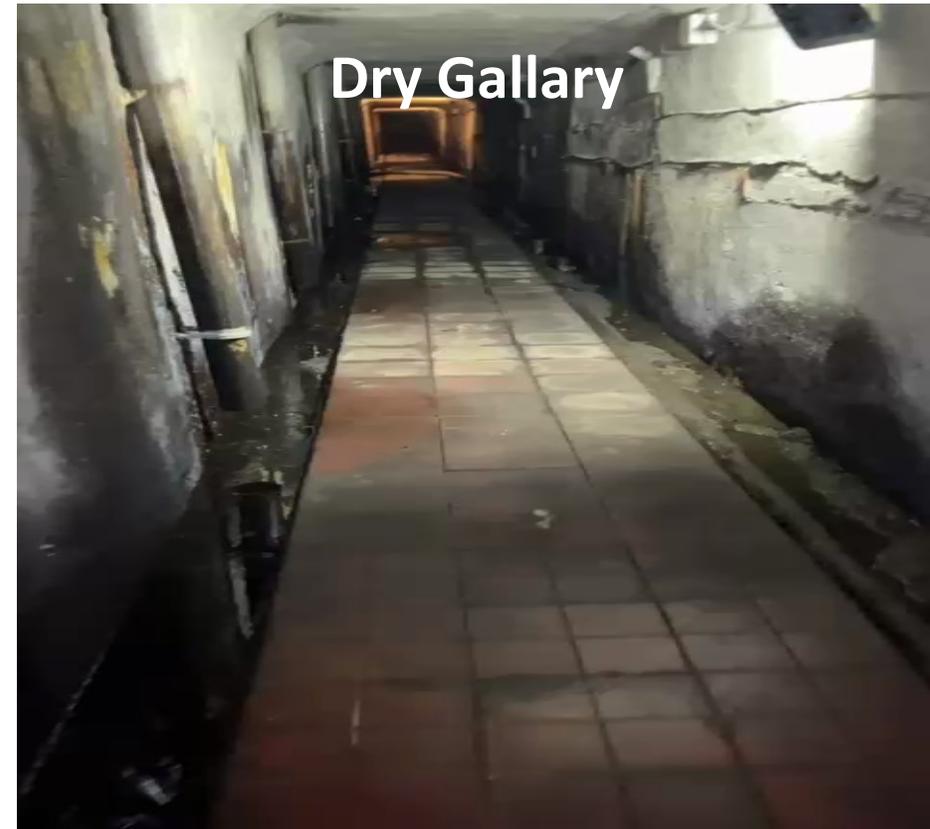
2026
Still - No Leakages
