# Evaluation and Optimization of the Instruments Installed on the Crack in Dam Block No. 9 - Karun 4 Dam & HPP Project

**Mohammad Ali Karimi<sup>1</sup>, Majid Hosseini<sup>2</sup>, Fatemeh Momeni<sup>1</sup>, Ali Dadi Givshad<sup>1</sup>**

1- AbanPazhouh Consulting Engineers, Tehran, Iran

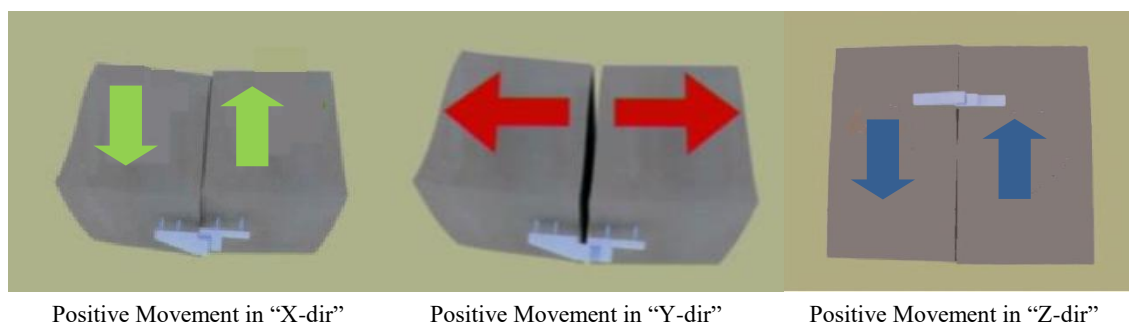
**Figure 3. Local coordinate system defined for jointmeter and crack-meter measurements**

To have a closer view and to evaluate the crack-meters & jointmeters results, the local coordinate system used for measuring the crack movements is presented in Figure 3 [2]; note that the reference for the positive movements in “X” and “Z” directions is the index jaw of the instrument.
