Monitoring of Lar Dam: Finding New Leakage Regions

Kamran Koohestani¹, Mahsa Ali-Haghezhad², Marjan Samuti³, MohammadReza Zarsazi⁴

Keywords: Dam, Leakage, Reanalyzing, Monitoring, Stability.

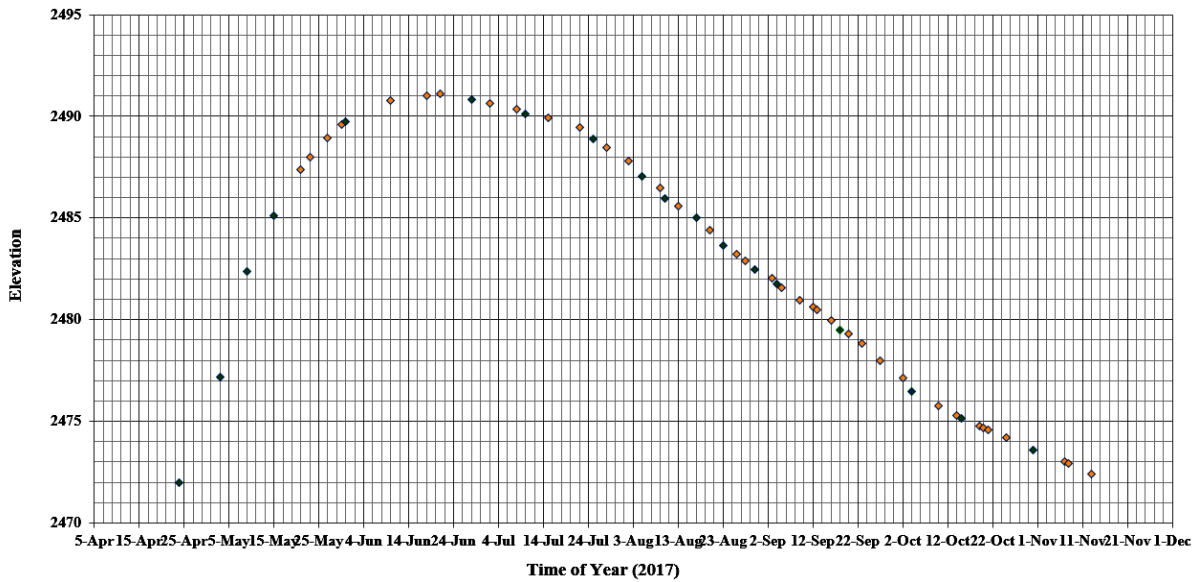
Figure 16. Changes of surface water elevation during monitoring periods

Based on these calculated value of discharge about 381L/s has 30% error. There are two important points for the discharge with the rate of 0.5 m³/s: considering 0.5 m/s for velocity of water flow was obtained by surveying of Terra Company with ADCP device. This device measures the velocity at least 1 m above the bed of reservoir. Therefore, the real velocity exactly at the place of holes probably is higher than calculated discharge. Finally, during several site visiting S.A.S Company found out there is a need to have more focus on small leakage points that could accumulatively produce a significant leakage flow rate. They also found out a loud voice, which came out from inside of the mountain at outlet points and under the lateral facilities at the right abutment, Emamanak Valley and its upstream that neglected before considered as probable leakage points. After the last field monitoring, by using the obtained data of water surface elevation in each monitoring period, the changes of water elevation during total periods of monitoring investigated (Figure.16).
