ICOLD Symposium on Sustainable Development of Dams and River Basins, 24th - 27th February, 2021, New Delhi

SUBSURFACE INVESTIGATION OF A MAJOR DAM FOUNDED IN KARSTIC TERRAIN

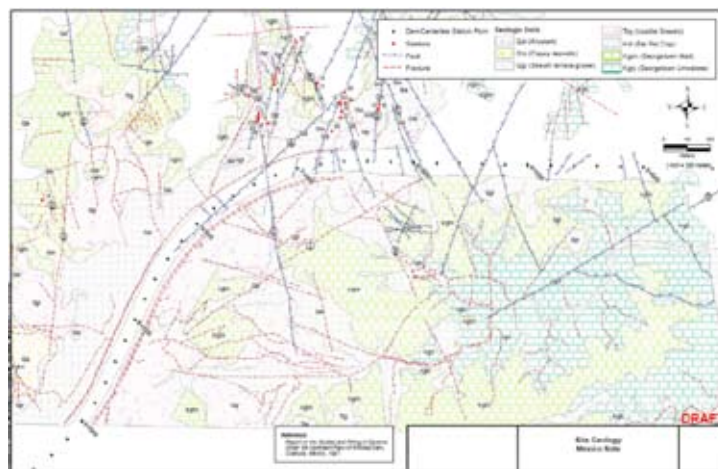
Figure 1 : Surface Geologic Map for the Western Embankment

The dam and surrounding area are within the Maverick Basin, a depositional basin that is part of the Ouachita thrust belt system. The Ouachita thrust belt is a northeast-southwest-trending structural belt that extends from the state of Arkansas to the state of Chihuahua in Mexico. The Ouachita thrust belt was formed from the late Paleozoic collision of the North and South American continental plates. This tectonic belt has resulted in a series of deep basins and exposed tectonically deformed and folded highlands (Hickman et. al., 2009). The Maverick Basin spans an area of approximately 200 square miles (mi²) (518 square kilometers [km²]) in southwest Texas and Mexico. The rocks of the Maverick Basin are predominantly Cretaceous-age marine deposits ranging from argillaceous mudstone to limestone. Figure 1 shows a geologic map of the western embankment with sinkholes.

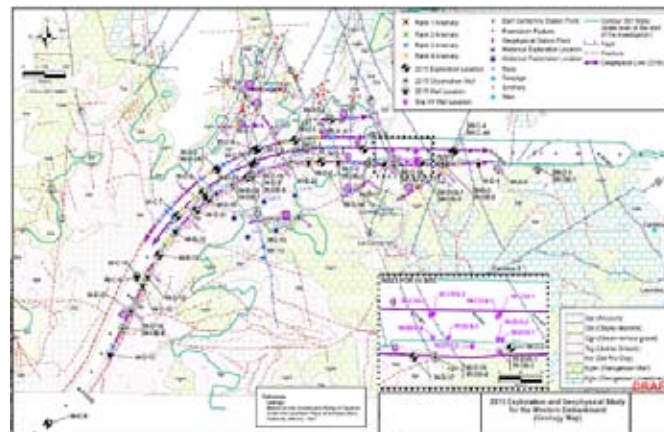
Figure 5 : Boring Location Map for the Western Embankment

The exploratory boring program consisting of 14 borings for the eastern embankment and 75 borings for the western embankment. Sonic drilling technique was used in embankment and through Alluvium, Del Rio Clay, and Georgetown Marl. Rock coring was performed in Georgetown Limestone. Total depths of 48 upstream and downstream borings ranged between 10 and 155 feet. Total depths of 27 crest borings ranged between 20 and 163 feet. Water pressure tests were also performed in Georgetown Limestone layers. Figure 5 shows a boring location map for the western embankment.

- Near known sinkhole locations
- Selected anomalies identified by surface geophysical surveys
- At mapped geologic features such as mapped faults and fractures
- Near known seepage exit locations
- Cavities identified during construction and known foundation treatment areas such as near V-4 seepage area
- Surface topography and geologic mapping indicating surface depressions or historic channels
- Near potential seepage path identified in historical and recent dye tracer study
- At selected locations through recently completed grouting in upstream toe

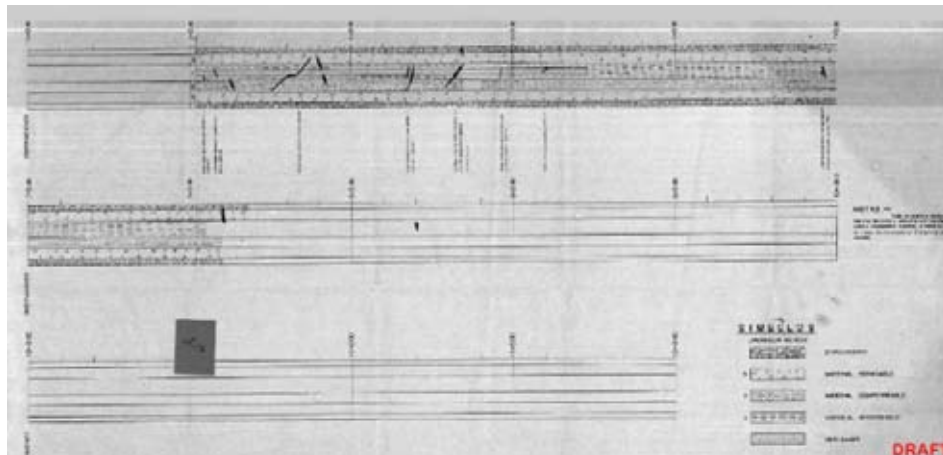
Figure 7 : Foundation Treatment Map for the Western Embankment

Historical foundation maps shows foundation treatment areas between Sta. 5+520 and Sta. 8+100. The large cavities that were infilled with concrete were generally oblique to the dam alignment. A total of 13 concrete infilling areas are present between Sta. 5+520 and Sta. 8+100. A single isolated concrete infilling area is also present outside of this zone, at Sta. 8+700. A dental concrete zone is shown within the clay core footprint between Sta. 5+520 and Sta. 6+725.

As excessive seepage was found on the western embankment since water impoundment in 1969, a French drain system was installed near Sta. 6+460 in 1973. This area is within a portion of the western embankment, where large cavities were encountered during construction and foundation treatment techniques included grouting, dental concrete, and concrete infilling of large cavities. V-4 area is also near the Georgetown Marl and Georgetown Limestone contact along the longitudinal profile and near multiple mapped faults. Figure 6 shows photographs of large cavities at Station 6+460 that were filled during construction. Figure 7 shows a map of foundation treatment in the western embankment.
